Model: <b>Stella-C3</b>	Date: 23-Aug-06	No.: RB262001e
-------------------------	-----------------	----------------

Subject: Firmware Release Note: Engine		Prepared by: M.Ishihara	
From: 1st Tech. Support Sec. Service Support Dept.			
Classification:	<input type="checkbox"/> Troubleshooting <input type="checkbox"/> Part information <input type="checkbox"/> Action required		
	<input type="checkbox"/> Mechanical <input type="checkbox"/> Electrical <input type="checkbox"/> Service manual revision		
	<input type="checkbox"/> Paper path <input type="checkbox"/> Transmit/receive <input type="checkbox"/> Retrofit information		
	<input checked="" type="checkbox"/> Other (       )

This RTB has been issued to announce the firmware release information for the **Engine (BICU-IC)**.

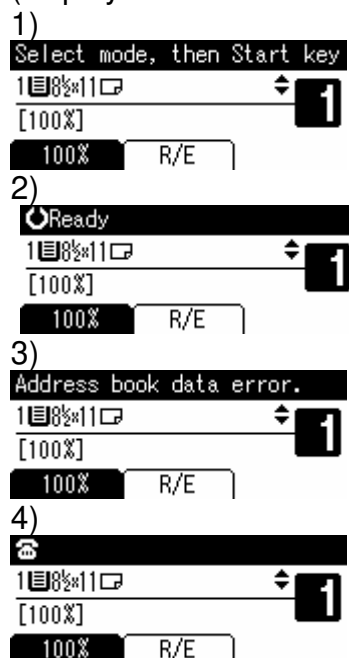
**Note:** This only occurs on some CF and CPSF models.

Screen samples #1-4 shown below are displayed in order, and then #2-4 are displayed (display interval: 3.5 sec).

The cover for the Fax or Printer/Scanner SD card was pressed by mistake (at the factory in some cases). As a result, the SD card comes loose.

1. Temporary: Two rubber pads (P/N B2621258) were added between the card cover and GW controller, so that the card does not come loose if the cover is pressed.
2. Permanent: The shape of the card cover was changed so that the card does not come loose if the cover is pressed.

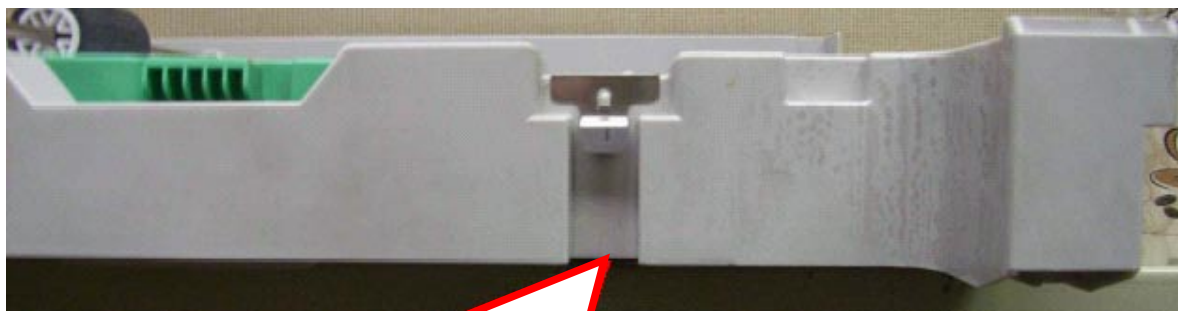
### B0442709/ B2622709

Electrical noise is being generated and it causes image control to function incorrectly. The possible symptoms caused by the electrical noise are SC929s, paper jams, and intermittent digital lines on copies. Static electricity is the source of this electrical noise.

One or both grounding plates on the bottom of the main body paper cassette may not be making proper contact. Reform or replace the grounding plates so that they make proper electrical contact.

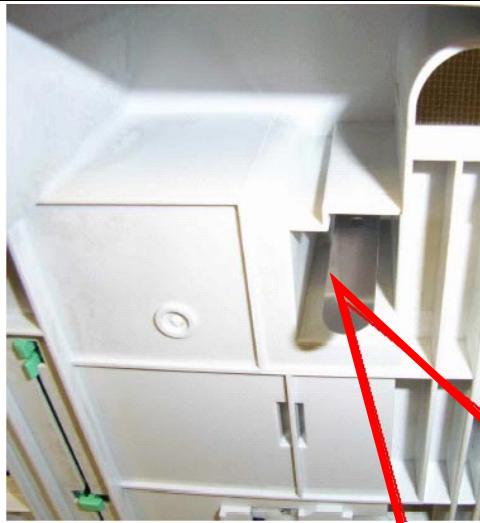
**B0442711/ B2622711****Bottom View of Cassette**

The above photograph is showing the front bottom view of the cassette.

Make sure to form the grounding plate to the rear so that it makes contact with the bottom machine frame.

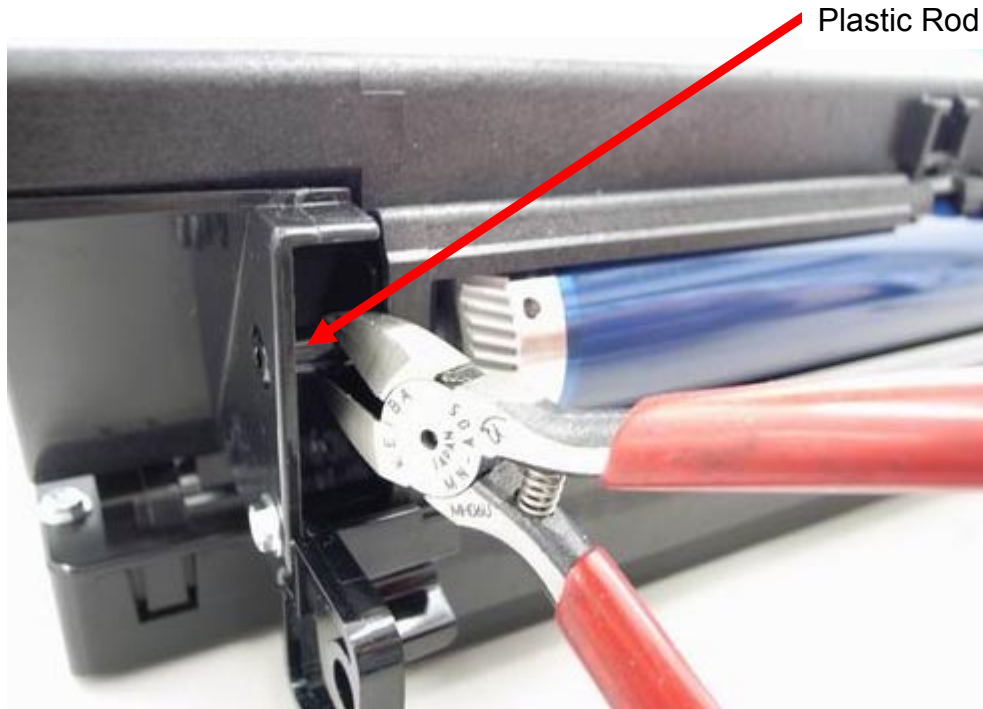
During the installation of a new machine, developer leaks out of the PCU.

1. Cut and remove the plastic rod using a pair of needle-nosed pliers.

**Note:** There is no side effect created by removing this rod from the PCU (even from a normal PCU).

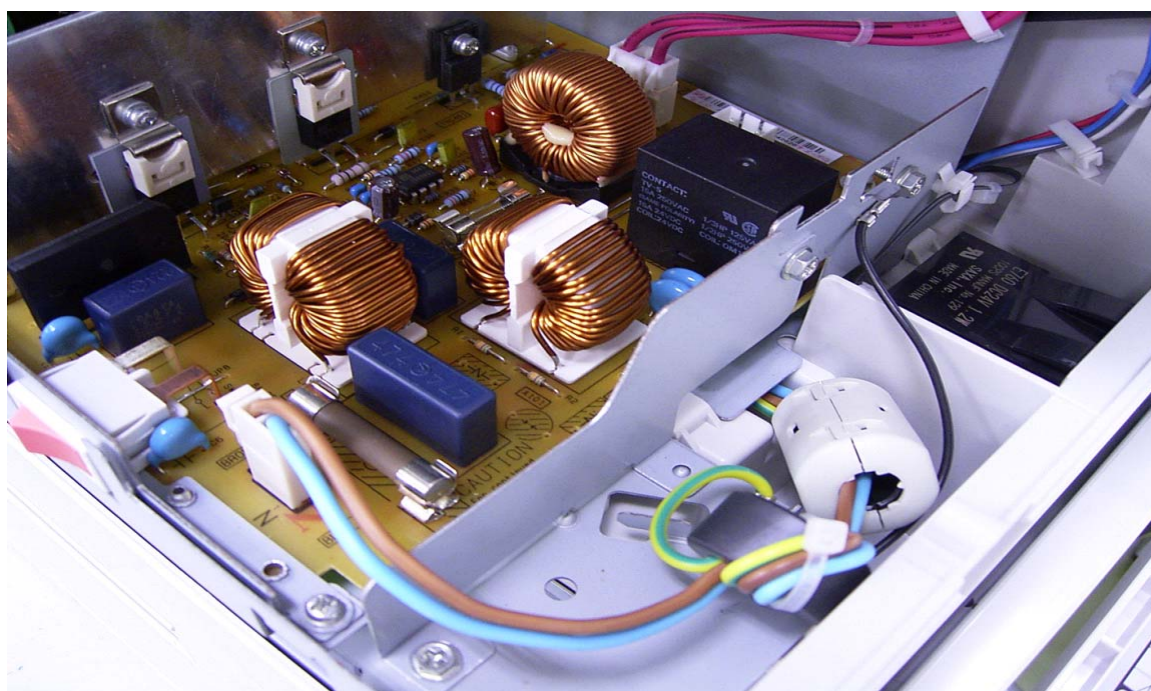
***The brown and the blue wires are the power supply cord.***

***The ferrite core (white one) pinches the power supply cord.***
