Model: Stella-C4	Date: 13-Jan-09	No.: RD067001
-------------------------	-----------------	---------------

Subject: Firmware Release Note: Engine(BICU-IC)		Prepared by: M. Ishihara	
From: 1st Tech. Support Sec. Service Support Dept.			
Classification:	<input type="checkbox"/> Troubleshooting	<input type="checkbox"/> Part information	<input type="checkbox"/> Action required
	<input type="checkbox"/> Mechanical	<input type="checkbox"/> Electrical	<input type="checkbox"/> Service manual revision
	<input type="checkbox"/> Paper path	<input type="checkbox"/> Transmit/receive	<input type="checkbox"/> Retrofit information
	<input type="checkbox"/> Product Safety	<input checked="" type="checkbox"/> Other ()	<input checked="" type="checkbox"/> Tier 2

This RTB has been issued to announce the firmware release information for the **Engine(BICU-IC)**

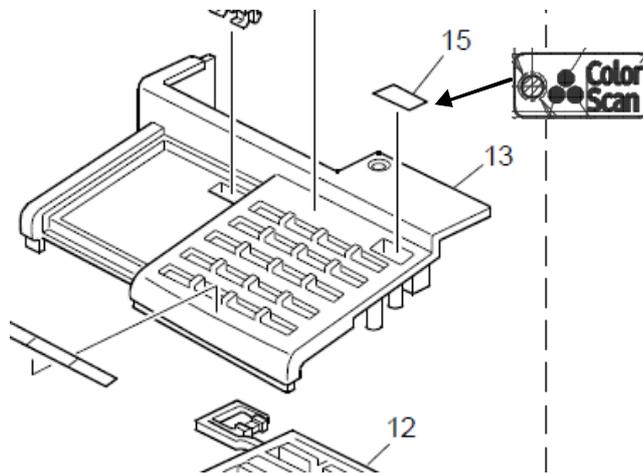
Change/Reason: The "Color Scan" decal was missing from the parts catalog.

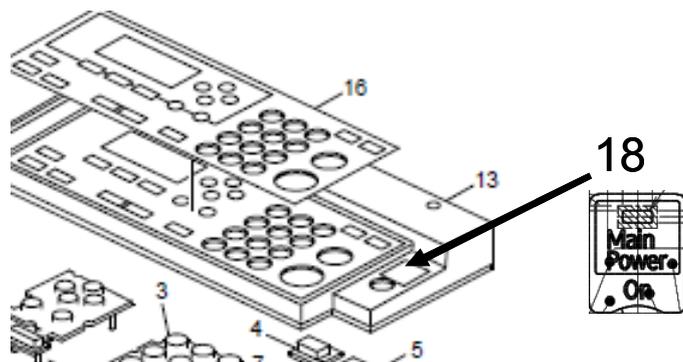
Change/Reason: The "Main Power On" decal was missing from the parts catalog.

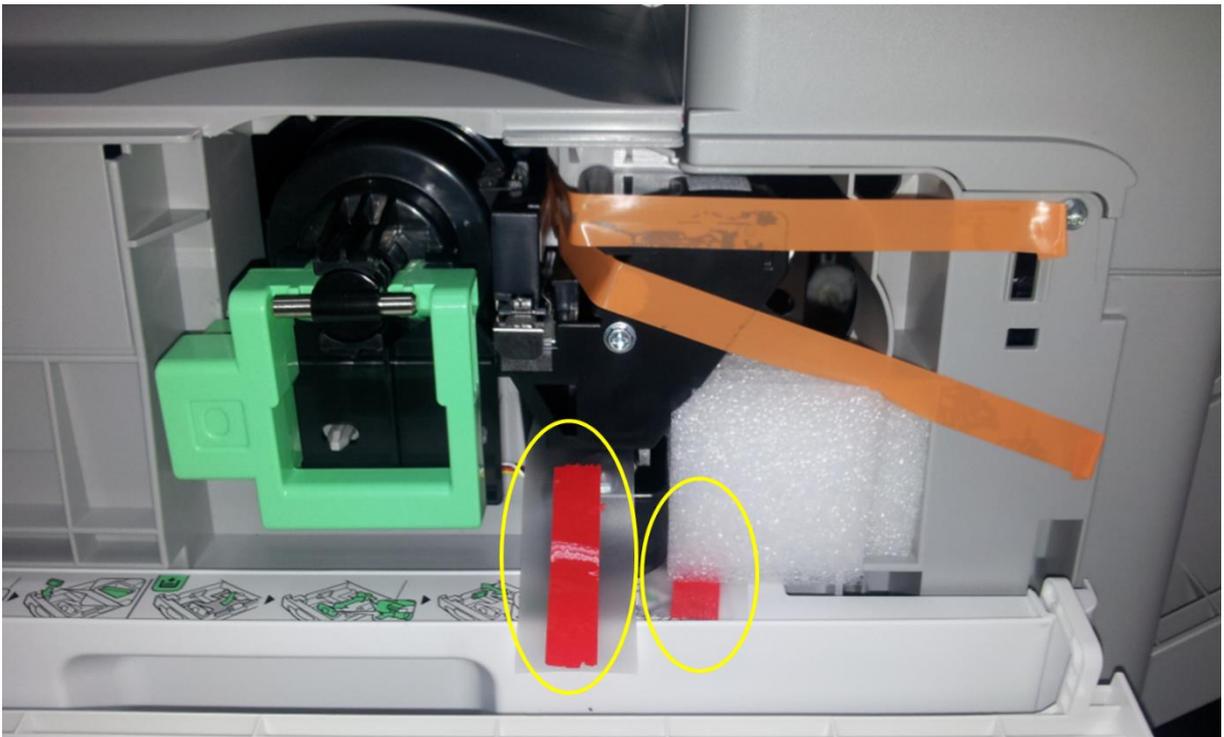
1. The strips of red tape (circled below) were changed.

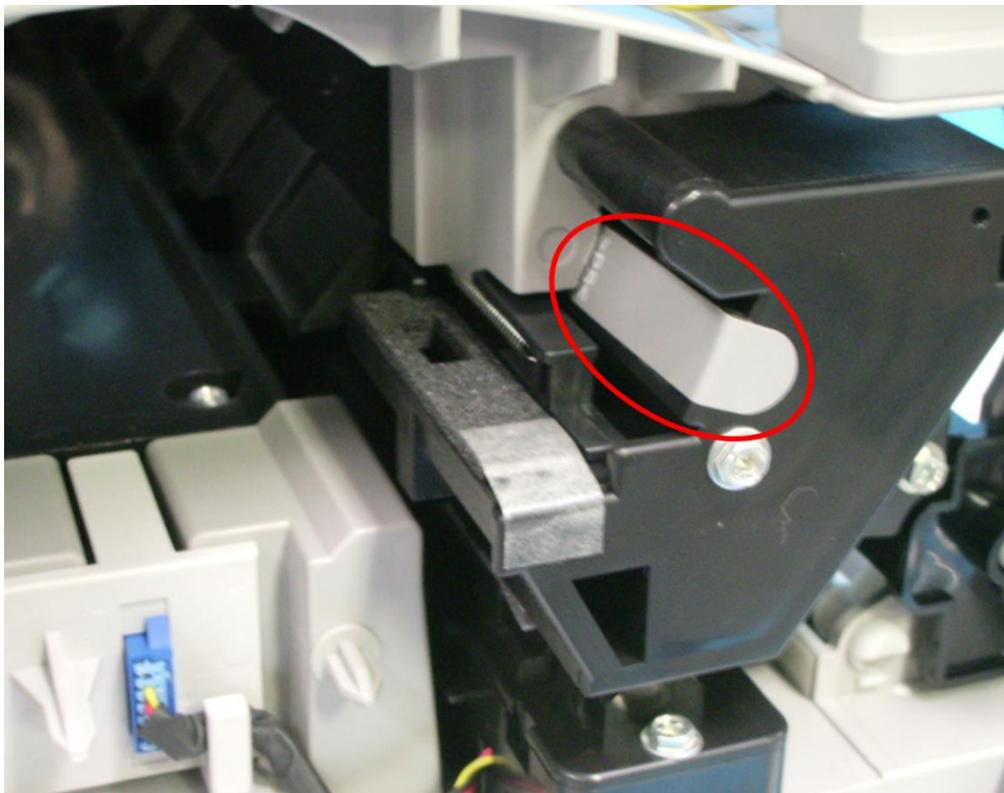
2. The seal affixed to the area circled in the photo was deleted.

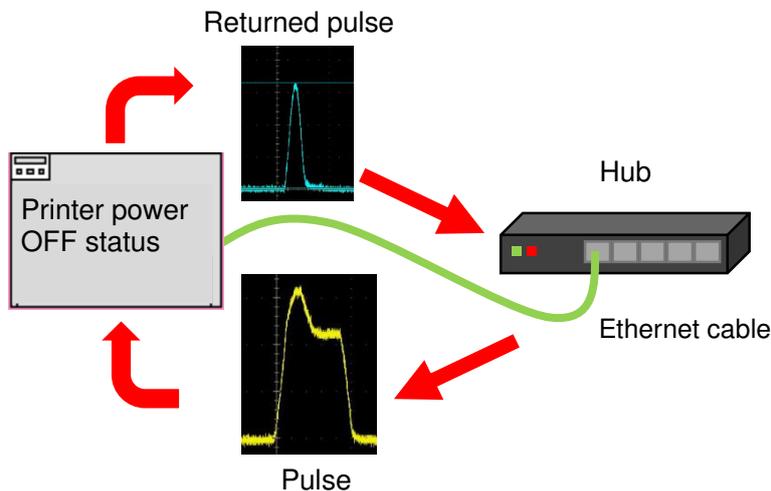
CAUSE

Pulse generated from hubs are transmitted to the printer while the printer is switched OFF (or unplugged). After transmitted to the printer, it then returns to the hub, causing interference in network communication.

SOLUTION

The circuit on the Controller Board was modified.
