Model: S-C4.5	Date: 26-Jan-11	No.: RD115004a
---------------	-----------------	----------------

Subject: Firmware Release Note: Engine		Prepared by: M.Ishihara	
From: 3rd Tech Service Sect., MFP/Printer Tech Service Dept			
Classification:	<input type="checkbox"/> Troubleshooting <input type="checkbox"/> Mechanical <input type="checkbox"/> Paper path <input type="checkbox"/> Product Safety	<input type="checkbox"/> Part information <input type="checkbox"/> Electrical <input type="checkbox"/> Transmit/receive <input checked="" type="checkbox"/> Other (Firmware)	<input type="checkbox"/> Action required <input type="checkbox"/> Service manual revision <input type="checkbox"/> Retrofit information <input checked="" type="checkbox"/> Tier 2

Subject: Troubleshooting for SC870		Prepared by: I. Soh	
From: 2nd Overseas Tech Support Sec.. 2nd PQM Dept			
Classification:	<input checked="" type="checkbox"/> Troubleshooting	<input type="checkbox"/> Part information	<input type="checkbox"/> Action required
	<input type="checkbox"/> Mechanical	<input type="checkbox"/> Electrical	<input type="checkbox"/> Service manual revision
	<input type="checkbox"/> Paper path	<input type="checkbox"/> Transmi

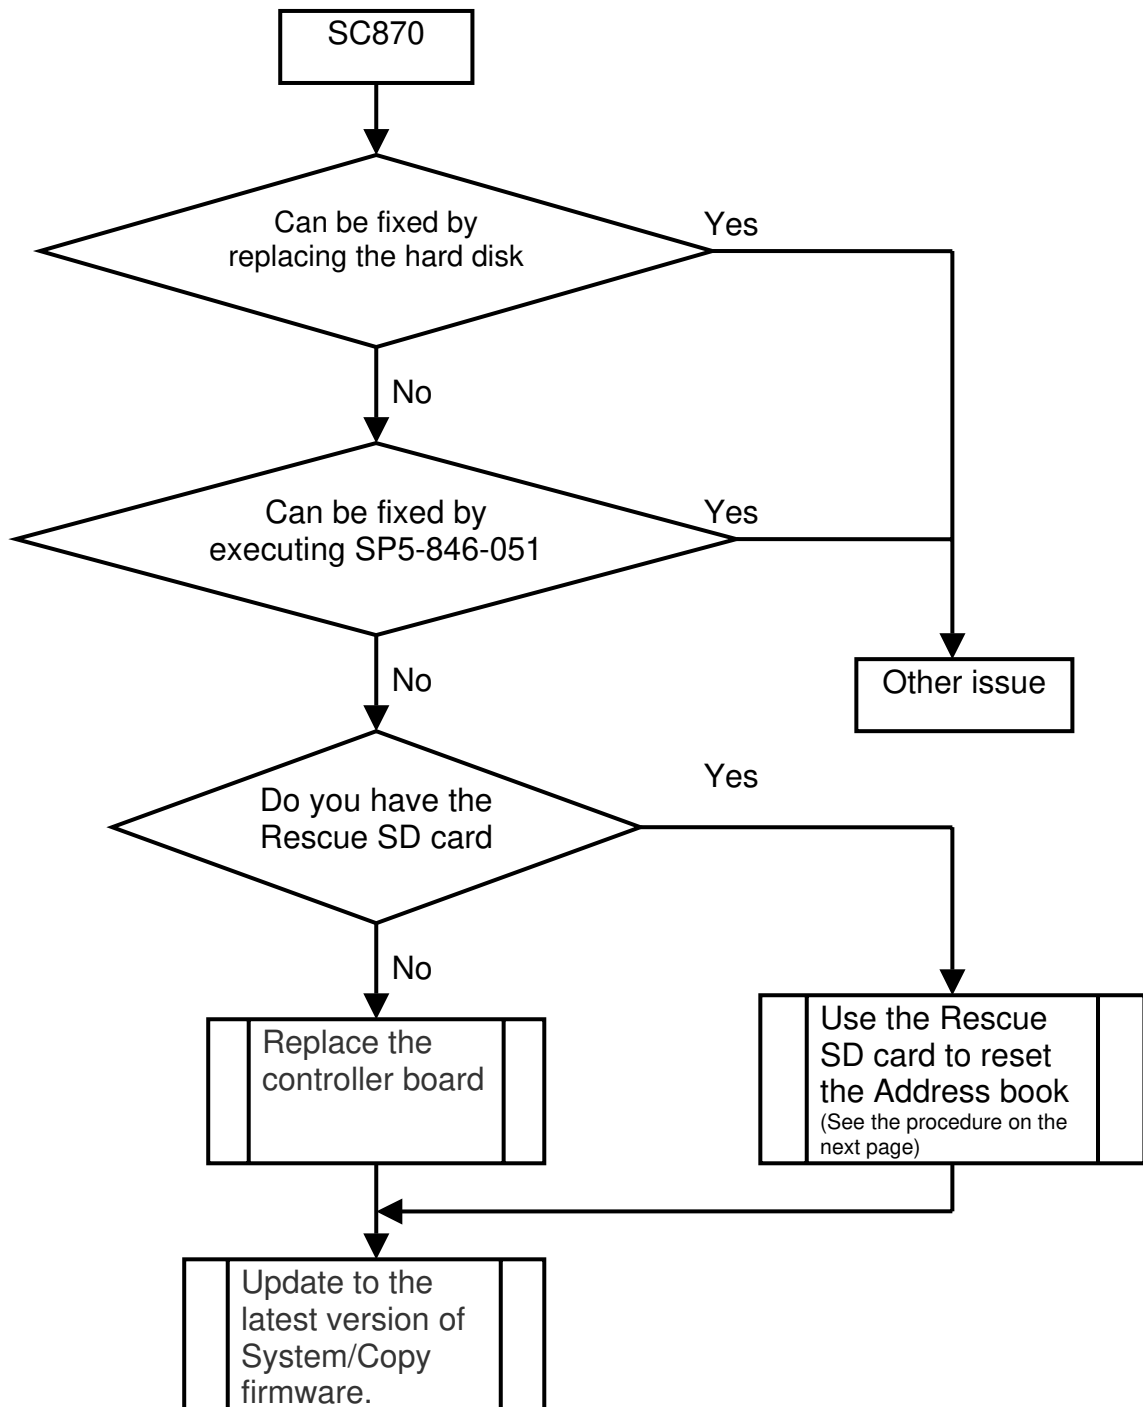
Action in the field

SC870 is triggered and cannot be cleared unless you replace the controller board.

The main power switch is turned off while data is being written to the Address Book.

Use the rescue SD card to reset the Address book, and then update to the newest version of System/Copy firmware.

Rescue SD card Applying Procedure

- 1) Turn the main switch ON. --->"Address book data error" will be displayed on the operation panel.
- 2) Insert the rescue SD card in slot # 1 (upper slot).
- 3) Wait for 30 seconds. --->Nothing will be displayed on the operation panel.
- 4) Turn the main switch OFF.
- 5) Remove the rescue SD card from slot # 1 (upper slot).
- 6) Turn the main switch ON. ---> You can confirm that "Address book data error" does not appear in the operation panel.
- 7) Perform SP5-846-050 (Initialize All Address Book Data) to initialize the address book data.
- 8) Turn the main switch OFF and ON.

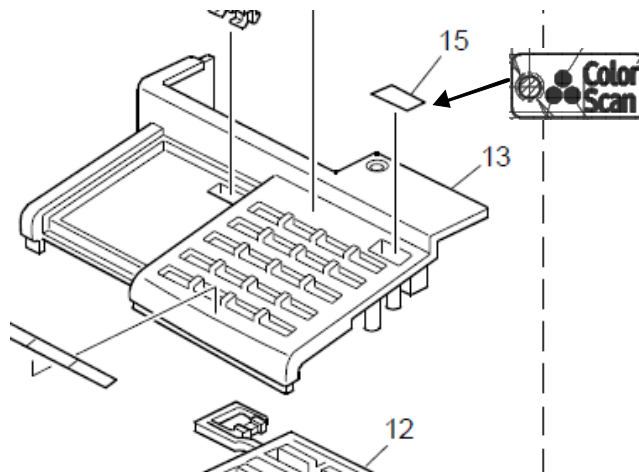
Change/Reason: The "Color Scan" decal was missing from the parts catalog.

Old part number	New part number	Description	Q'ty	Int	Page	Index	Note
	B2621467	SHEET:DISPLAY:EXPAND:B:NA	1-1		11	15

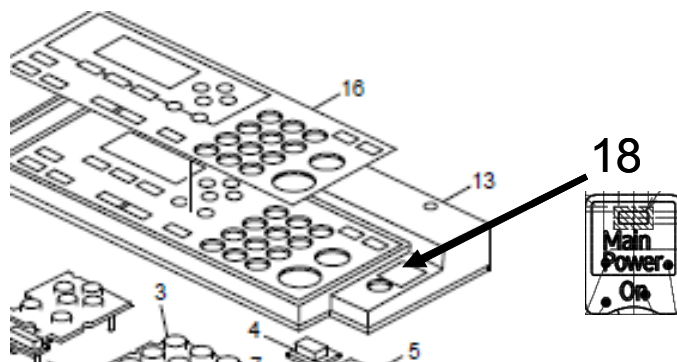
Change/Reason: The "Main Power On" decal was missing from the parts catalog.

Old part number	New part number	Description	Q'ty	Int	Page	Index	Note
	B2621458	SHEET:DISPLAY:POWER SOURCE:NA	1-1		9	18

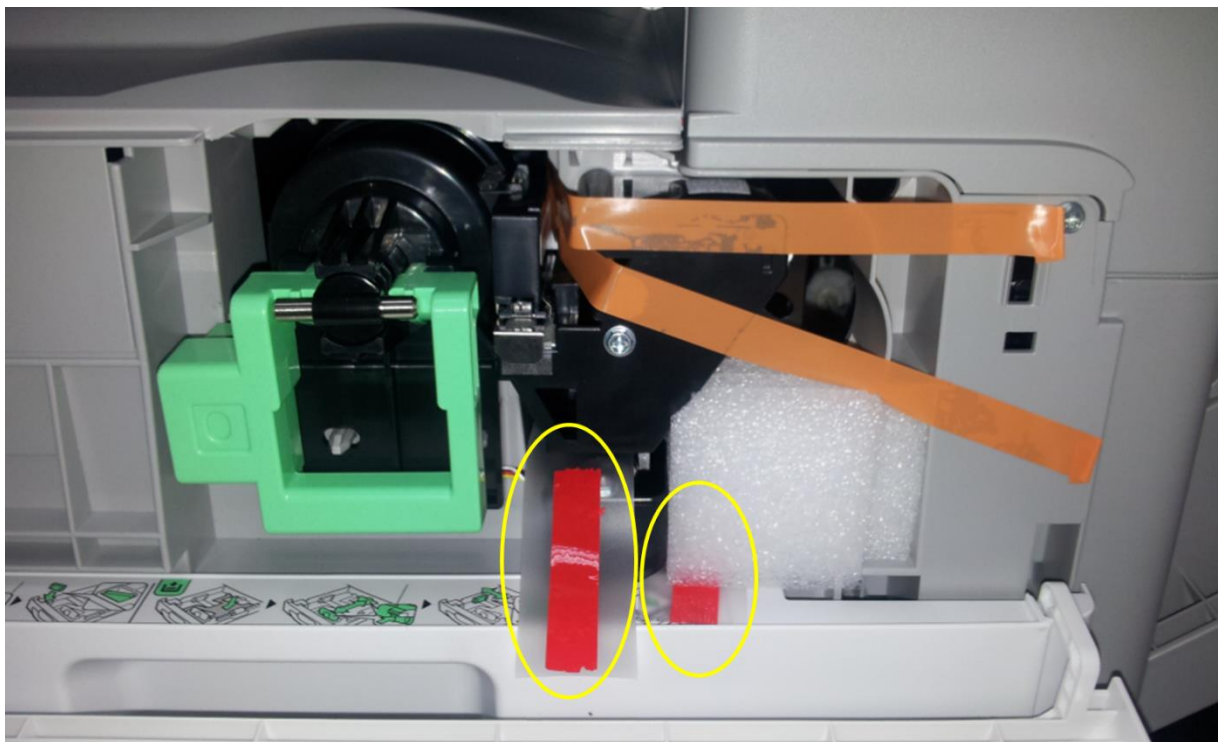
1. The strips of red tape (circled below) were changed.

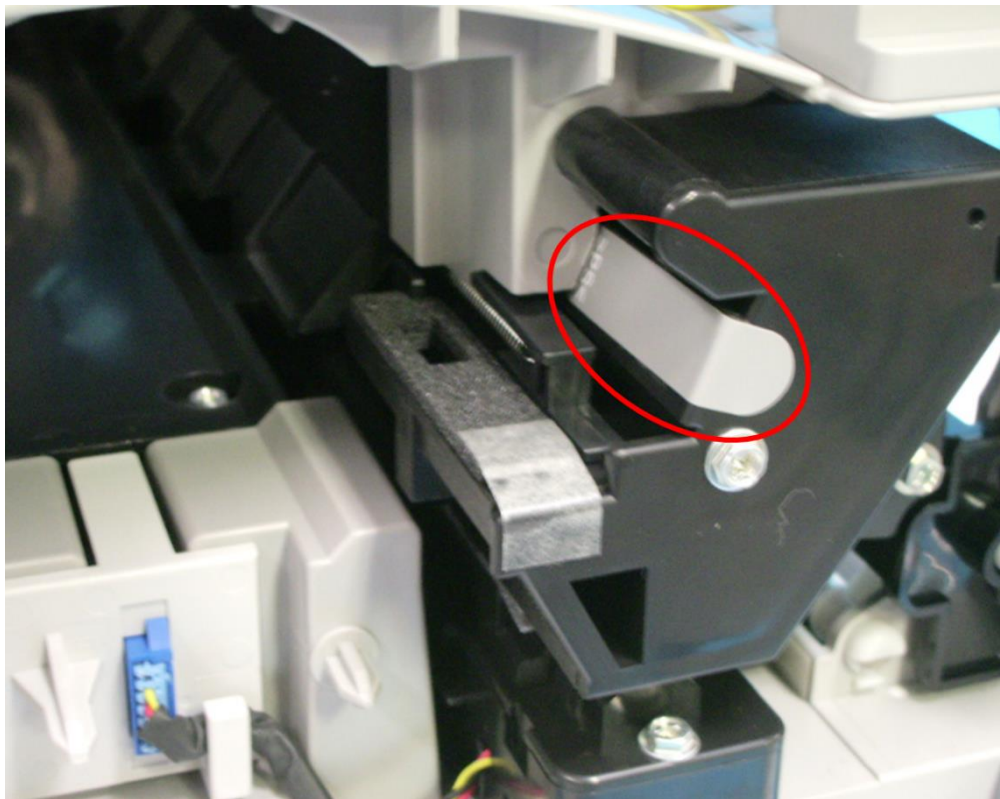
2. The seal affixed to the area circled in the photo was deleted.

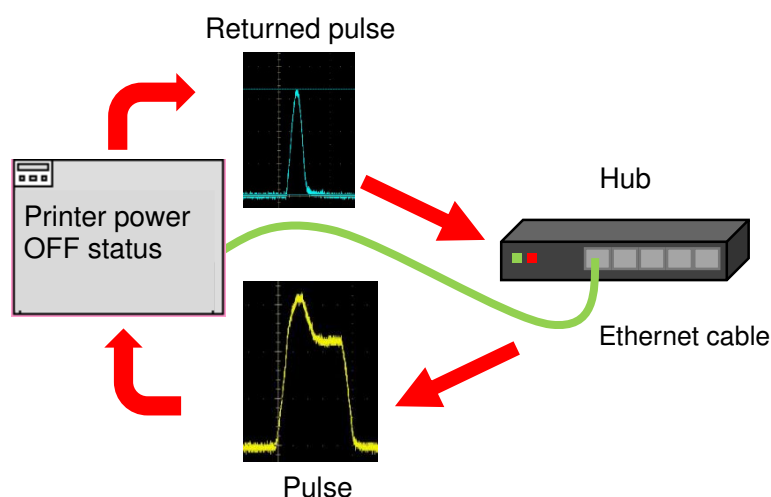
Interference in network communication may occur, if the printer is connected to a hub and the printer switch had been turned OFF (or the power cable was unplugged).

Pulse generated from hubs are transmitted to the printer while the printer is switched OFF (or unplugged). After transmitted to the printer, it then returns to the hub, causing interference in network communication.

The circuit on the Controller Board was modified.

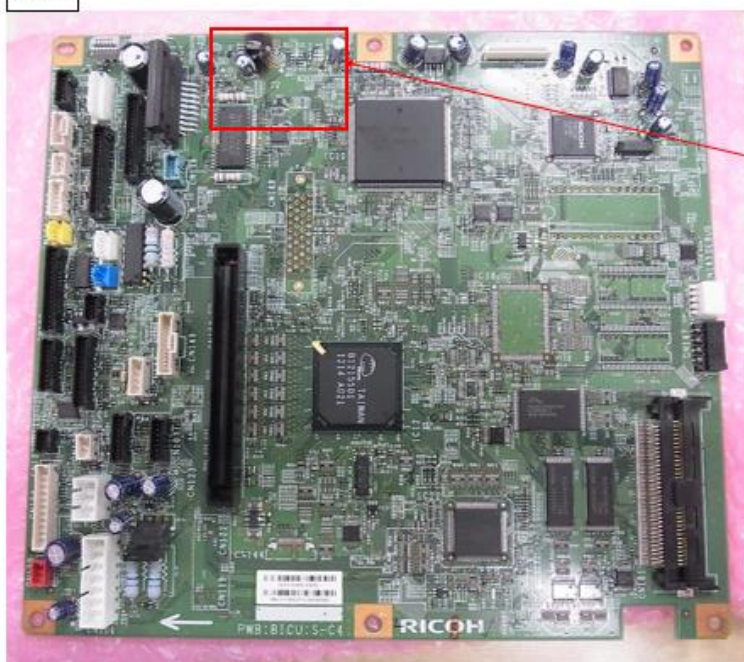
Smoke is emitted from the BICU board.

The harness containing 5v lines was pinched between the BICU and surrounding electrical component(s) and then damaged. This resulted in electrical stress on the IC (Q22).

Check the following harnesses of the 5v line and replace the damaged harness and BICU.

Important: Make sure that you do not allow harnesses to be pinched when you replace a harness or board.

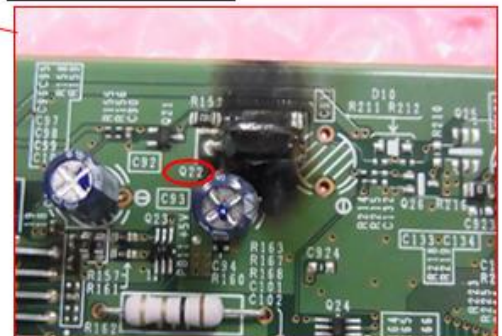
The burned portion
