Model: K-C4	Date: 22-Jan-13	No.: RD158002a
-------------	-----------------	----------------

Subject: Firmware Release Note: PowerSaving Sys		Prepared by: Y.Saitoh	
From: 2nd Tech Service Sect., MFP/Printer Tech Service Dept.			
Classification:	<input type="checkbox"/> Troubleshooting <input type="checkbox"/> Mechanical <input type="checkbox"/> Paper path <input type="checkbox"/> Product Safety	<input type="checkbox"/> Part information <input type="checkbox"/> Electrical <input type="checkbox"/> Transmit/receive <input checked="" type="checkbox"/> Other (Firmware)	<input type="checkbox"/> Action required <input type="checkbox"/> Service manual revision <input type="checkbox"/> Retrofit information <input checked="" type="checkbox"/> Tier 2

This RTB has been issued to announce the firmware release information for the **PowerSaving Sys.**

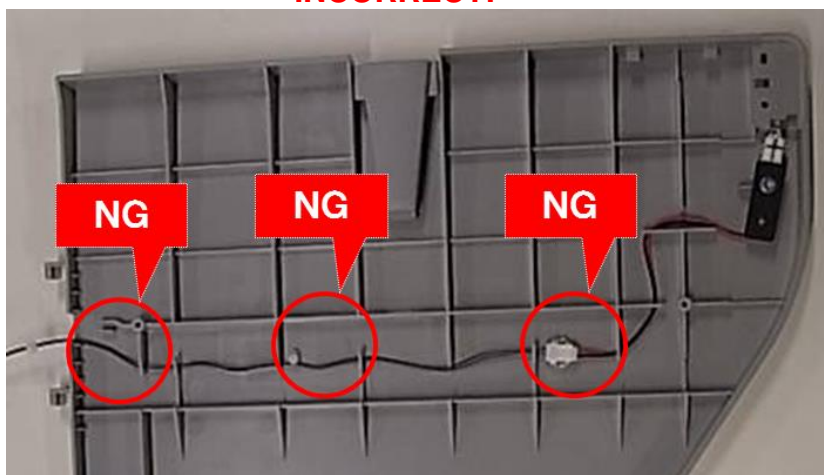
INCORRECT:

6. Re-route the harness as shown in the following photos.

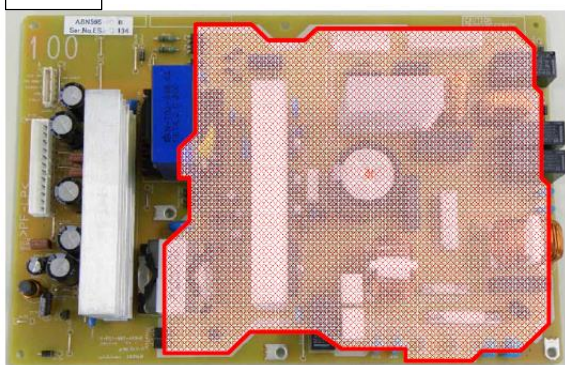
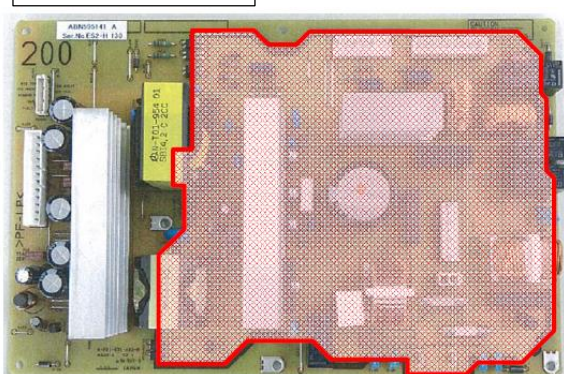
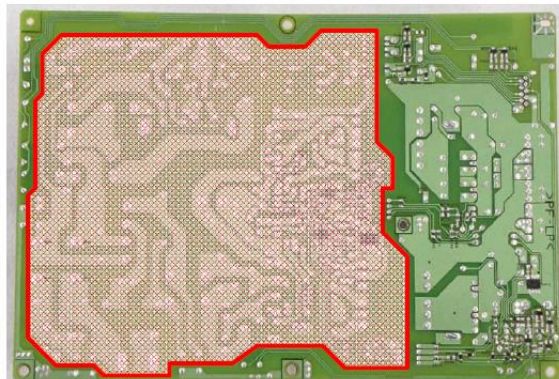
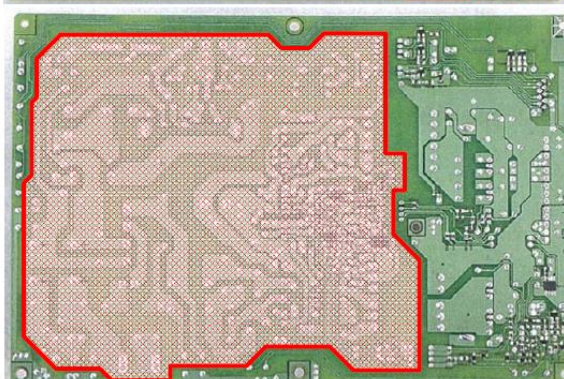
The procedure to discharge residual charge from the machine by unplugging the power cord from the AC wall outlet and pressing the main power switch works only for the DC circuits on this board. Residual charge remains in the AC circuits.

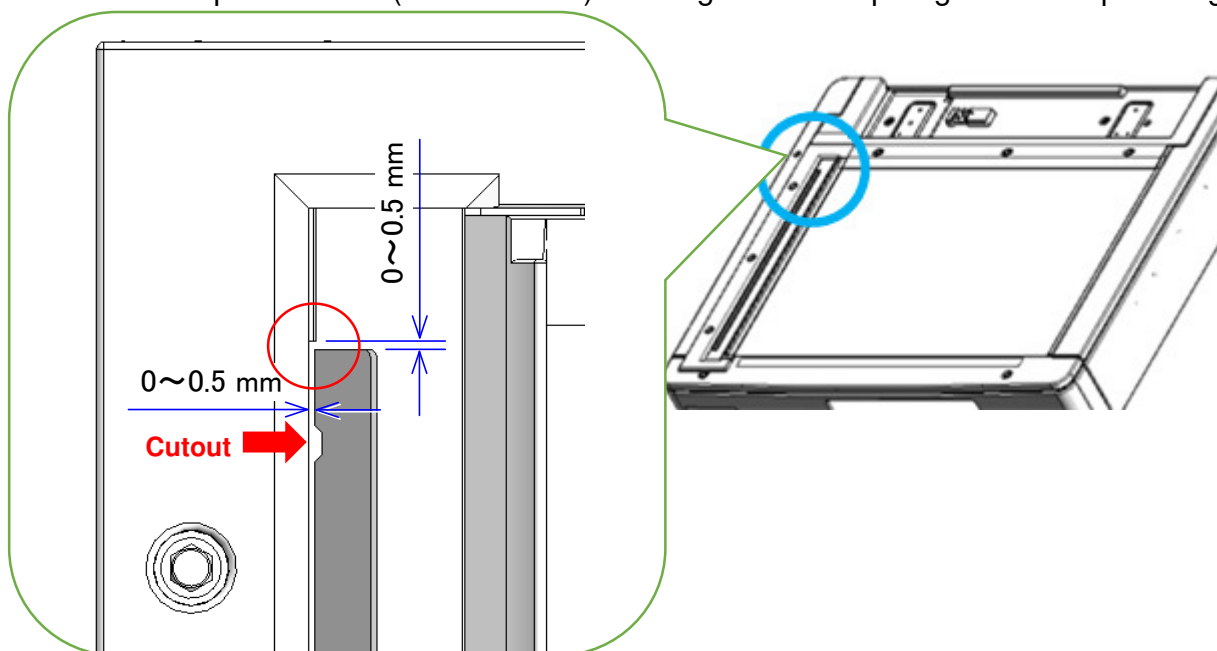
- If the mylar could not be attached properly, remove it and attach a new one at your next visit.
- Without the new mylar, feeding thick paper for more than 90K pages may cause jitter.

1. Remove the originally attached mylar from the document feeder exposure glass.
2. Wipe the document feeder exposure glass with cloth.
3. Attach the new mylar.
 - The cutout in the mylar faces the left.
 - Set the top left corner (circled in red) flush against the top edge of the exposure glass.

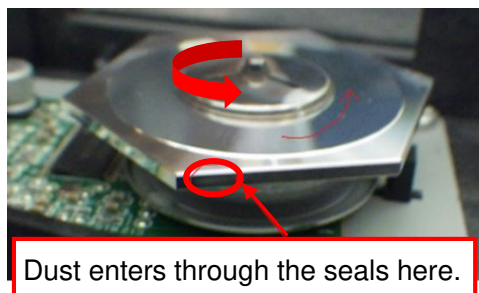
Dust enters the laser unit and adheres to the polygon mirror.

The height of the seals covering the polygon mirrors was increased (from 3mm to 6mm) to prevent dust from the entering the housing.
