Model: K-C4L/C4a	Date: 28-Dec-12	No.: RD160001g
------------------	-----------------	----------------

Subject: Firmware Release Note: BICU_IC		Prepared by: Y.Suzuki	
From: 2nd Tech Service Sect., MFP/Printer Tech Service Dept.			
Classification:	<input type="checkbox"/> Troubleshooting <input type="checkbox"/> Mechanical <input type="checkbox"/> Paper path <input type="checkbox"/> Product Safety	<input type="checkbox"/> Part information <input type="checkbox"/> Electrical <input type="checkbox"/> Transmit/receive <input checked="" type="checkbox"/> Other (Firmware)	<input type="checkbox"/> Action required <input type="checkbox"/> Service manual revision <input type="checkbox"/> Retrofit information <input checked="" type="checkbox"/> Tier 2

Model: K-C4L		Date: 1-Sep-14	No.: RD160007
Subject: How to adjust the LE registration		Prepared by: Y.Saitoh	
From: 2nd Tech Service Sect., MFP/P Tech Service Dept.			
Classification:	<input checked="" type="checkbox"/> Troubleshooting <input type="checkbox"/> Mechanical <input type="checkbox"/> Paper path <input type="checkbox"/> Product Safety	<input type="checkbox"/> Part information <input type="checkbox"/> Electrical <input type="checkbox

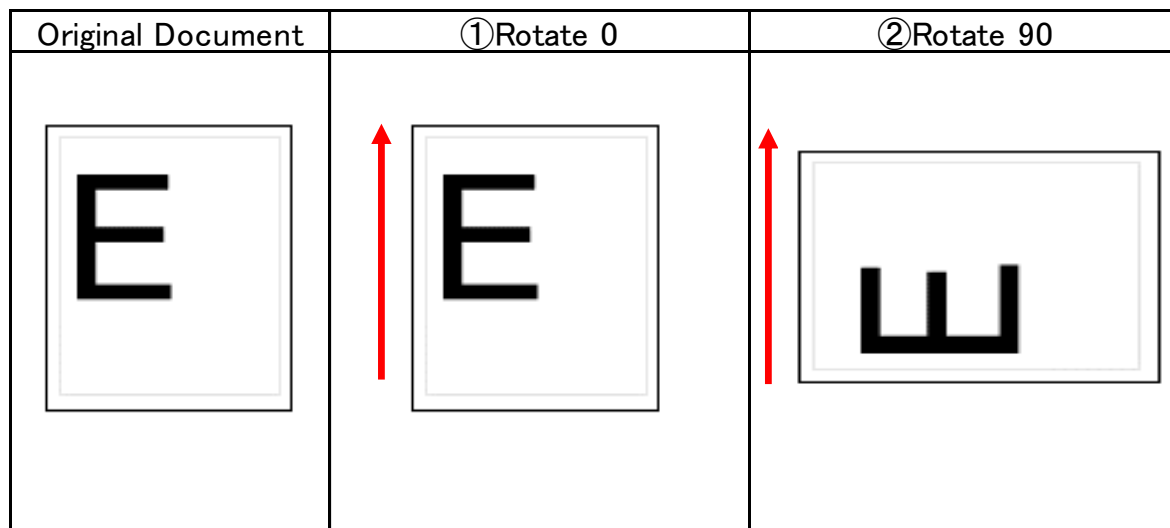
Paper feed direction (**red arrow**) and orientation of paper in the tray:

The leading edge registration settings are not applied in the vertical direction of the image with copy or print jobs, if the paper is loaded in the tray **at 90 degrees to (i.e. in the opposite orientation of) the original.**

The image must be rotated 90 degrees if the paper is loaded perpendicular to the direction of the image on the original (see “2. Rotate 90” below). As a result, the leading edge registration settings (See “ $\alpha$ ” below) are not applied in the direction of the image, as the user would expect.

1. Load the paper in the tray in the **same direction** as the image on the original, and then adjust the leading edge registration, and:
2. Do the registration adjustment with the following SP modes:  
 Simplex: **SP1-001-002**  
 Duplex: **SP1-001-002 and SP1-001-013**

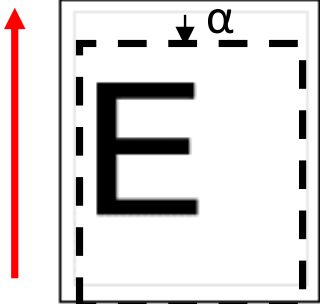
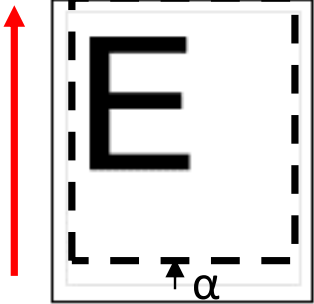
Original Document	①The setting up $\alpha$	②The setting down $\alpha$

- 1) For duplex, the value of **SP1-001-002** is applied to **page 2** (the rear side). This is because in duplex mode, the second image is printed first. The value of **SP1-001-013** is then applied to **page 1** (the front side).
- 2) **Higher** values shift the image toward the **trailing** edge, and **lower** values toward the **leading** edge (See "The setting up  $\alpha$ " and "The setting down  $\alpha$ " below, respectively).

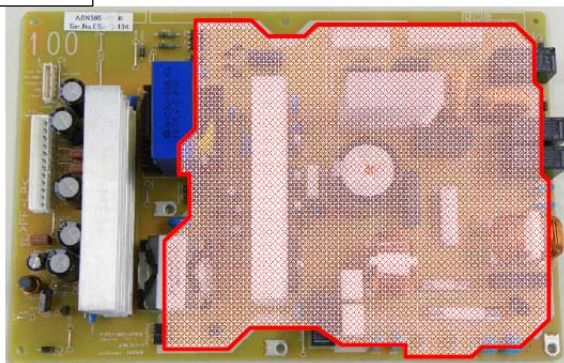
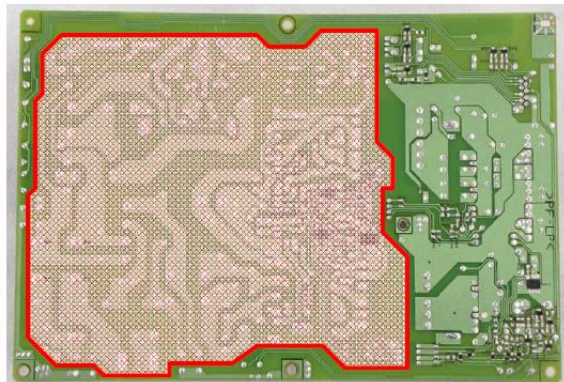
NA

**NEVER touch** the areas outlined in red in the photos below, to prevent electric shock caused by residual charge.

Residual charge of about 100V-400V remains on the PSU board for several months even when the board has been removed from the machine after turning off the machine power and unplugging the power cord.

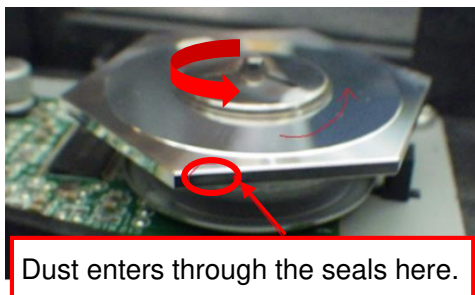
Blurred image, low image density

Dust enters the laser unit and adheres to the polygon mirror.

The height of the seals covering the polygon mirrors was increased (from 3mm to 6mm) to prevent dust from entering the housing.
