Model: OR-C1	Date: 12-Sep-11	No.: RD120001c
--------------	-----------------	----------------

Subject: Firmware Release Note: Fax		Prepared by: J. Kitagawa	
From: 1st Tech Service Sect.MFP/Printer Tech Service Dept.,			
Classification:	<input type="checkbox"/> Troubleshooting <input type="checkbox"/> Mechanical <input type="checkbox"/> Paper path <input type="checkbox"/> Product Safety	<input type="checkbox"/> Part information <input type="checkbox"/> Electrical <input type="checkbox"/> Transmit/receive <input checked="" type="checkbox"/> Other (Firmware)	<input type="checkbox"/> Action required <input type="checkbox"/> Service manual revision <input type="checkbox"/> Retrofit information <input checked="" type="checkbox"/> Tier 2

This RTB has been issued to announce the firmware release information for the **Fax**.

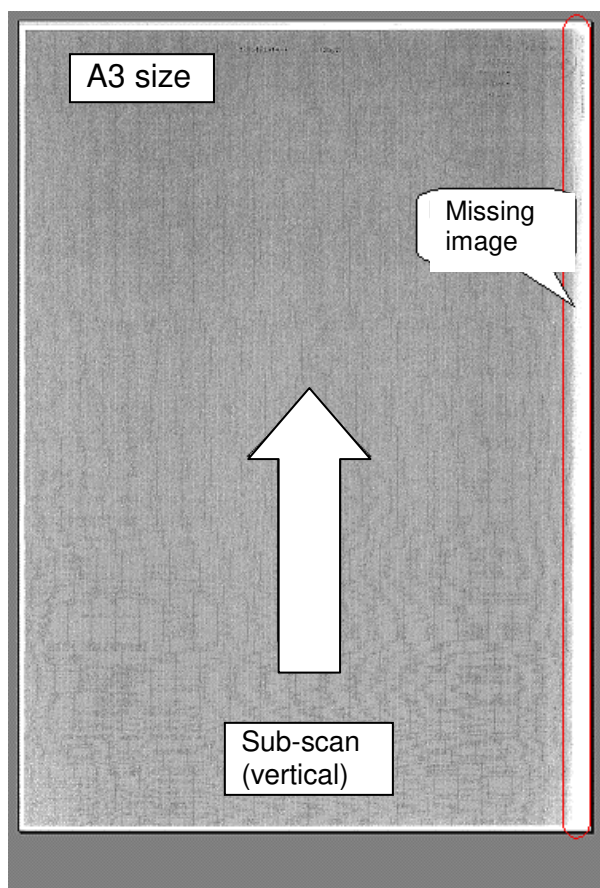
Part of the image is missing on the right side along the sub-scan direction, as shown in the photo below.

The positional relationship between the laser unit and PCU can sometimes block the beam emitted from the diode.

If the symptom occurs, or whenever you replace the laser unit or PCU **on a machine produced before the Cut-in S/N**, adjust the attachment position of the laser unit as follows.

- 1) Open the duplex unit.
- 2) Remove the upper front cover (screw x 1, hook x 1).
- 3) Remove the front cover (pin x 2).
- 4) Remove the front inner cover (screw x 5).
- 5) Loosen the two screws ("(1)" and "(2)" in the photo) that fix the laser unit in place.
Important: If you are replacing the laser unit, remove these screws and then attach the new unit.
- 6) Lift up the **right** side of the laser unit as far as it will go, and hold the unit there while you tighten **screw (1)**.
- 7) Tighten screw (2) on the left side of the unit.
- 8) Reattach the front inner cover, front cover, and upper front cover, and then close the duplex unit.
- 9) Check the image quality and make sure the symptom does not occur.

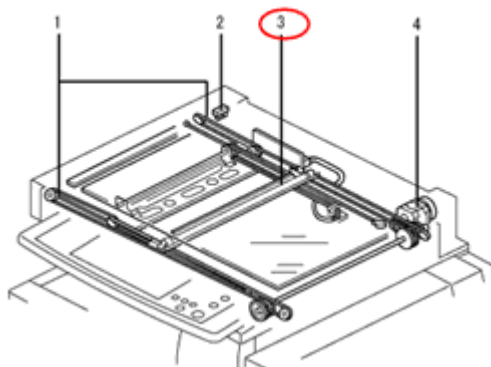
The scanner carriage, circled in red below, touches the front frame when the user pushes down on the original.

- 1) Advise users not to push down on the original when making copies using the exposure glass.
- 2) If the SC still occurs, remove the **center** rubber cushion from the exposure glass (see details below).

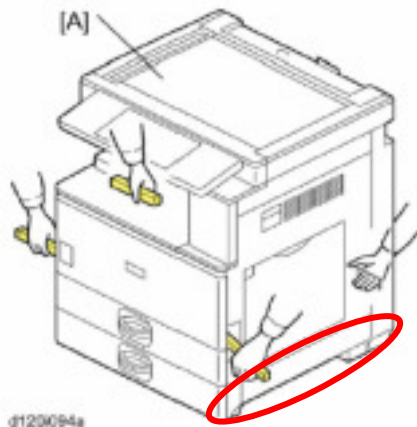
The person installing the machine carries it by the bottom right section of the frame (circled in red below), instead of using the correct holding positions. As a result, the right vertical transport guide is damaged, and the paper cannot be fed correctly.

An instructional sheet will be taped to the right side of the machine, as shown in the photo below. Make sure all installers are aware of the correct way to carry the machine.

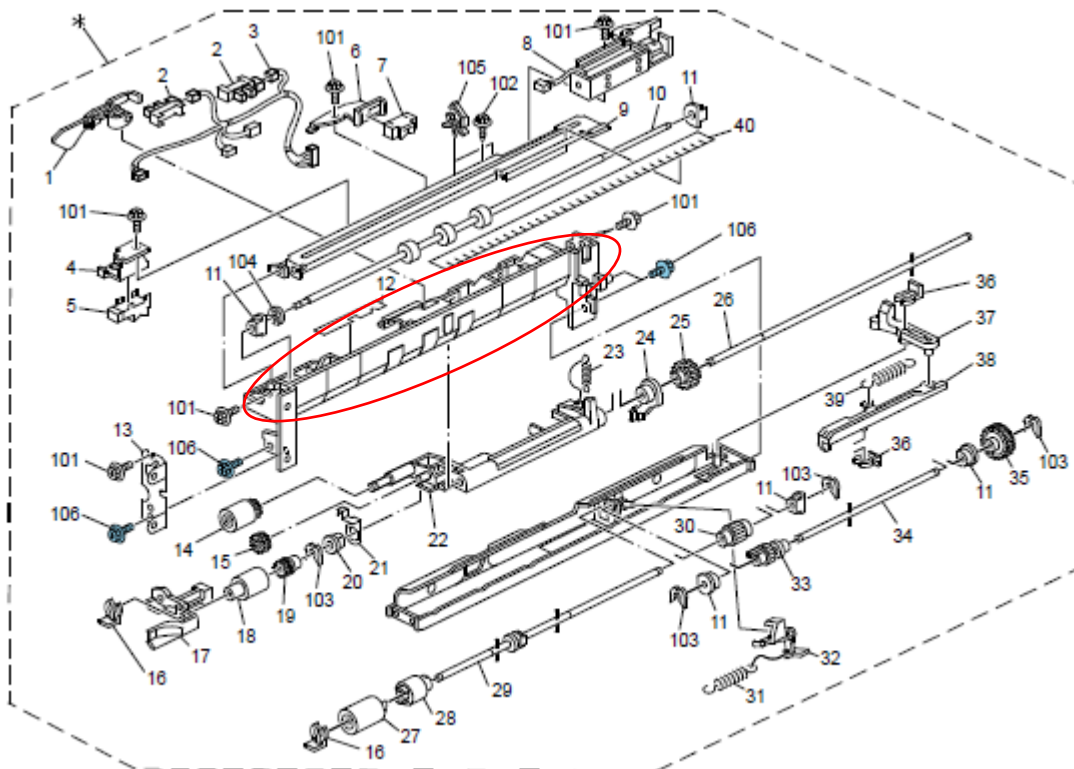
The part circled in red below shrinks in low temperatures, which can sometimes cause the transport roller (index #10) to lock up.

Replace the bushing (index #11) with the modified one.
