Model: PR-C1		Date: 29-Jun-07	No.: RD010001
Subject: ROM History for Engine for PR-C1		Prepared by: Yuichiroh Murata	
From: 1st Tech. Support Sec. Service Support Dept.			
Classification:	<input type="checkbox"/> Troubleshooting <input type="checkbox"/> Mechanical <input type="checkbox"/> Paper path <input type="checkbox"/> Product Safety	<input type="checkbox"/> Part information <input type="checkbox"/> Electrical <input type="checkbox"/> Transmit/receive <input checked="" type="checkbox"/> Other ()	<input type="checkbox"/> Action required <input type="checkbox"/> Service manual revision <input type="checkbox"/> Retrofit information

We hereby inform you of the Engine firmware history for the PR-C1.

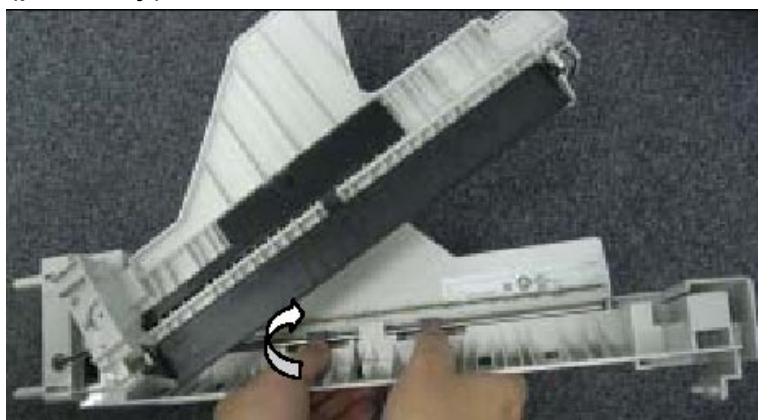
If the 1-bin unit is installed without first checking motor rotation, jamming may occur. In that case, please release the motor by rotating the exit roller.

Please rotate the Exit Roller (B6214453) manually before installing the 1-Bin Tray. This action confirms that the motor rotates properly and will release a (possibly) stuck motor.

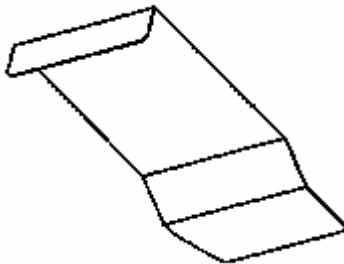
D3394451

Reason: To further minimize exit jams caused by paper curl.

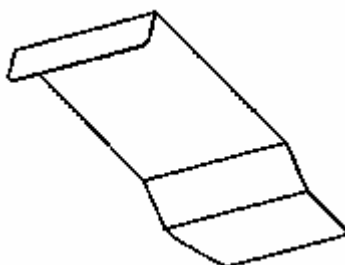
D3394451

Reason: To further minimize exit jams caused by paper curl.

Note: *This modification has been applied to the October 2007 production machines onward. (Machine serial No. M40782xxxxx -)*
The material of those guides is transparent Mylar.

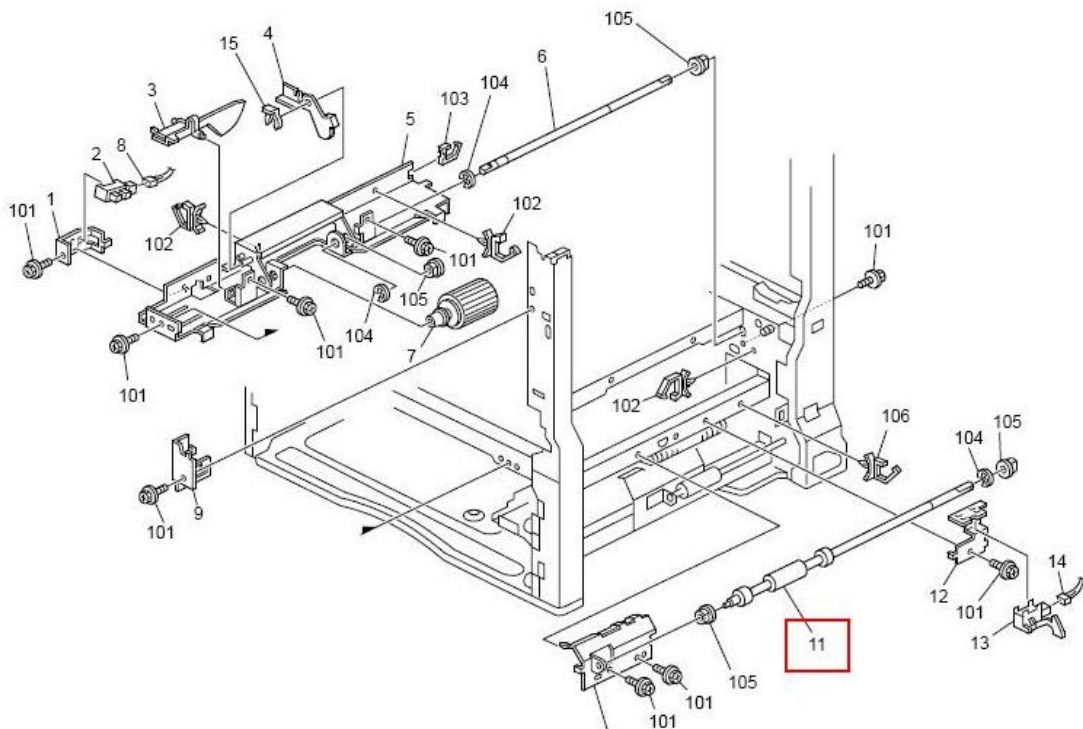
12.1ST PAPER FEED SECTION (D010/D043)

Incorrect P/N	Correct P/N	Description	Q'ty	Int	Page	Index	Note
B0902668	D0102682	Drive Roller - Vertical Transport	1-1	X/O	29	11

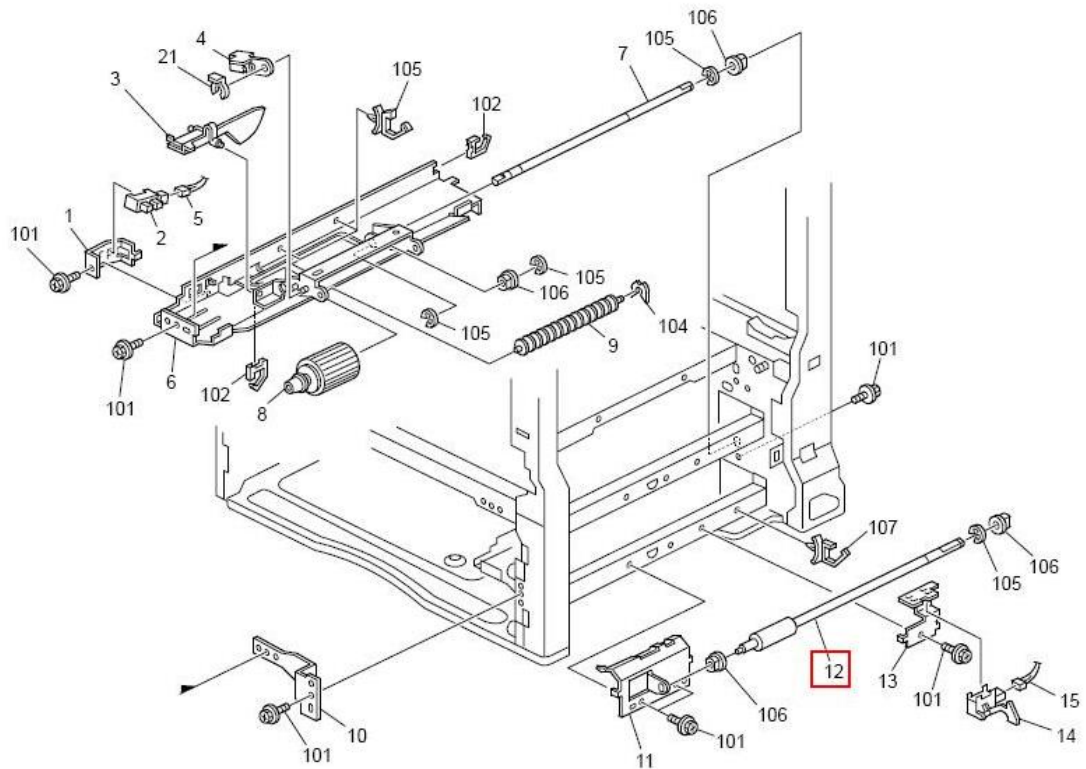
13.2ND PAPER FEED SECTION 1 (D010/D043)

Model: PR-C1				Date: 5-Aug-14		No.: RD010028	
Incorrect P/N	Correct P/N	Description	Q'ty	Int	Page	Index	Note
D0102682	B0902668	Drive Roller - Vertical Transport	1-1	X/O	31	12
