Model: Model R-C5	Date: 31-Jan-08	No.: RD017001
--------------------------	-----------------	---------------

Subject: Firmware Release Note: Font Exp		Prepared by: Yuji Mimura	
From: 2nd Tech. Support Sec. Service Support Dept.			
Classification:	<input type="checkbox"/> Troubleshooting	<input type="checkbox"/> Part information	<input type="checkbox"/> Action required
	<input type="checkbox"/> Mechanical	<input type="checkbox"/> Electrical	<input type="checkbox"/> Service manual revision
	<input type="checkbox"/> Paper path	<input type="checkbox"/> Transmit/receive	<input type="checkbox"/> Retrofit information
	<input checked="" type="checkbox"/> Other ()

Model: Russian-C5		Date: 28-Apr-08	No.: RD017021
Subject: Key Counter Interface Unit(B870) installation procedure		Prepared by: Yuji Mimura	
From: 1st Tech. Support Sec. Service Support Dept.			
Classification:	<input type="checkbox"/> Troubleshooting <input type="checkbox"/> Mechanical <input type="checkbox"/> Paper path <input type="checkbox"/> Product Safety	<input type="checkbox"/> Part information <input type="checkbox"/> Electrical <input type="checkbox"/> Transmit/receive <input type="checkbox"/> Other ()	<input type="che

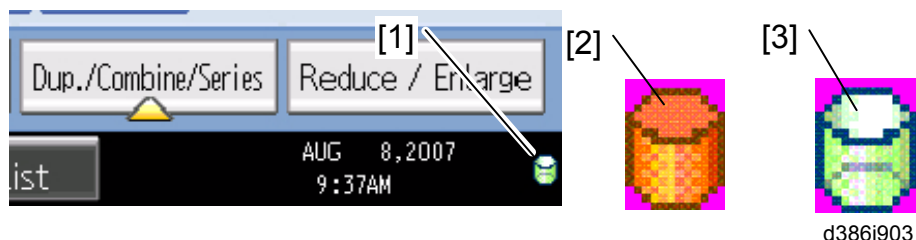
Incorrect:

The display image has been corrected.

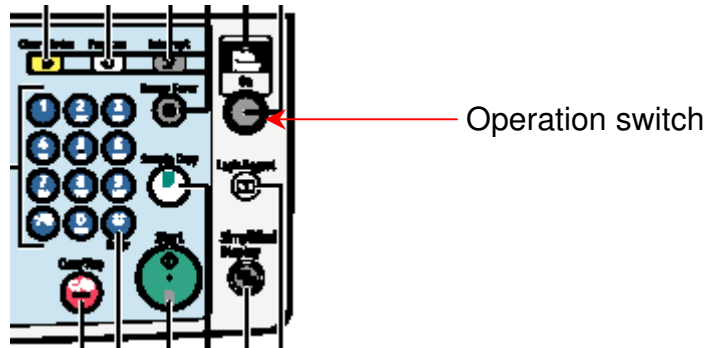
When the machine reaches the Ready condition after boot-up, the operator turns off the main power switch without first pressing the operation switch. As a result, the NAND flash memory on the controller board is damaged, triggering the SC.

1. Please make machine users aware of the following:

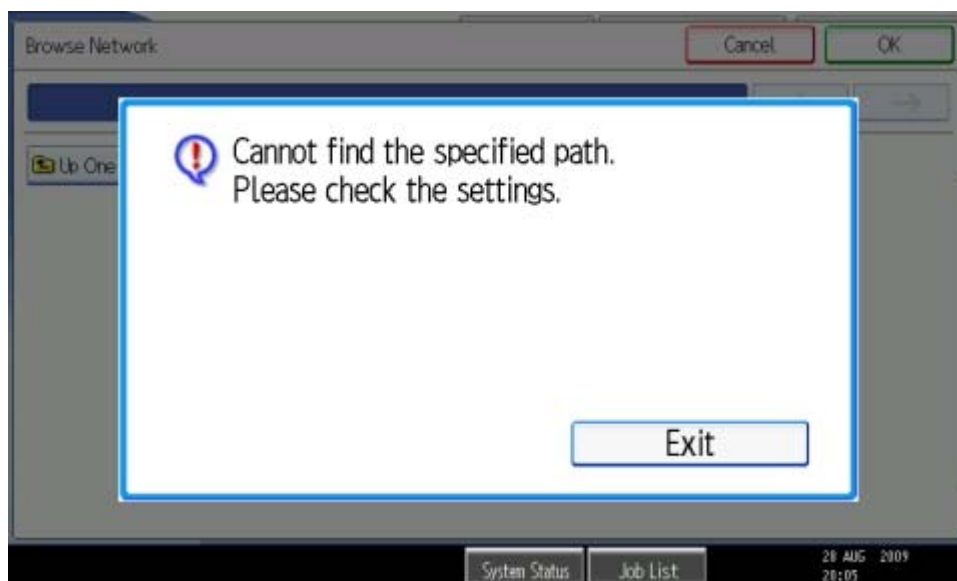
Problem. Scan to Folder destinations cannot be selected by browsing. When a user attempts to select a destination by browsing, an error is displayed.

Conditions of occurrence: The destination is Windows 7 or Windows Server 2008 R2.

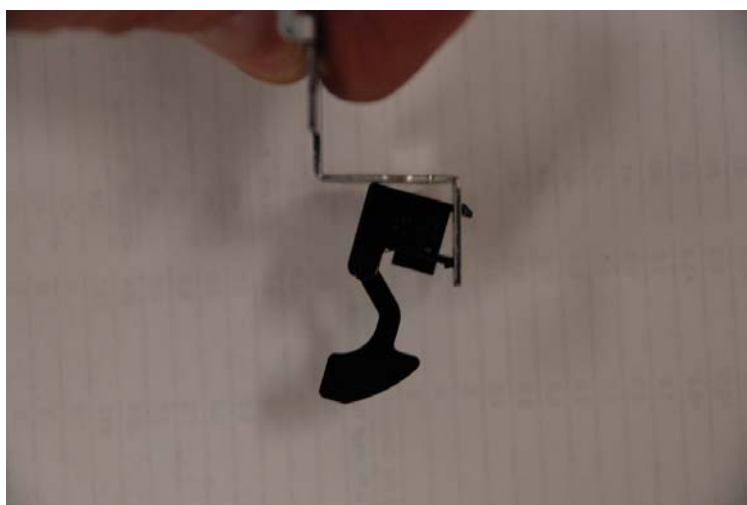
Non-feed jams

The holes in the mounting bracket for the side fence sensor are not the proper size for the sensor. Sometimes, the sensor can partially detach from the bracket, and the sensor actuator does not touch the paper tray tab. As a result, paper size detection does not work, triggering the jam.
