Model: OR-C2		Date: 20-Sep-13	No.: RD184001
Subject: Data Overwrite Security Unit Type I		Prepared by: T. Nihei	
From: 2nd Tech Service Sect., MFP/P Tech Service Dept.			
Classification:	<input type="checkbox"/> Troubleshooting	<input type="checkbox"/> Part information	<input type="checkbox"/> Action required
	<input type="checkbox"/> Mechanical	<input type="checkbox"/> Electrical	<input checked="" type="checkbox"/> Service manual revision
	<input type="checkbox"/> Paper path	<input type="checkbox"/> Transmit/receive	<input type="checkbox"/> Retrofit information
	<input type="checkbox"/> Product Safety	<input type="checkbox"/> Other ()	<input type="checkbox"/> Tier 2

Service Manual Revision

Data Overwrite Security Unit Type I (D362)

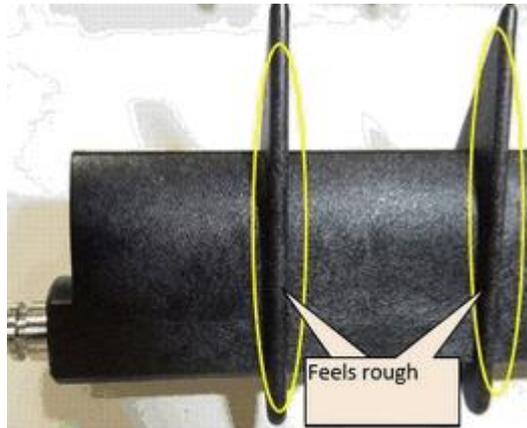
The paper catches on the rough surface of the lower gate pawl (P/N AF025045).

<p>-Open the machine's right cover. -Remove the lower gate pawl (AF025045).</p>
2	<p>Sandpaper</p>

<p>-Bend the sandpaper and hold it as shown in the photo on the left.</p> <p>Note: You can also use a cloth between the sandpaper and your finger, as shown in the photo on the right.</p>
3	<p>GATE PAWL:LOWER (AF025045)</p>

<p>Touch both tips of the gate pawl and check for any sharp or rough edges.</p>

-Use a file to smooth down the edges (marked with numbers in the photo) of each of the 15 pawls.

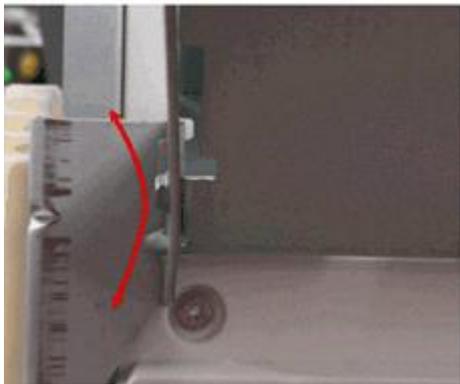
There is a difference in level on the frame of the side plate tray. If the screw is tightened too tightly, the side plate may deform.

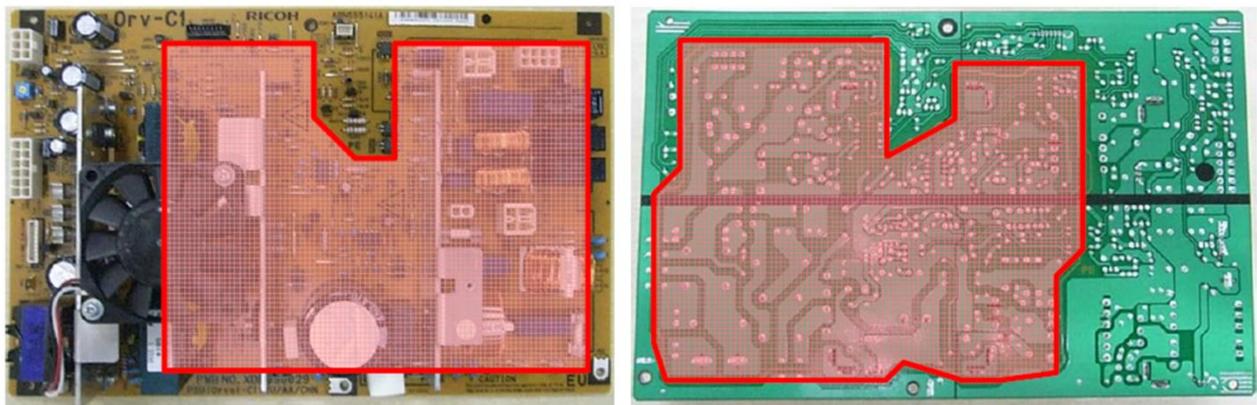
NEVER touch the areas outlined in red in the photos below, to prevent electric shock caused by residual charge.

The procedure to discharge residual charge from the machine by unplugging the power cord from the AC wall outlet and pressing the main power switch works only for the DC circuits on this board. Residual charge remains in the AC circuits.

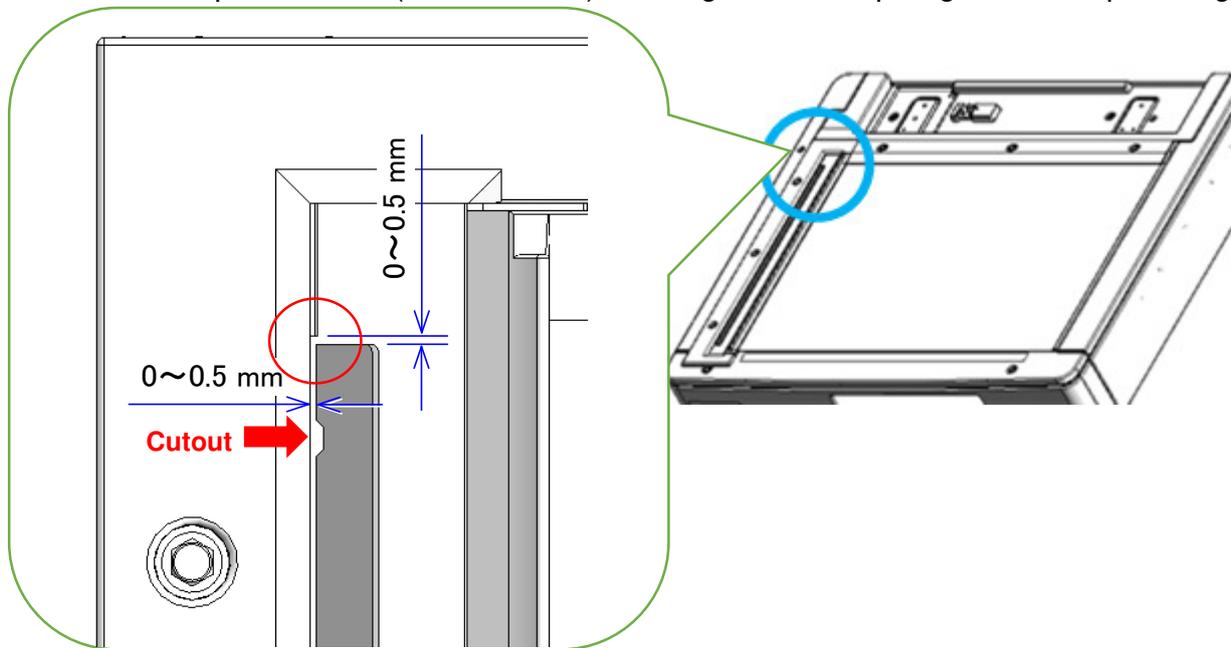
When installing the Document Feeder (DF3090), replace the mylar originally attached to its exposure glass with the new mylar included as an accessory to the Document Feeder. Scan quality, especially at the trailing edge of the original, is better with the new mylar.

- If the mylar could not be attached properly, remove it and attach a new one at your next visit.
 - Without the new mylar, feeding thick paper for more than 90K pages may cause jitter.
1. Remove the mylar originally attached from the document feeder exposure glass.
 2. Wipe the document feeder exposure glass with cloth.
 3. Attach the new mylar.
 - The cutout on the mylar faces to the left.
 - Set the top left corner (circled in red) flush against the top edge of the exposure glass.
