Model: S-C5	Date: 21-Mar-12	No.: RD127001b
-------------	-----------------	----------------

Subject: Firmware Release Note: (Java VM v10 for eDC)		Prepared by: H. Tamaki	
From: 1st Tech Service Sect., MFP/Printer Tech Service Dept.			
Classification:	<input type="checkbox"/> Troubleshooting	<input type="checkbox"/> Part information	<input type="checkbox"/> Action required
	<input type="checkbox"/> Mechanical	<input type="checkbox"/> Electrical	<input type="checkbox"/> Service manual revision
	<input type="checkbox"/> Paper path	<input type="checkbox"/> Transmit/receive	<input type="checkbox"/> Retrofit information
	<input type="checkbox"/> Product Safety	<input checked="" type="checkbox"/> Other (Firmware)	<input checked="" type="checkbox"/> Tier 2

This RTB has been issued to announce the firmware release information for the **Java VM v10 for eDC**.

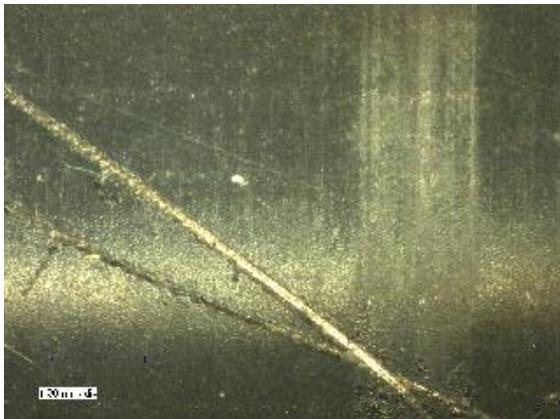
If you find some scratches on the fusing roller, it is possible that the customer tried to remove the jammed paper from the fusing unit by using a sharp object.

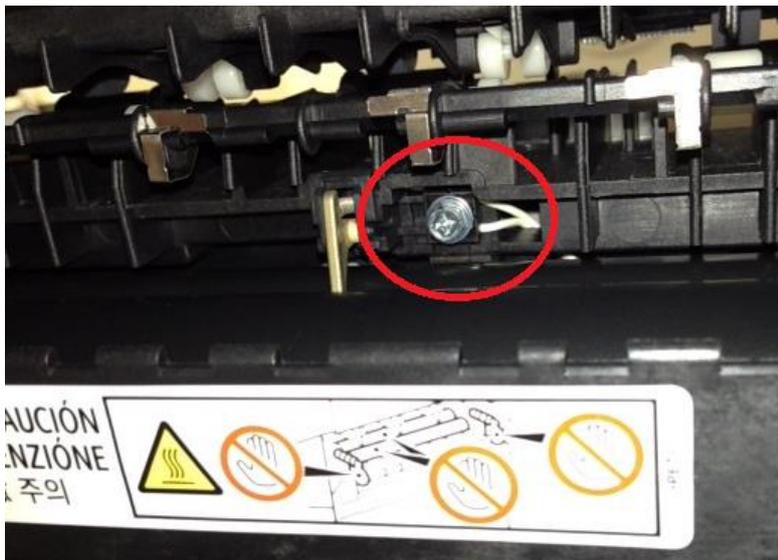
In this case, the thermistor may be damaged.

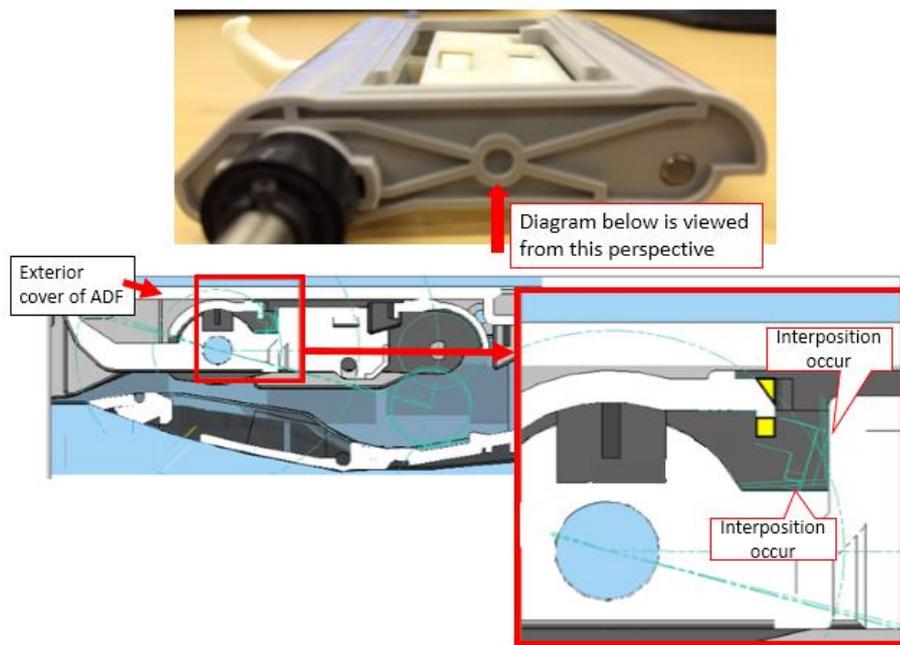
1. The customer uses an unsupported thin paper type (approx. 0.33gsm or thinner), which causes the ADF feed unit to interfere with the movement of the pick-up roller. As a result, the pick-up roller cannot be lowered to the proper position.

- **If the customer is using an unsupported thin paper type** (approx. 0.33gsm or thinner), replace the ADF feed unit (P/N D6062122; HOLDER:PICKUP ROLLER).
- **In all other cases**, do the **Procedure** on the next page.

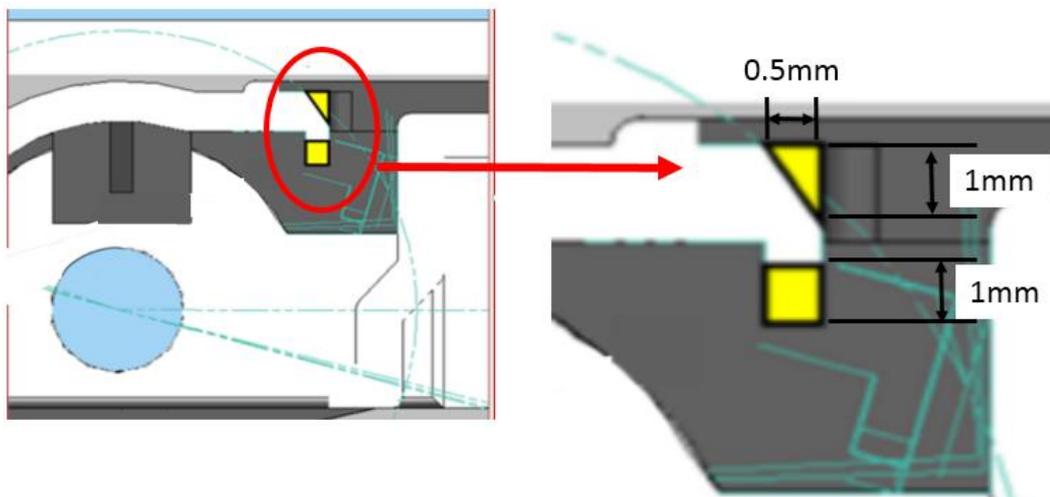
- The areas in yellow were cut away to prevent interference.
- See **Cut-in serial numbers** below.

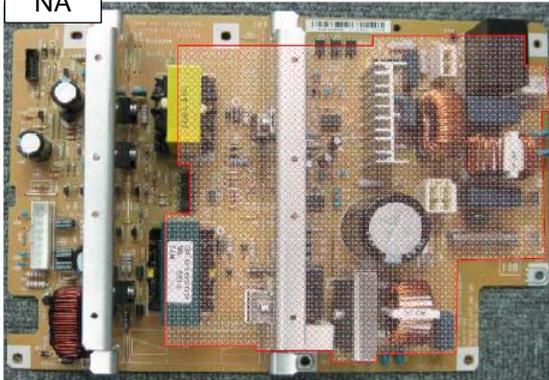
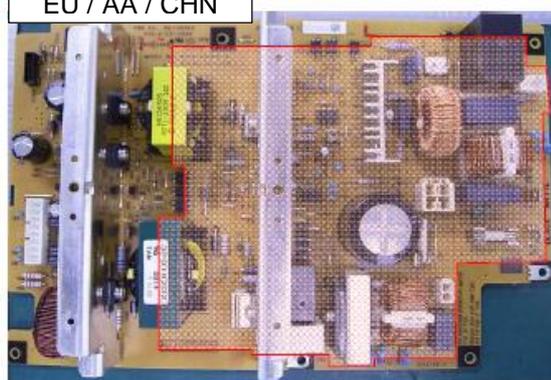
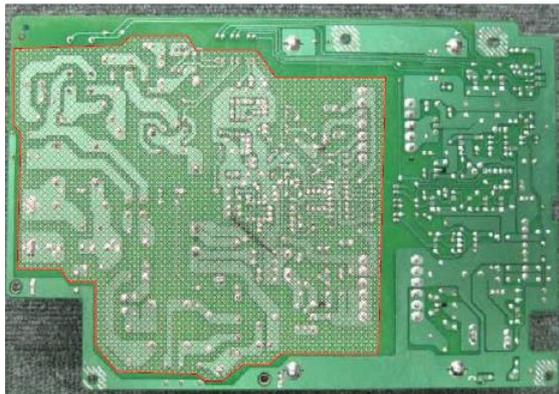
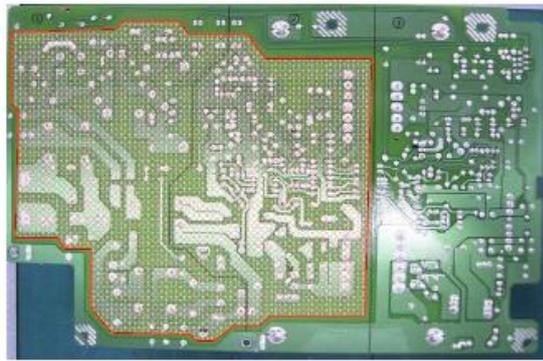
NEVER touch the areas outlined in red in the photos below, to prevent electric shock caused by residual charge.
