Model: Lef-C1	Date: 29-Jan-16	No.: RD259006
---------------	-----------------	---------------

Subject: Firmware Release Note: RPCS		Prepared by: Y. Saitoh	
From: 1st Tech Service Sect., MFP/Printer Tech Service Dept.			
Classification:	<input type="checkbox"/> Troubleshooting <input type="checkbox"/> Mechanical <input type="checkbox"/> Paper path <input type="checkbox"/> Product Safety	<input type="checkbox"/> Part information <input type="checkbox"/> Electrical <input type="checkbox"/> Transmit/receive <input checked="" type="checkbox"/> Other (Firmware)	<input type="checkbox"/> Action required <input type="checkbox"/> Service manual revision <input type="checkbox"/> Retrofit information <input checked="" type="checkbox"/> Tier 2

This RTB has been issued to announce the firmware release information for the **RPCS**.

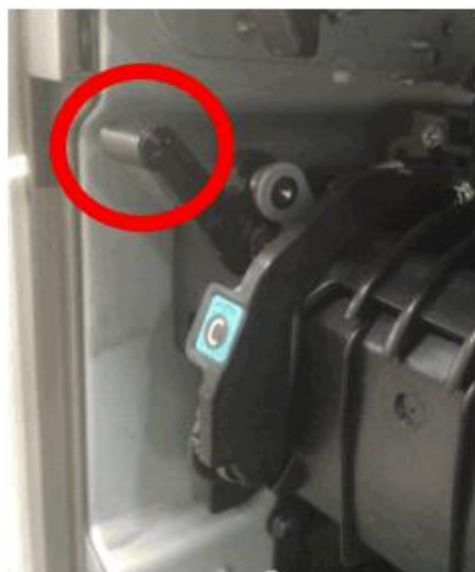
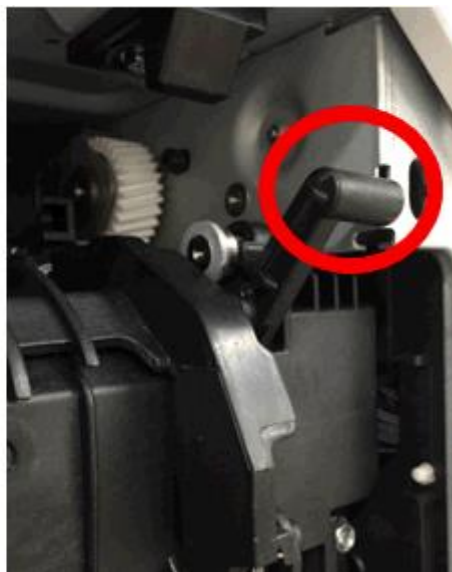
Machine operators may falsely press down the pressure lever (circled in red in the photo below) of the fusing unit instead of pulling down the guide plate [C], to remove a paper jam.

In this case, the spring on the lever comes off and locks the lever in the down position. Poor fusing is the end result, because pressure is not applied when the paper passes through the nip of the fusing unit.

The right cover can be closed and printing is possible even when the pressure lever is locked in the down position.

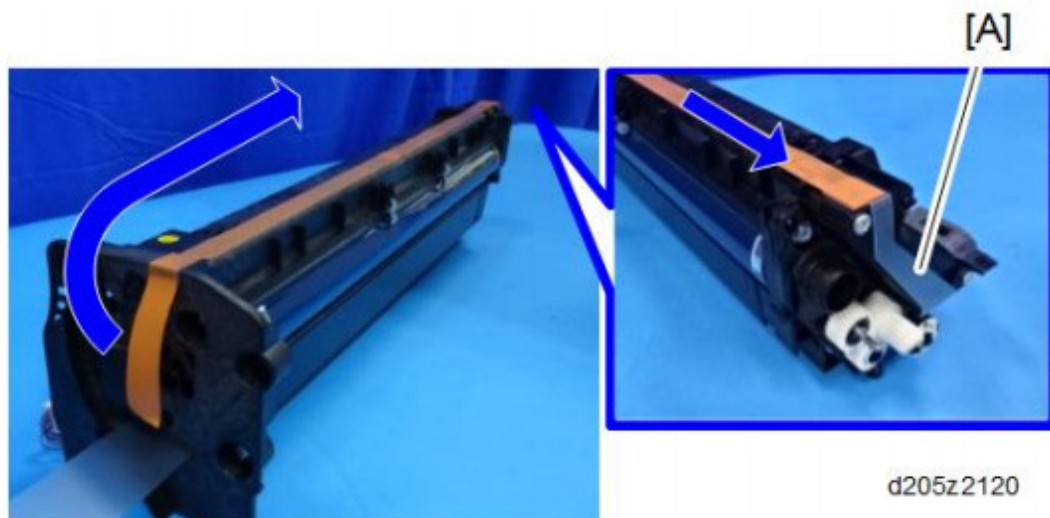
4. Replacement or Adjustment – PCDU – PCDU

- When you install the machine ***or replace PCDU***, make sure to remove the protective sheet [A] and heat seal [B] from the development unit.
- If you do not ***do this remove protective sheet [A], toner cannot be supplied to development unit and*** toner will coagulate and clog inside the toner pipe ***in Mainframe.***
- If you do not ***do this remove heat seal [B], no image appears.***

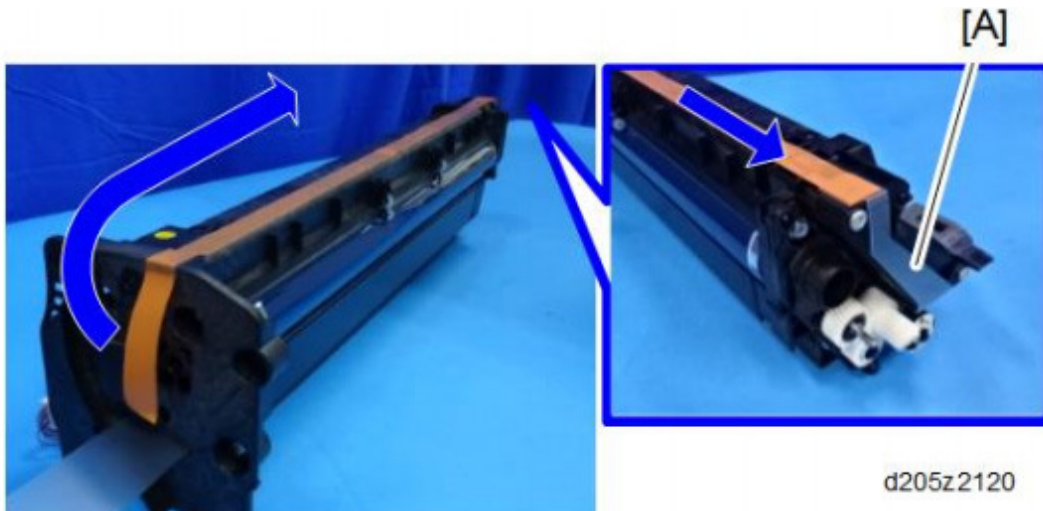
Toner Bottle replacement message does not disappear even the Toner Bottle is not empty.

The protective sheet [A] is not removed at machine installation or PCDU replacement. As a result, toner coagulates and clogs inside the toner supply pipe (machine-side).

- **Make sure to remove the protective sheet** at machine installation and whenever you replace the PCDU.
- If the symptom has already occurred, replace the toner supply pipe (P/N: D2053212).

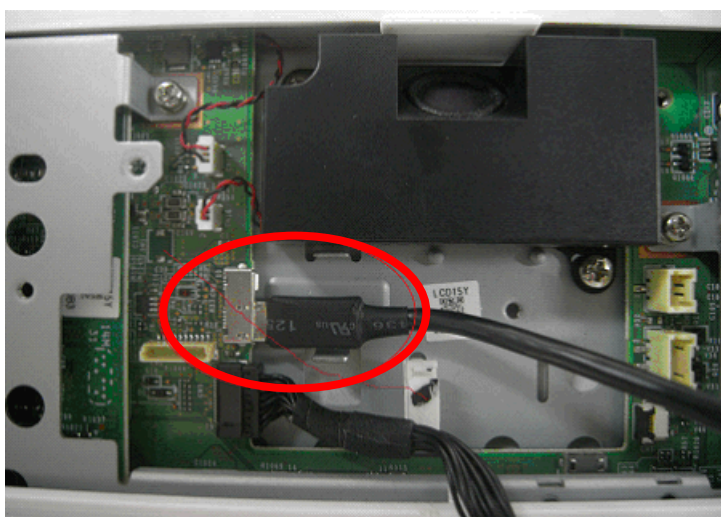
When reconnecting the USB cable, make sure it is connected in the right location. If it is not connected correctly, SC672-11 is displayed.

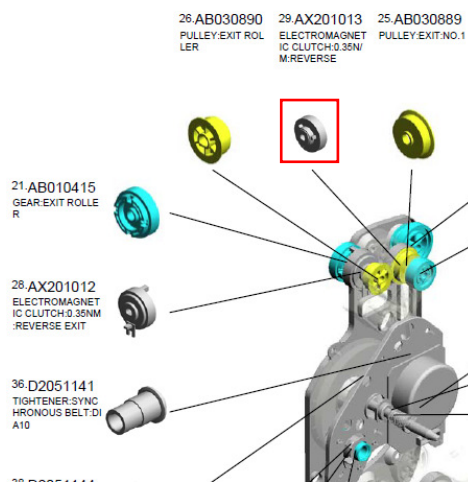
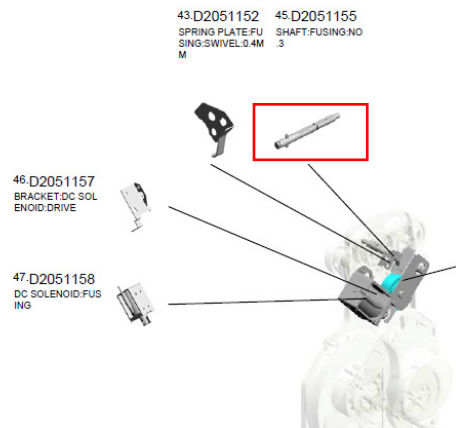
U013
MAIN DRIVE

Paper jams (Jam code 065) frequently occur when making duplex prints. The shaft (D2051155) of the electromagnetic clutch (AX201013) is wet with oil and the problem is resolved after replacing the clutch.

Oil comes out from the bushing of the shaft when the temperature of the bushing increases by the fusing heat. The oil travels on the shaft and goes into the clutch causing the problem.

Replace the clutch (AX201013) and clean the shaft with dry cloth to remove remaining oil.

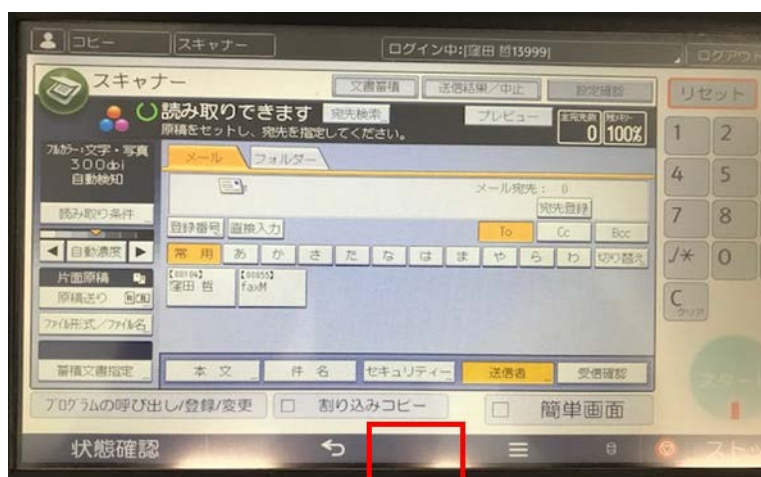
With firmware combination **#3** below, the Home button is not displayed, making it impossible to switch between applications.

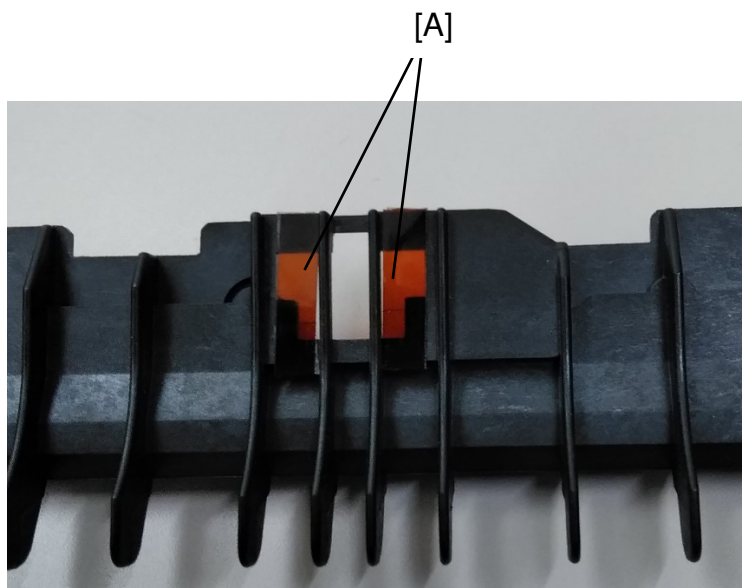
The heat from the fusing process causes the oil-based components in the toner to evaporate and gradually accumulate on the shaft of the exit sensor feeler. If the inside of the printer is cold, the oil solidifies and interferes with the movement of the feeler.

Two plastic seals [A] (D2054409) were added to cover the opening of the fusing unit guide (which will block the airflow toward the sensor).
