Model: Model AI-C1	Date: 07-Nov-07	No.: RD009001j
---------------------------	-----------------	----------------

Subject: Firmware Release Note: NetworkDocBox		Prepared by: T. Hirakawa	
From: 2nd Tech Service Sect., MFP/Printer Tech Service Dept.			
Classification:	<input type="checkbox"/> Troubleshooting	<input type="checkbox"/> Part information	<input type="checkbox"/> Action required
	<input type="checkbox"/> Mechanical	<input type="checkbox"/> Electrical	<input type="checkbox"/> Service manual revision
	<input type="checkbox"/> Paper path	<input type="checkbox"/> Transmit/receive	<input type="checkbox"/> Retrofit information
	<input type="checkbox"/> Product Safety	<input checked="" type="checkbox"/> Other ()	<input checked="" type="checkbox"/> Tier 2

This RTB has been issued to announce the firmware release information for the **Network DocBox**.

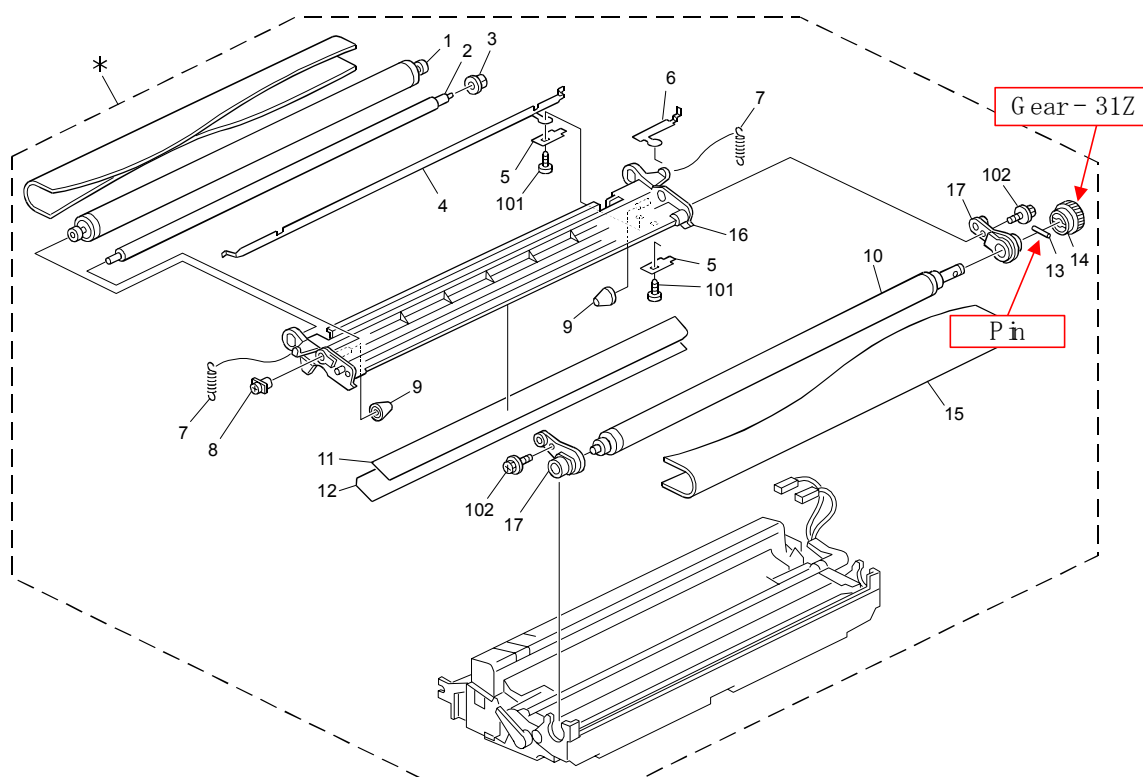
If the Gear - 31Z (transfer unit drive gear) is held by hand when the transfer unit is removed/reattached, the gear comes off the drive shaft. Sometimes, the pin also comes off the shaft and falls into the machine.

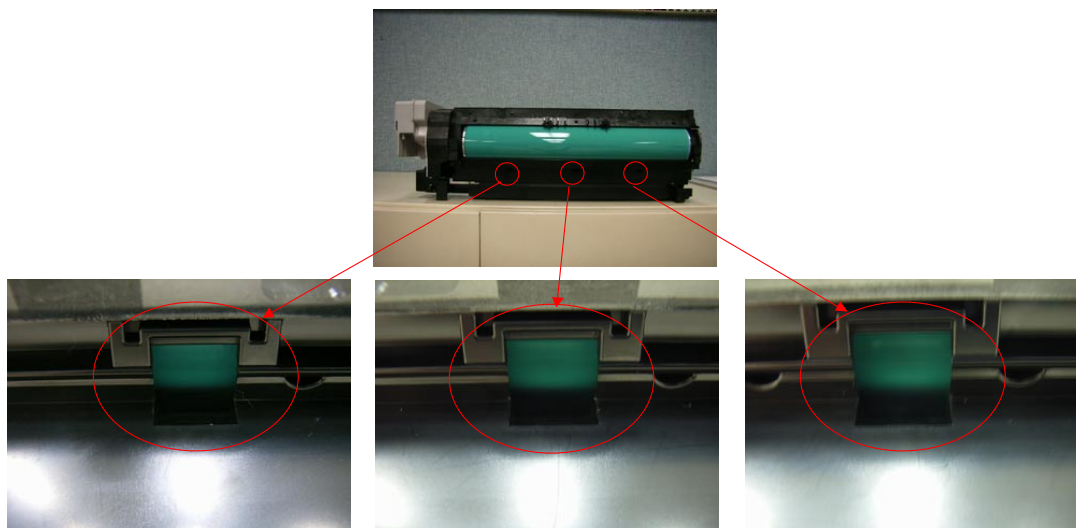
Note: If you can see the surface of the drum from below the PDCU (see the photos), this means the caps are not attached.

2. If the caps are not attached to the development unit inside the machine, either install the three caps (P/N D0093102) or replace the development unit with one that already has the caps (D0092301).

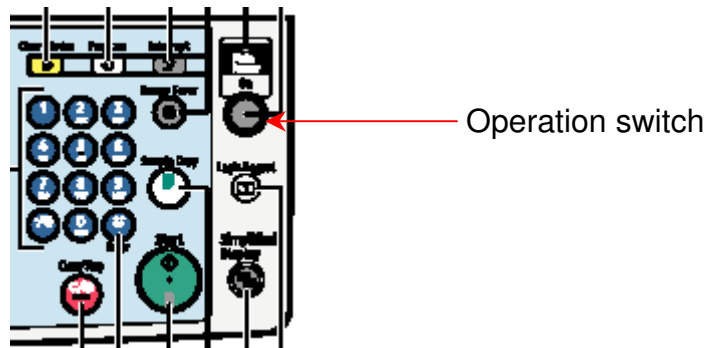
When the machine reaches the Ready condition after boot-up, the operator turns off the main power switch without first pressing the operation switch. As a result, the NAND flash memory on the controller board is damaged, triggering the SC.

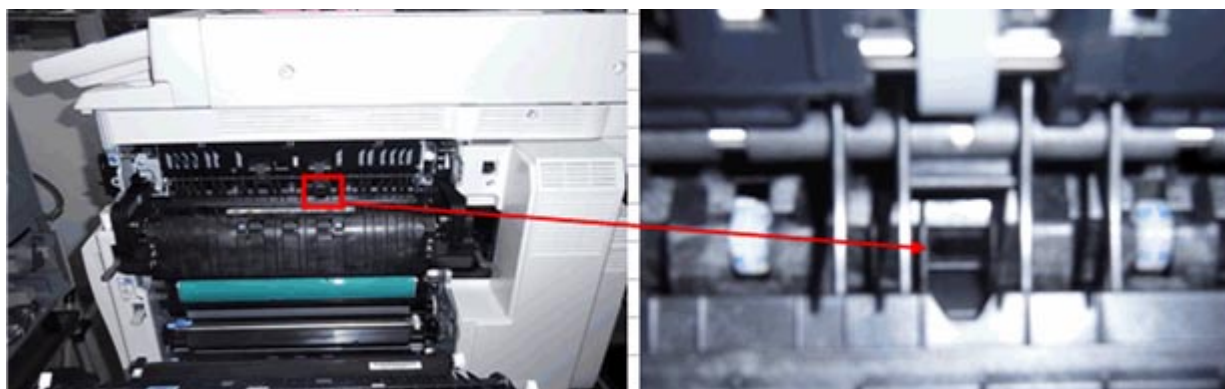
Therefore, when the machine expects to detect paper at the sensor (based on the paper feed timing), paper is not detected, and the machine indicates an A, B, and C Jam.

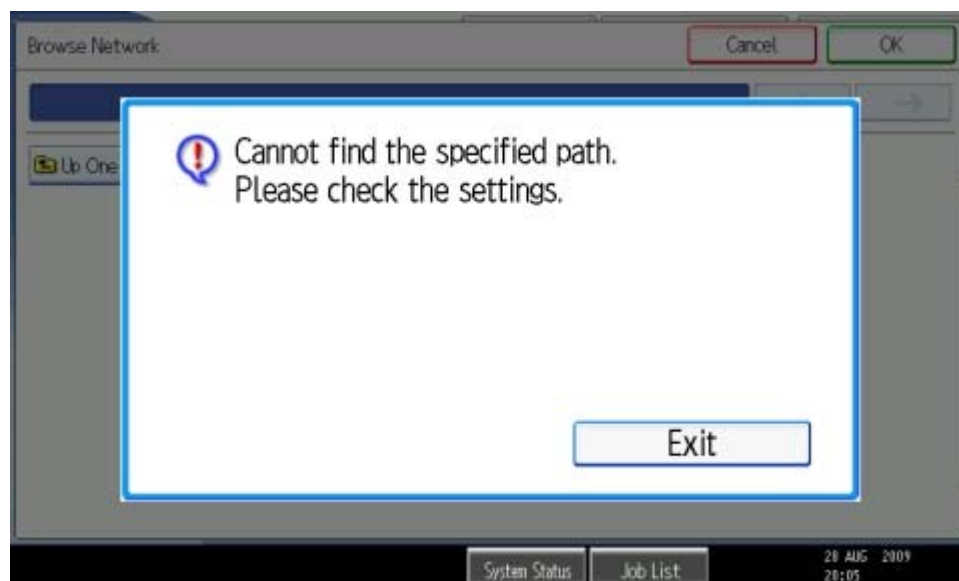
Problem. Scan to Folder destinations cannot be selected by browsing. When a user attempts to select a destination by browsing, an error is displayed.

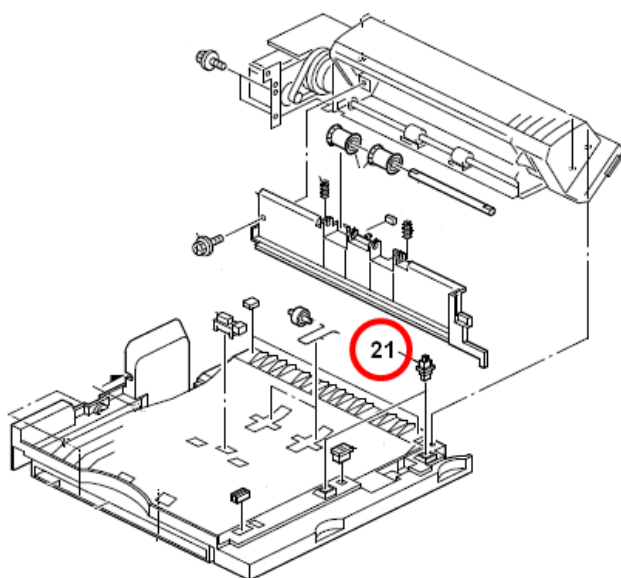
Jam 1 (Cover open) occurs frequently in the BU3030 Bridge unit.
If you replace the push switch in the red circle below, this symptom occurs again.

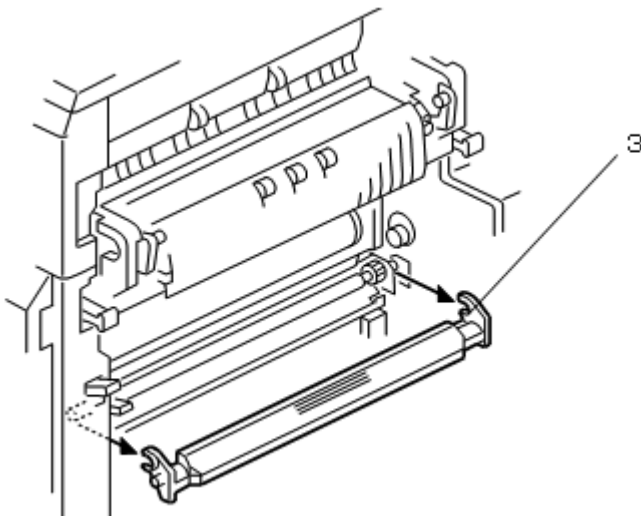
The guide plate is fixed by mounting the ends of the shaft and fixing it in place with spring pressure.
