Model: AI-C1.5	Date: 16-Dec-09	No.: RD091001a
----------------	-----------------	----------------

Subject: Firmware Release Note: Fax		Prepared by: K.Hamada	
From: 1st Overseas Tech Support Sec., 1st PQM Dept.			
Classification:	<input type="checkbox"/> Troubleshooting	<input type="checkbox"/> Part information	<input type="checkbox"/> Action required
	<input type="checkbox"/> Mechanical	<input type="checkbox"/> Electrical	<input type="checkbox"/> Service manual revision
	<input type="checkbox"/> Paper path	<input type="checkbox"/> Transmit/receive	<input type="checkbox"/> Retrofit information
	<input type="checkbox"/> Product Safety	<input checked="" type="checkbox"/> Other (Firmware)	<input checked="" type="checkbox"/> Tier 2

This RTB has been issued to announce the firmware release information for the **Fax**.

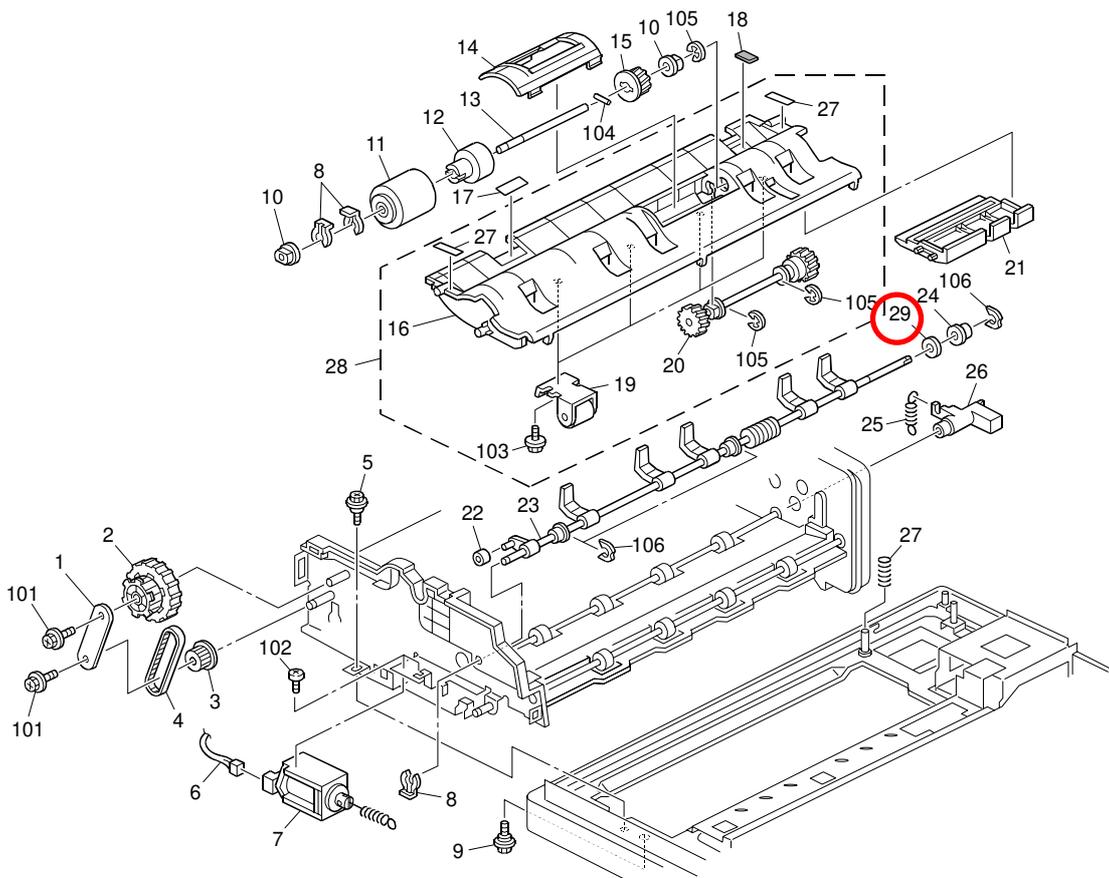
**Change:** The part in the table was added.

**Reason:** To further improve the movement of the guide (B8022226).

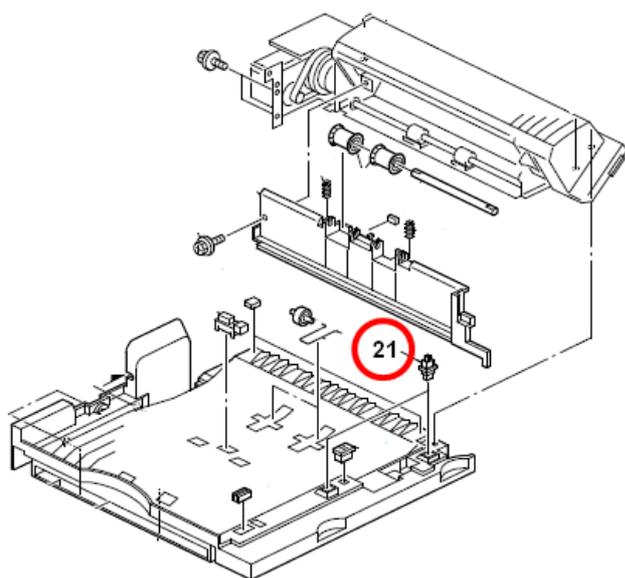
Jam 1 (Cover open) occurs frequently in the BU3030 Bridge unit.  
 If you replace the push switch in the red circle below, this symptom occurs again.

Because of the following two reasons, the push switch mistakenly detects a “cover open” when paper exits

- 1) The contact finish on the push switch wears with time, causing an unstable signal from the sensor, and this causes most of the false detection errors during continuous paper feed.
- 2). Detection timing of the push switch was designed to be very short and strict, because of the situation described above in cause 1).

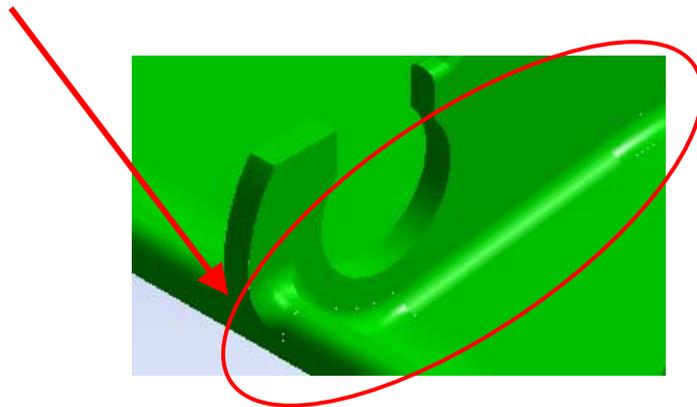
**The thickness of this area was increased**

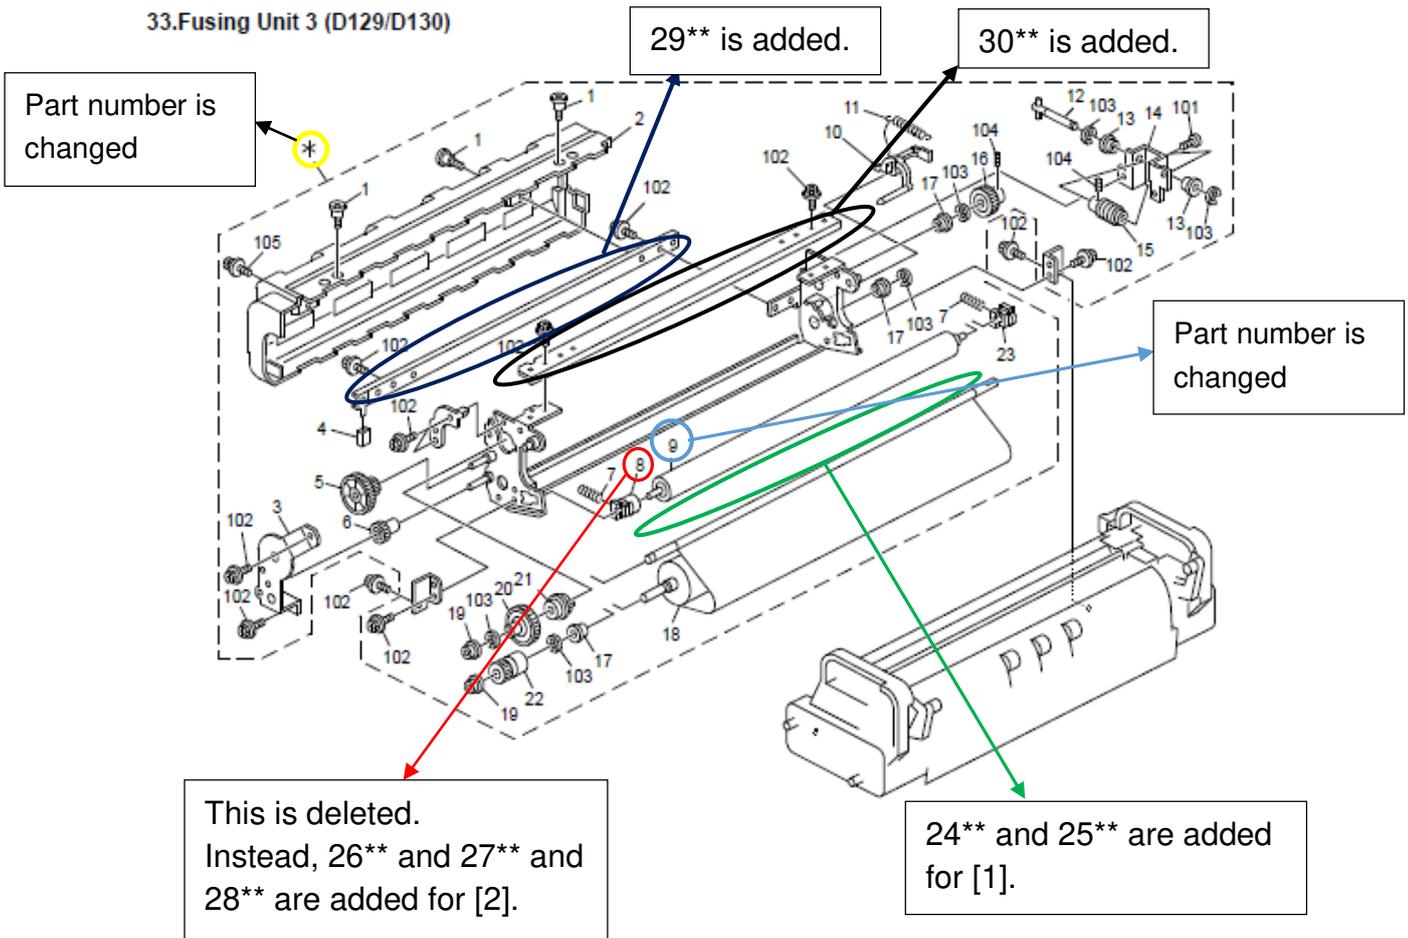
33.Fusing Unit 3 (D129/D130)

**Change/Reason:** To prevent the cleaning web from coming loose, the following parts are changed and newly added to the fusing unit.

Please install a new cleaning unit (p/n: D1294304) when a cleaning web issue occurs, because individual parts are not compatible due to changing of a frame on the fusing unit. After that, individual parts can be replaced.
