Model: AI-C2	Date: 19-Dec-11	No.: RD129001h
--------------	-----------------	----------------

Subject: Firmware Release Note: Fax		Prepared by: T.Hirakawa	
From: 2nd Tech Service Sect., MFP/Printer Tech Service Dept.			
Classification:	<input type="checkbox"/> Troubleshooting	<input type="checkbox"/> Part information	<input type="checkbox"/> Action required
	<input type="checkbox"/> Mechanical	<input type="checkbox"/> Electrical	<input type="checkbox"/> Service manual revision
	<input type="checkbox"/> Paper path	<input type="checkbox"/> Transmit/receive	<input type="checkbox"/> Retrofit information
	<input type="checkbox"/> Product Safety	<input checked="" type="checkbox"/> Other (Firmware)	<input checked="" type="checkbox"/> Tier 2

This RTB has been issued to announce the firmware release information for the **Fax**.

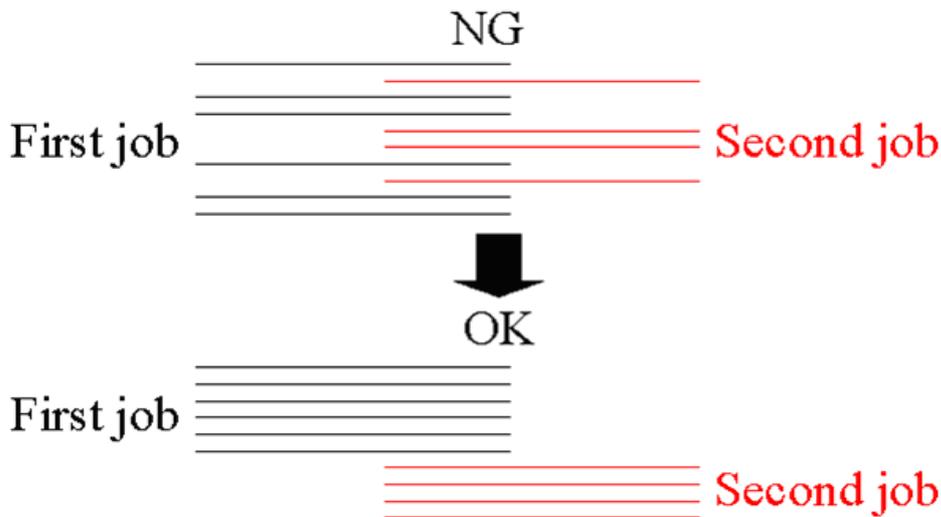
Pages from two separate faxes are printed out in the wrong order if one is received (via one line) while the other has already started to print out (having been received via another line).

FCU firmware bug

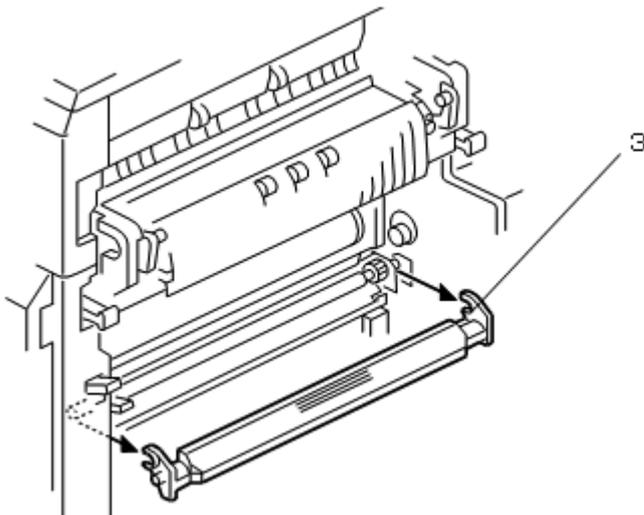
The guide plate is fixed by mounting the ends of the shaft and fixing it in place with spring pressure.

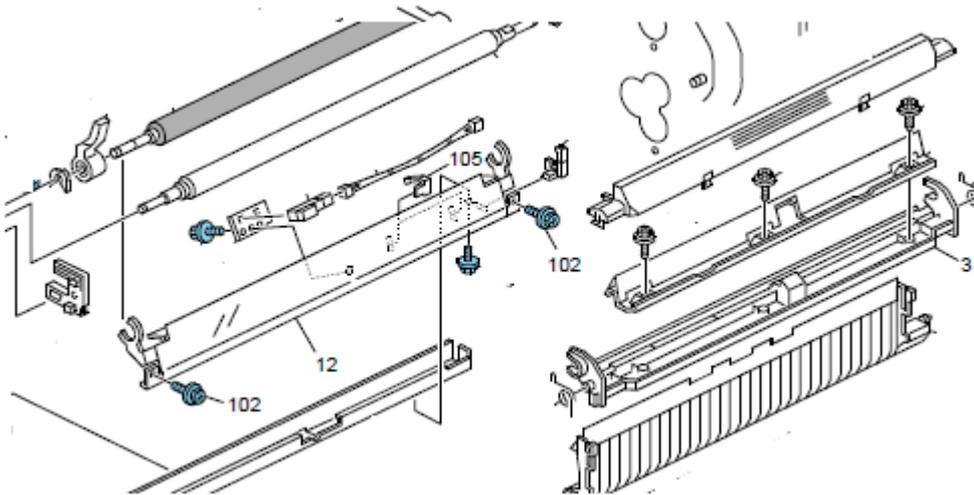
- Co-fastening ribs were added to the guide plate (index #3 below).
- This guide plate and registration lower guide plate (index #12) are fastened to each other using a screw (after the shaft is attached).
- The length of this fastening screw was increased from 6mm to 8mm (index #102)

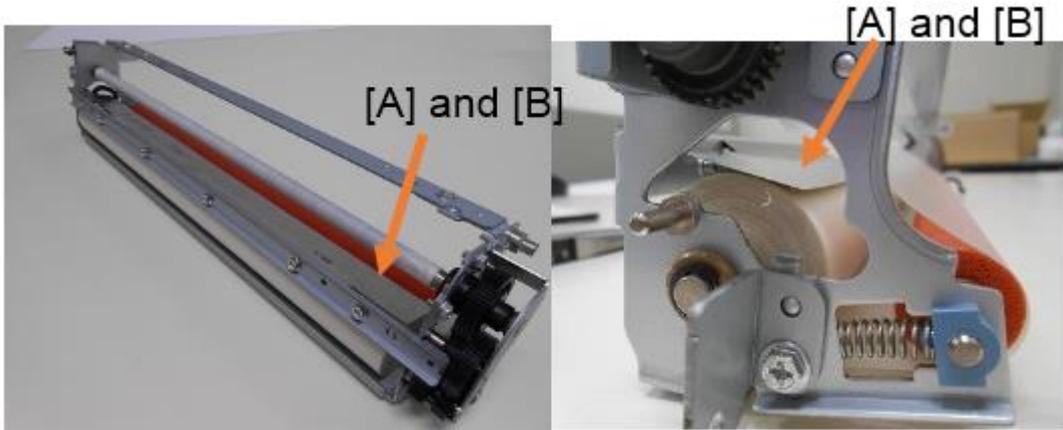
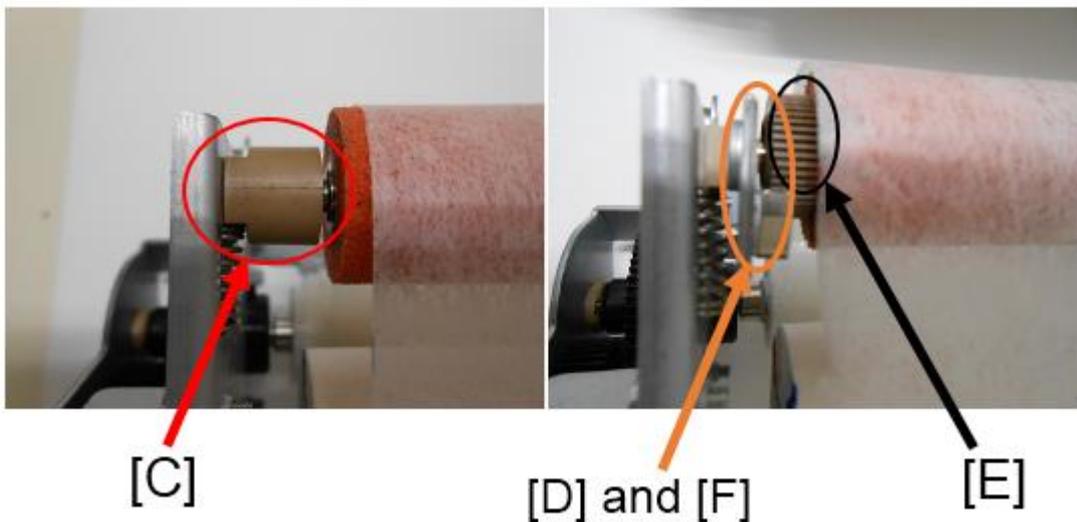
Change/Reason: To prevent the cleaning web from coming loose, the following parts are changed or newly added to the fusing unit.

[A] and [B] are the variable brake.

Please install a new cleaning unit (p/n: D1294304) when a cleaning web issue occurs, because individual parts are not compatible due to modification of a frame on the fusing unit. After that, individual parts can be replaced.

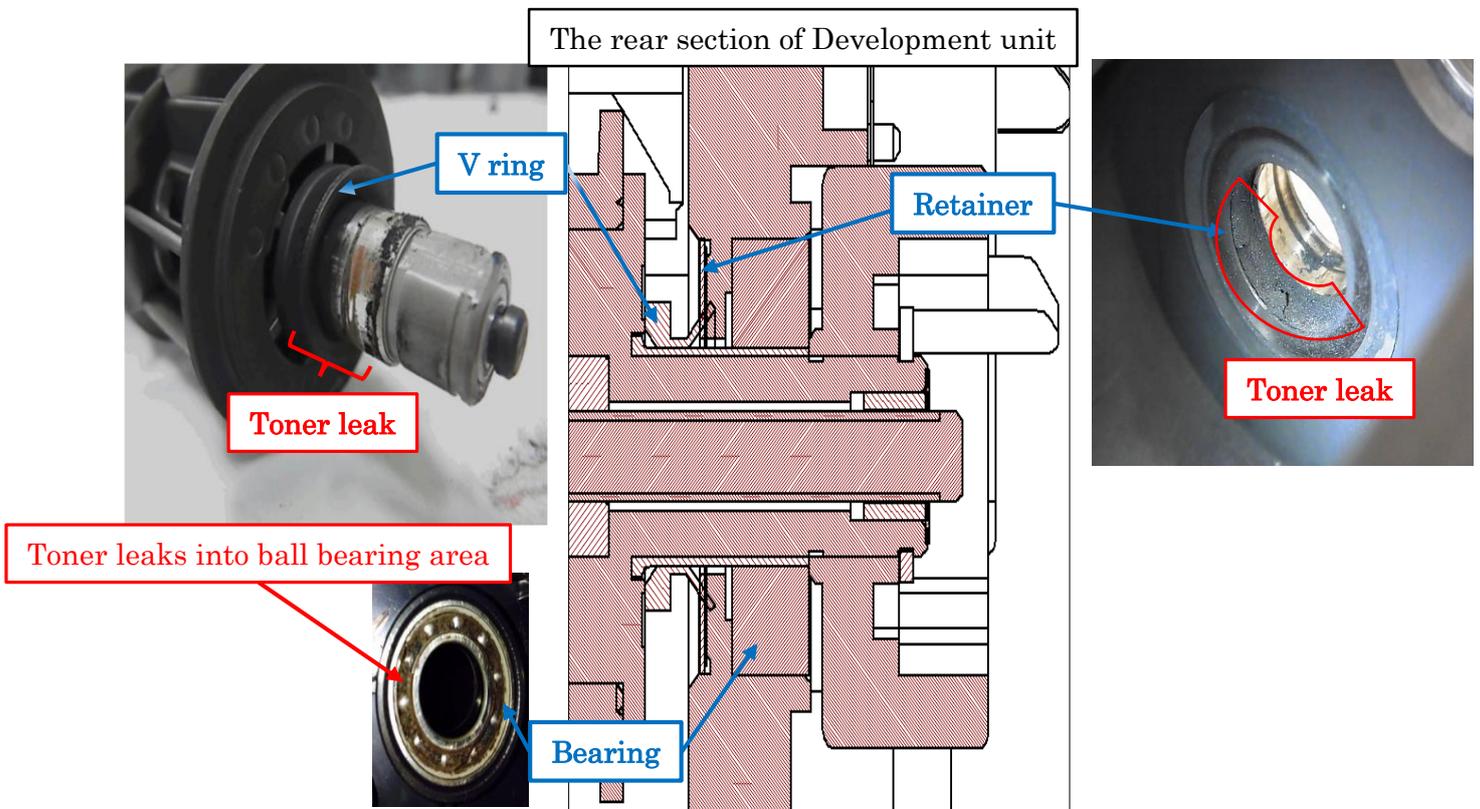
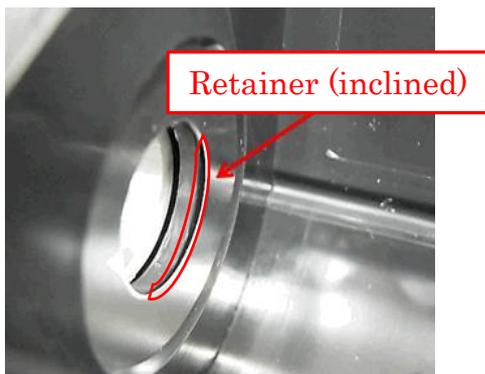
SC324 (Development paddle motor error) or noise occurs.

The retainer is inclined (see photo), allowing toner to leak into the bearing area of the development unit. This increases the mechanical load on the paddle motor, resulting in the SC and/or noise.

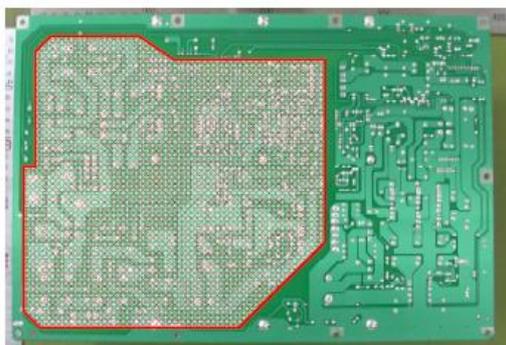
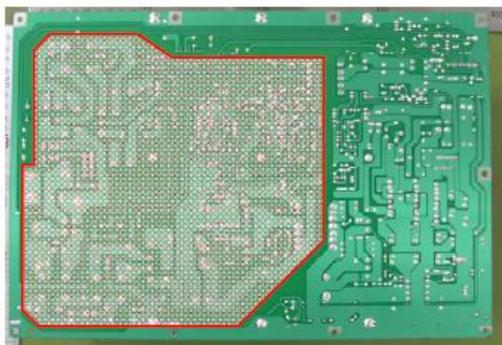
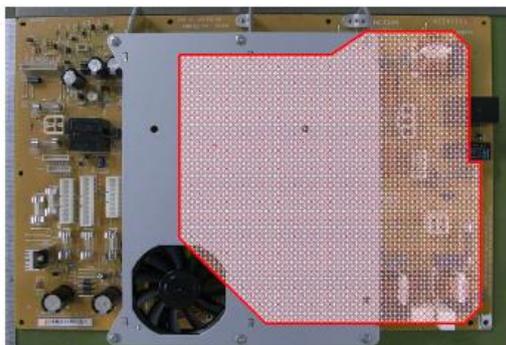
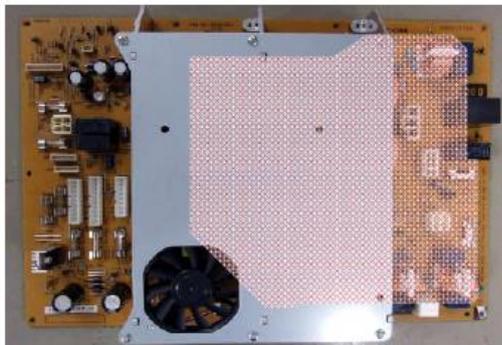
Alex-C2 200V EU PSU

The areas outlined in red on the bracket show where the residual charge of about 100V-400V remains on the PSU board under the bracket.
