Model: Gim-MF1.5dM	Date: 27-Jul-16	No.: RM0A0003a

Subject: Firmware Release Note: Web Uapl			Prepared by: Y. Gaman
From: 2nd Tech	Service Sect., MFP/Printer Tec	ch Service Dept.	
Classification:	☐ Troubleshooting☐ Mechanical☐ Paper path☐ Product Safety	☐ Part information☐ Electrical☐ Transmit/receive☒ Other (Firmware)	☐ Action required☐ Service manual revision☐ Retrofit information☒ Tier 2

This RTB has been issued to announce the firmware release information for the Web Uapl.

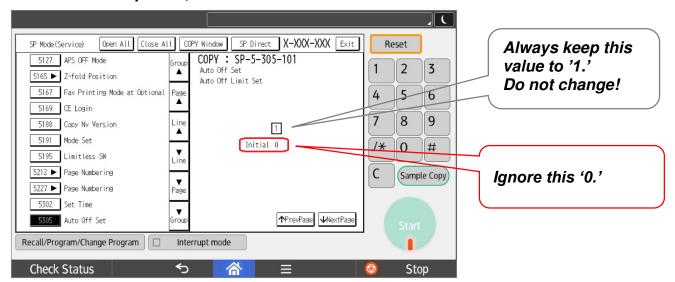
The default value of SP 5-305-101 was corrected from '0' to '1'.

The *Initial* value appears as '0' in the SP mode, but the actual value is set to '1' at the factory. *('0' indicates machines installed in Japan and '1' indicates machines installed outside of Japan.)*

DO NOT change this SP setting. Always maintain '1' unless when running tests. If the NVRAM is replaced, set the value back to '1.'

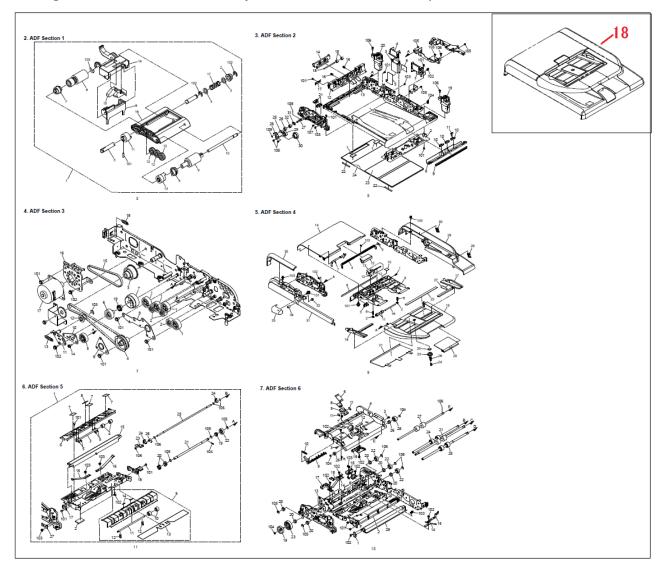
Old part number	New part number	Description	Q'ty	Int	Page	Index	Note
-	D3DJ0014	ADF:ASS'Y	1	-	4	18

Change/Reason: The ADF Ass'y was added as a service part.

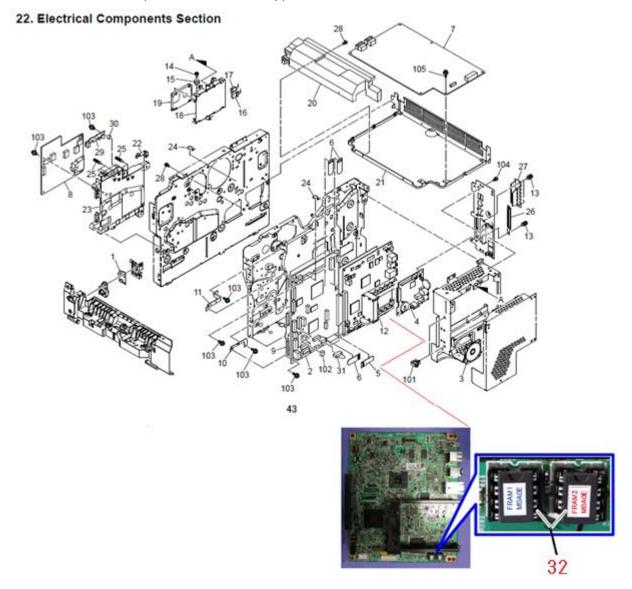
Old part number	New part number	Description	Q'ty	Int	Page	Index	Note
-	M0A09590	NVRAM	1	-	44	32

NOTE: The above part contains two types of NVRAMs as a set.

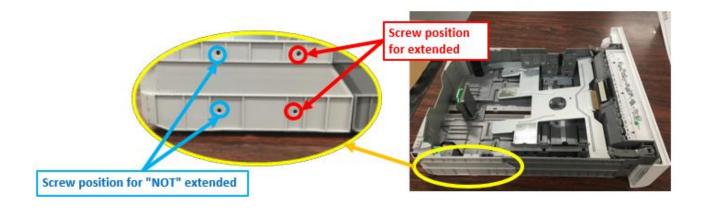
Advise the user to lock the catches and **NOT** to extend the tray when loading A4 SEF or smaller paper sizes (as mentioned in the Operator's Instructions). If the user uses only A4 SEF or smaller paper sizes, then the catches can be fixed in place (both sides) using the following screws:

P/N	Description	Necessary Q'ty
04583010N	HEXAGON HEAD TAPPING SCREW:3X10	4

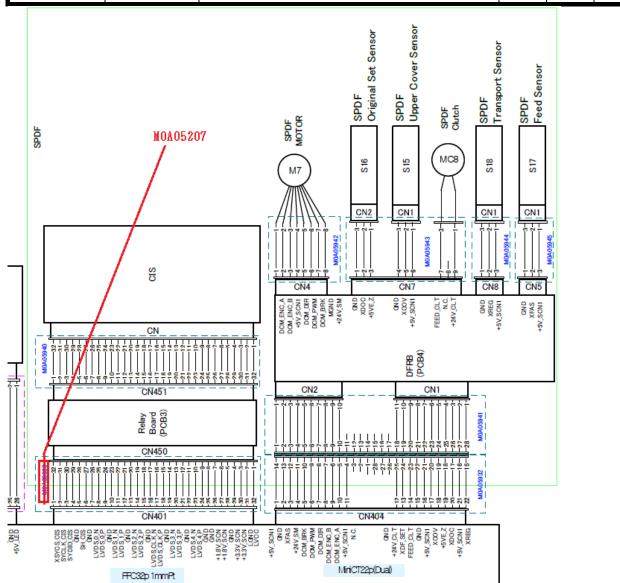
Change/Reason: Please correct your part catalog as shown.

Old part	New part	Description	Q'ty	Int	Note
number	number				
M0A05930	M0A05207	HARNESS:SCANNER:FFC:CIS:ASS'Y	1	-

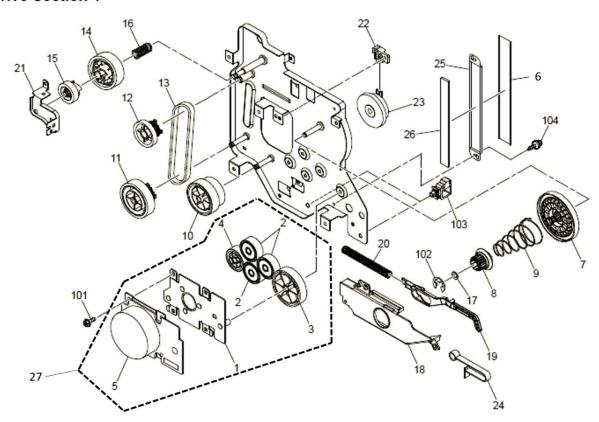
20. Drive Section 1

Reason: These parts were missing from the Parts Catalog.

P/N M0A00035 is assy including parts from index 1 to 5

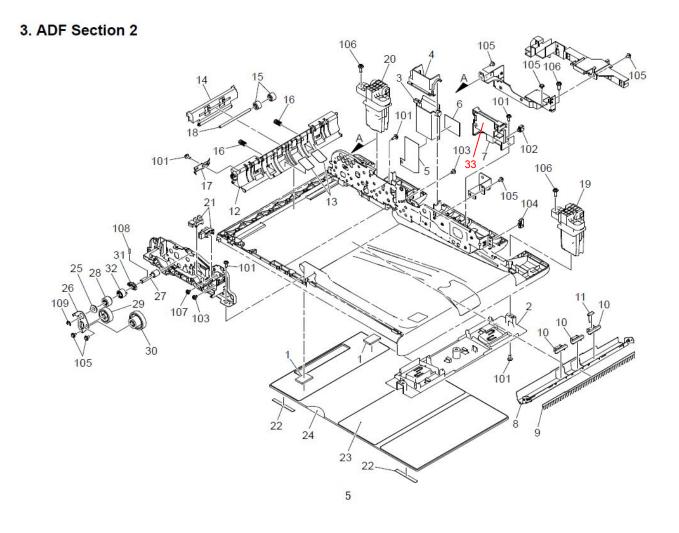
Part Number	Description	Q'ty	Page	Index	Note
M0A05922	PCB:DFRB3	1	5	33

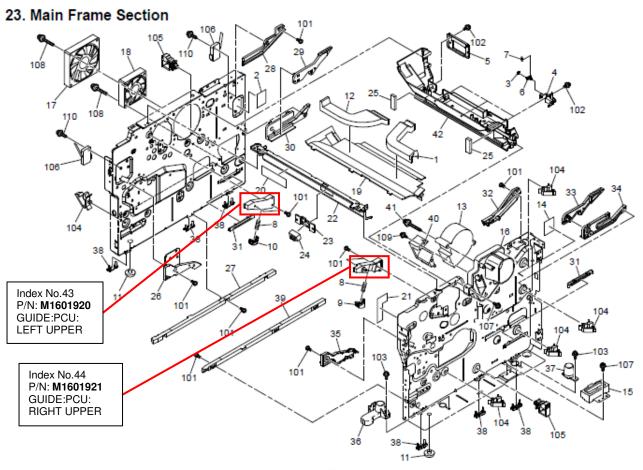
The following parts were registered as a service part.

Old part	New part	Description	Q'ty	Page	Index	Note
number	number					
-	M1601920	GUIDE:PCU:LEFT UPPER	1	45	43	
-	M1601921	GUIDE:PCU:RIGHT UPPER	1	45	44
