| Model: Gim-MF1a/b | | Date: 23-Feb-15 | No.: RM172001 |
| Subject: Service manual revision | | Prepared by: T.Suzuki | |

| Subject: Troubleshooting - No image printing of received fax | | Prepared by: T.Suzuki | |

| Subject: Dirty reverse side of printing sheets | | Prepared by: J.Kitagawa | |

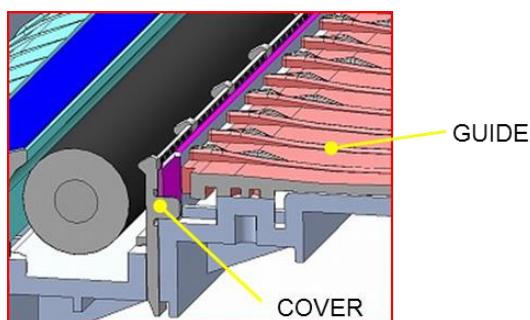
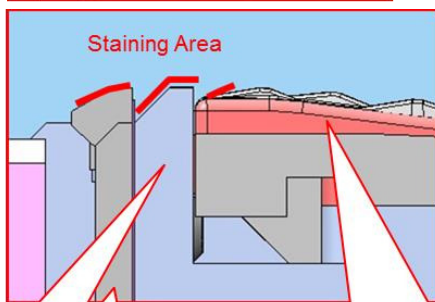
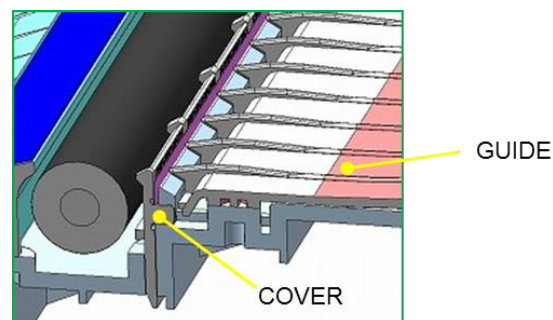
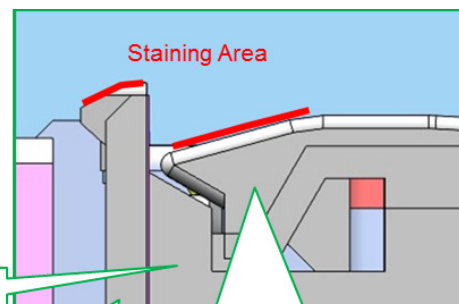
1. The maximum height of the guide rib of the exit guide stay was shortened.
2. The material and shape of the electrode plate cover was changed.
3. The shape of the transfer stay was changed as shown in the illustration.

Note: The reverse side of the printing sheets may get dirty when the sheets pass through the area indicated in the illustration.

Change: The shapes and/or material of the following parts were changed.

Important: These three parts need to be installed **together as a set**.

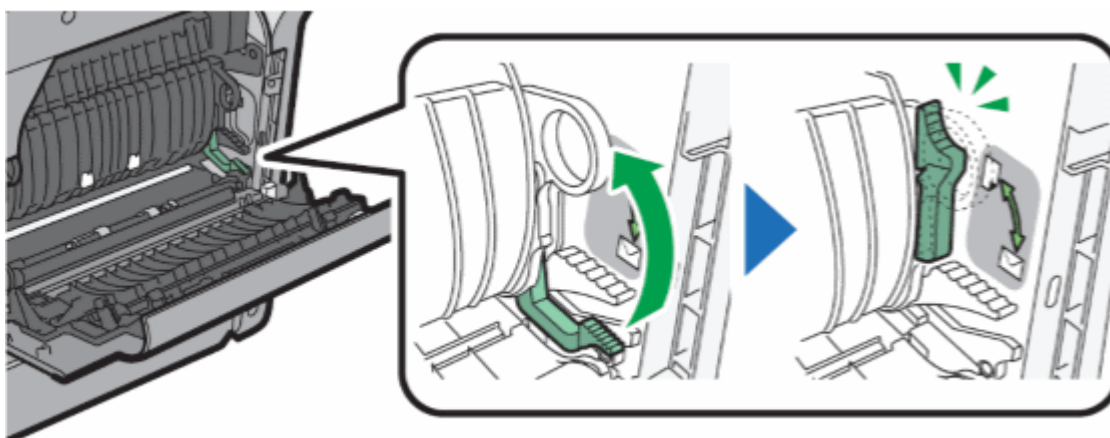
CYN480

Toner is not properly fixed when printed on a recommended type of plain paper.

Raise the lever to the high position.

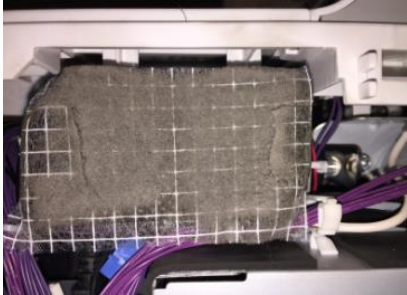
1. *A foreign substance enters the machine via the intake fan.*

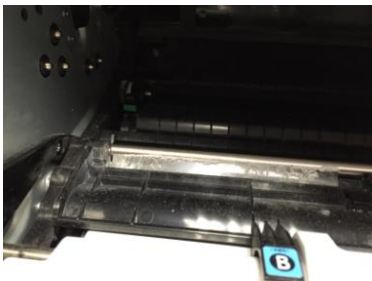
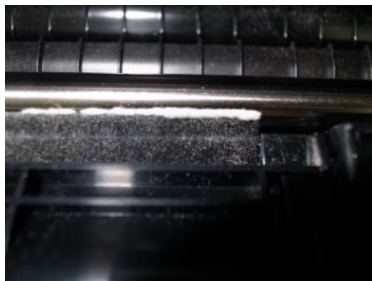
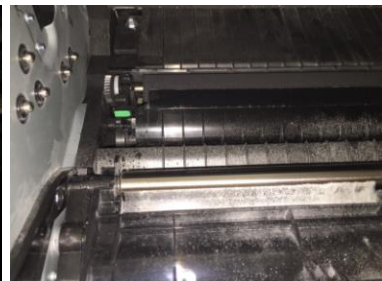
2. *Paper dust accumulates inside the paper path.*

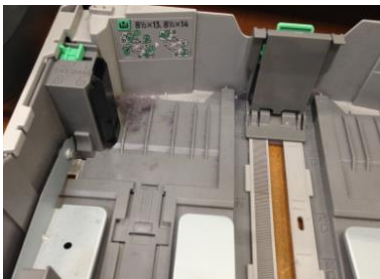
3. *A foreign substance adheres to the paper loaded in the tray and on the bypass.*

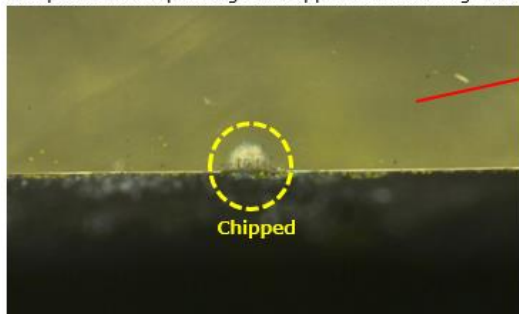
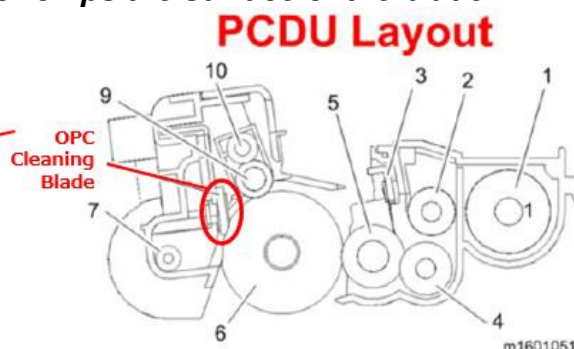
Sample: microscope image of chipped OPC cleaning blade

Paper dust or other foreign substance adheres to the drum, gets caught between the drum and cleaning blade, and/or chips the surface of the blade.

At such a location, the cleaning blade cannot clean toner out from the PCDU, causing a black line on prints. Gradually the unremoved toner transfers to the charge roller and charge cleaning roller. When it comes to a certain level, the charge roller cannot charge sufficiently, causing a white line on prints.

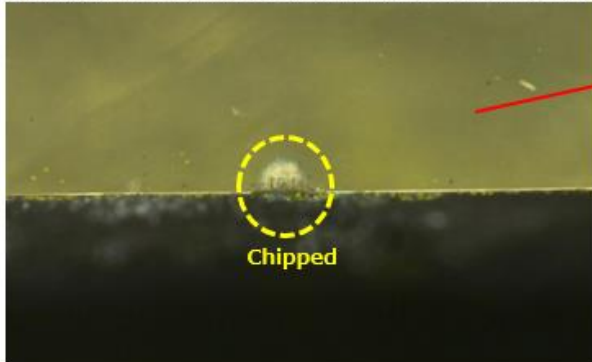
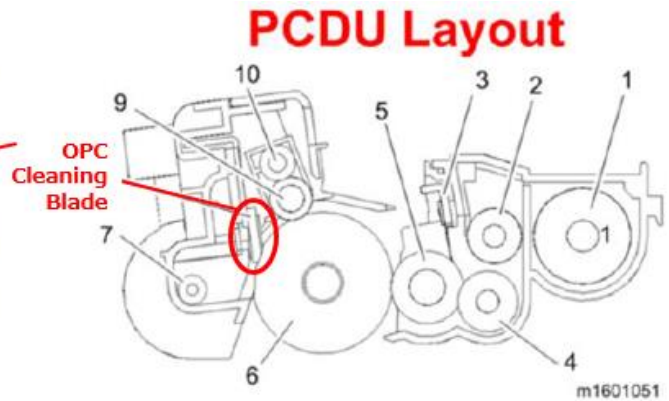
Sample: microscope image of chipped OPC cleaning blade

Abnormal substance comes inside from the intake fan, then it adheres on the drum. Then the abnormal substance which adheres to the drum is caught and/or chips the cleaning blade.

At such a location, the cleaning blade cannot clean toner out from the PCDU, causing black lines on prints. Gradually this toner transfers to the charge roller and charge cleaning roller. When it comes to a certain level, the charge roller cannot charge sufficiently, causing white lines on prints.

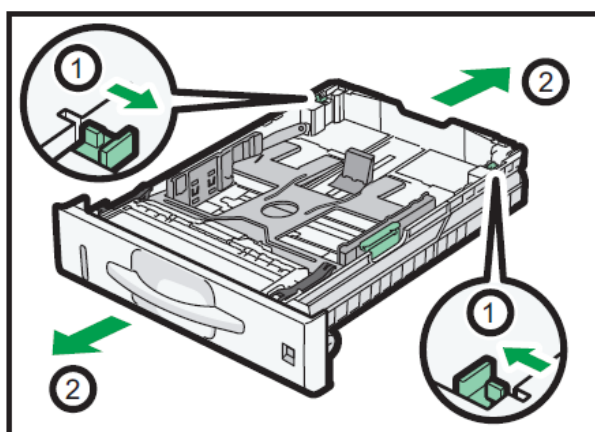
CXC607

- A) The end fence may be kicked a few notches back by the loaded paper if the fence is adjusted after the paper is loaded.
- B) The end fence may be pushed back when the paper is loaded if the catches (1) do not lock the tray extension.

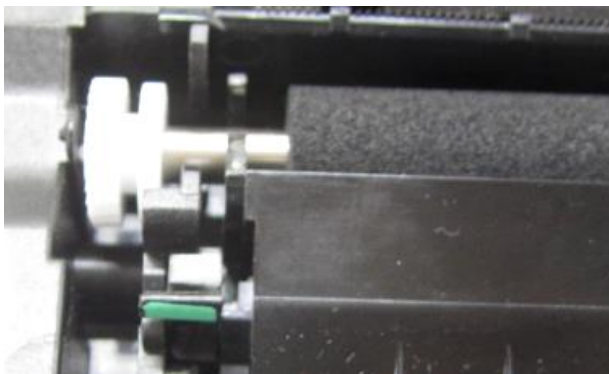
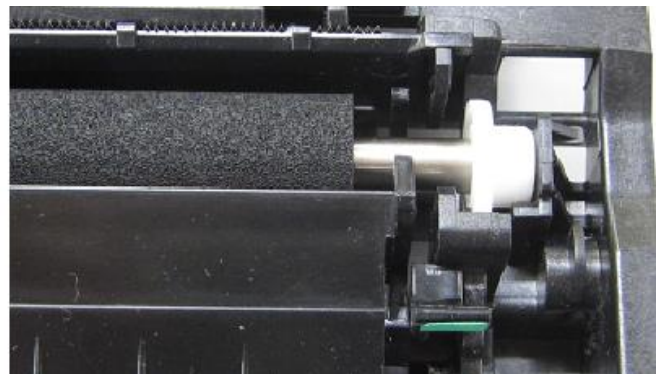
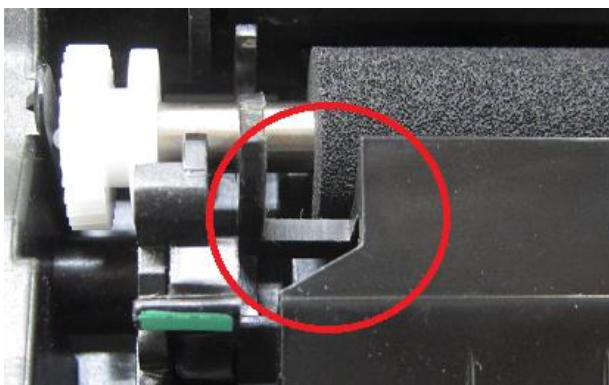
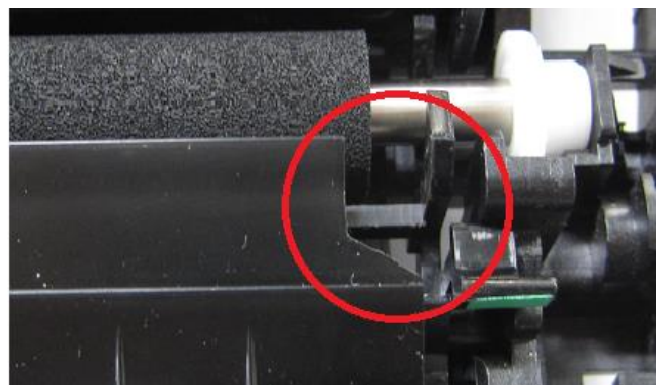
To avoid black band stains caused by dropped toner on the front paper guide of the transfer roller.

With this modification, dropped toner goes around the right and left edges of the front paper guide and accumulates on the transfer stay.
