Important Information about Normal/Smart Panel Firmware Updates

Technical Bulletin

Model: Gim-P1a Dat			te: 23-Feb	-15	No.: RM171002	
Subject: Service manual revision			Prepared by: T.Suzuki			
From: 3rd Tech.	Support Sec. Service Support I	Dept,				
Classification:	 Troubleshooting Mechanical Paper path Product Safety 	Part info Electrica Transmi	al		—	required e manual revision it information

RTB Reissue					
Subject: Dirty reverse side of printing sheets			Prepared by: J.Kitagawa		
From: 1st Tech S	Service Sect., MFP/P Tech Ser	vice Dept.			
Classification:	 Troubleshooting Mechanical Paper path Product Safety 	Part informat Electrical Transmit/rec Other (Action required Service manual revision Retrofit information Tier 2

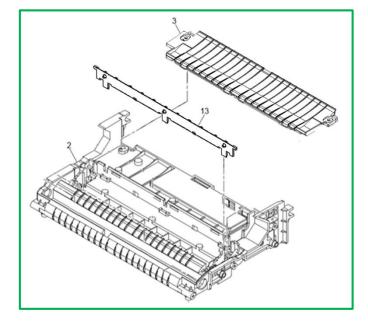
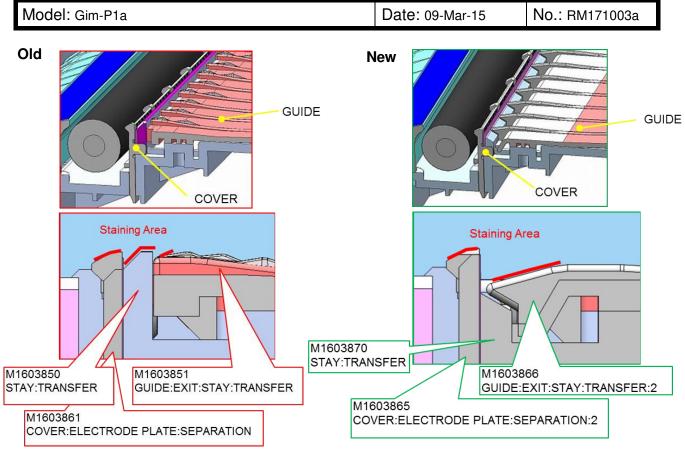
Change: The shapes and/or material of the following parts were changed.

- 1. The maximum height of the guide rib of the exit guide stay was shortened.
- 2. The material and shape of the electrode plate cover was changed.
- 3. The shape of the transfer stay was changed as shown in the illustration.

Reason: To further minimize staining on the printed paper.

Note: The reverse side of the printed sheets may get dirty when the sheets pass through the area indicated in the illustration.

Important: These three parts need to be installed **together as a set**.

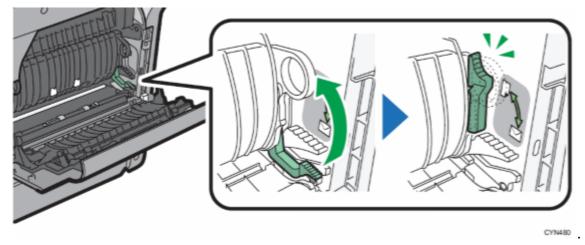
Toner is not properly fixed when printed on a recommended type of plain paper.

The lever is set to the low position for envelope printing.

Raise the lever to the high position.

Lower this lever only when printing on envelopes.

After installing the device or replacing the fusing unit, make sure to raise the lever.

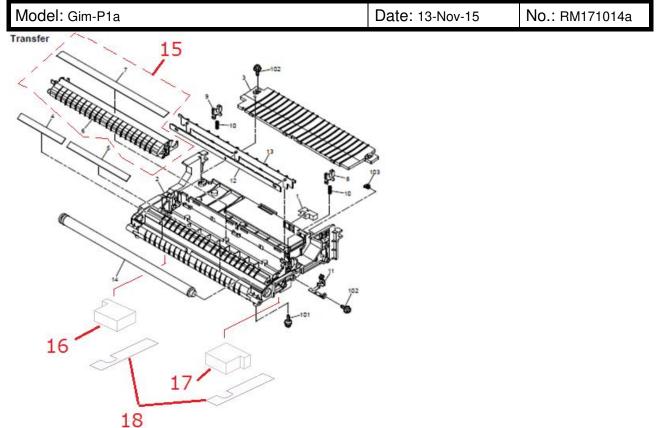
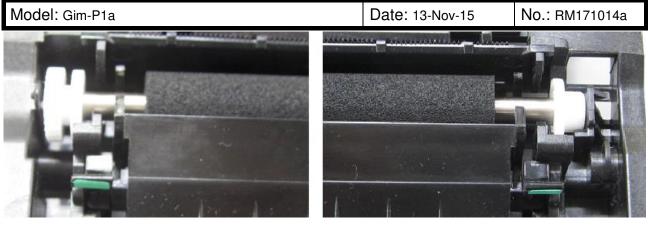
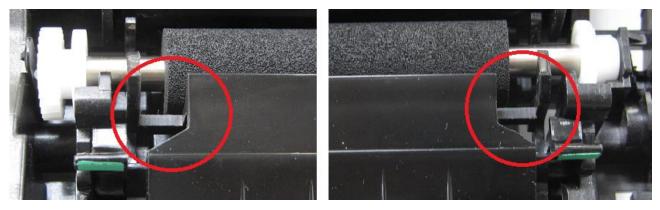
- A cut-out was applied to the right and left edges of the front paper guide of the transfer roller.
- Sponges and sheets were added to the transfer stay.

To avoid black band stains caused by dropped toner on the front paper guide of the transfer roller.

With this modification, dropped toner goes around the right and left edges of the front paper guide and accumulates on the transfer stay.

This modification has compatibilities. Since the old transfer stay cannot be replaced in the field and the stay of the old type is compatible only with the front paper guide of the old type, when replacing the front paper guide of an old machine, make sure to procure the old type.

This modification allows usage of the PCDU even after exceeding 23K by modifying SP5-931-003*. However, DO NOT modify this SP on machines manufactured prior to this modification, because the front paper guide and transfer stay are both of the old type and will cause toner accumulation on the front paper guide when reaching approximately 23K.

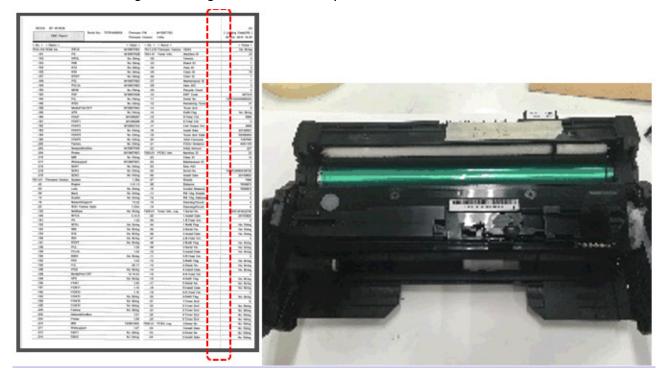
Black line or white line appears on prints in the feeding direction along with unwanted toner on the charge cleaning roller at the line position.

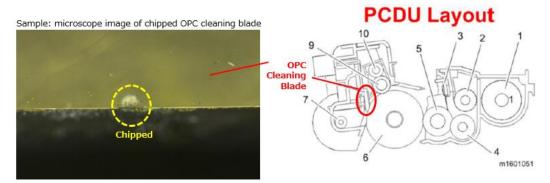
Paper dust or other foreign substance adheres to the drum, gets caught between the drum and cleaning blade, and/or chips the surface of the blade.

At such a location, the cleaning blade cannot clean toner out from the PCDU, causing a black line on prints. Gradually the unremoved toner transfers to the charge roller and charge cleaning roller. When it comes to a certain level, the charge roller cannot charge sufficiently, causing a white line on prints.

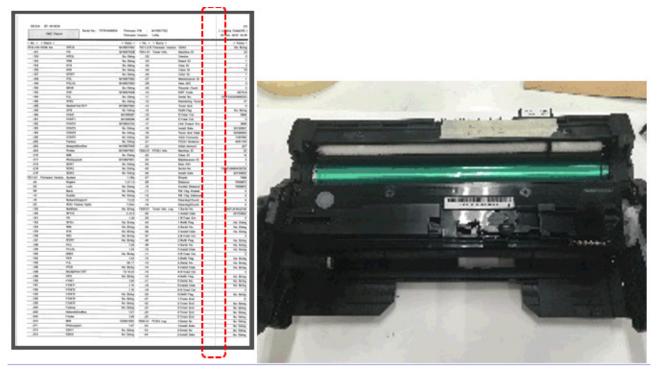
Black line or white line appears on prints in the feeding direction along with toner on the charge cleaning roller at the line position.

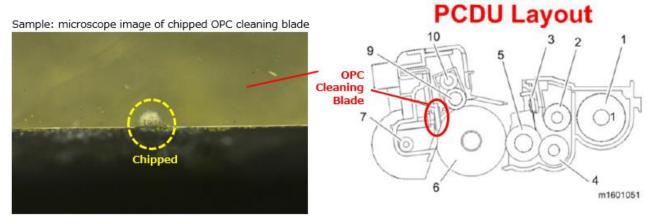
Abnormal substance comes inside from the intake fan, then it adheres on the drum. Then the abnormal substance which adheres to the drum is caught and/or chips the cleaning blade.

At such a location, the cleaning blade cannot clean toner out from the PCDU, causing black lines on prints. Gradually this toner transfers to the charge roller and charge cleaning roller. When it comes to a certain level, the charge roller cannot charge sufficiently, causing white lines on prints.
