Model: Gim-P1c/Gim-P1d Date: 21-		Nov-14	No.: RM158003		
Subject: Firmware	Release Note: NetworkDock	Зох		Prepared	by: Y. Gaman
From: 3rd Tech Se	rvice Sect., MFP/Printer Tech	Service Dept.			
Classification:	☐ Troubleshooting	☐ Part informati	on	☐ Action re	equired
	☐ Mechanical	Electrical		Service ı	manual revision
	☐ Paper path	☐ Transmit/rece	eive	☐ Retrofit i	nformation
	☐ Product Safety	Other (Firmwa	are)	□ Tier 2

Technical Bulletin

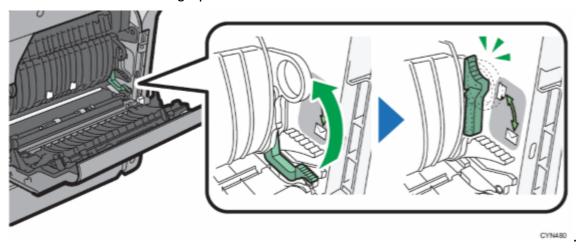
Toner is not properly fixed when printed on a recommended type of plain paper.

Raise the lever to the high position.

Lower this lever only when printing on envelopes.

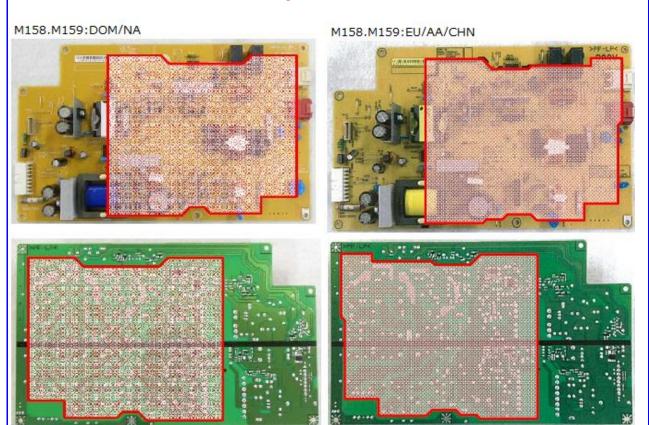
NEVER touch the areas outlined in red in the photos below to prevent electric shock caused by residual charge.

Residual charge of about 100V-400V remains in the AC circuits on the PSU board for several months even when the board has been removed from the machine after turning off the machine power and unplugging the power cord.

The procedure to discharge residual charge from the machine by unplugging the power cord from the AC wall outlet and pressing the main power switch works only for the DC circuits on this board. Residual charge remains in the AC circuits.

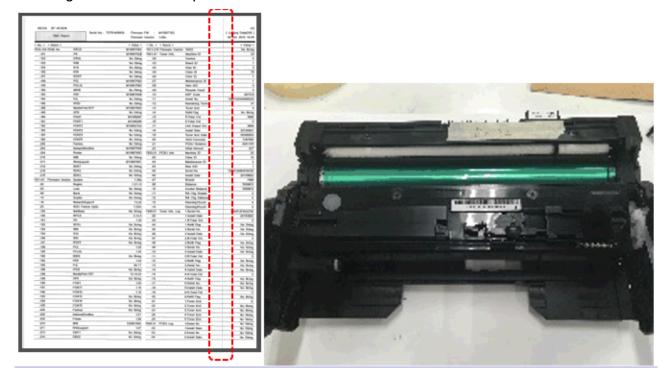
Black line or white line appears on print at feeding direction along with toner dirt on charge cleaning roller at the line position.

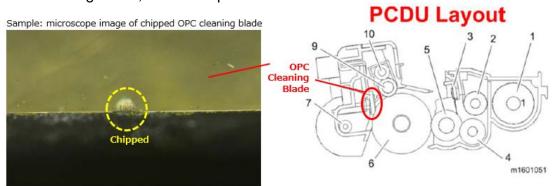
Paper dust or other foreign substance adheres to the drum, gets caught between the drum and cleaning blade, and/or chips the surface of the blade.

At such the location, the cleaning blade cannot clean toner out from PCDU, causing black line on print images. Gradually the uncleaned toner transfers to charge roller and charge cleaning roller. When it comes to certain level, the charge roller cannot charge sufficiently, causing white line on print images.

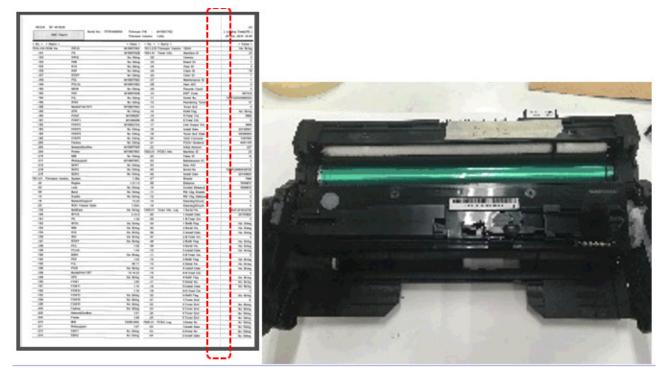
Black line or white line appears on prints in the feeding direction along with toner on the charge cleaning roller at the line position.

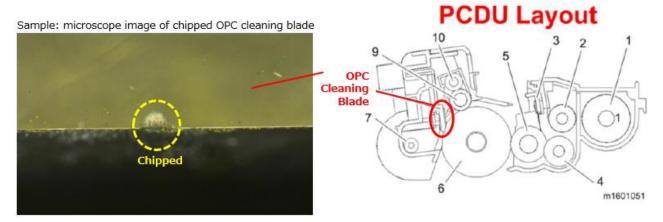
Abnormal substance comes inside from the intake fan, then it adheres on the drum. Then the abnormal substance which adheres to the drum is caught and/or chips the cleaning blade.

At such a location, the cleaning blade cannot clean toner out from the PCDU, causing black lines on prints. Gradually this toner transfers to the charge roller and charge cleaning roller. When it comes to a certain level, the charge roller cannot charge sufficiently, causing white lines on prints.

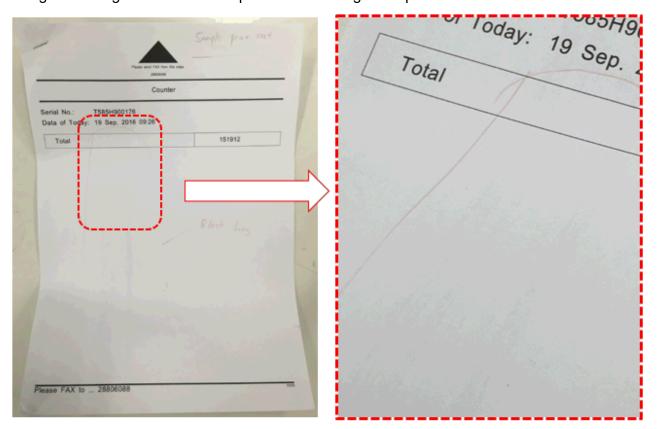
Symptom #2

Streaky dirty background on print at feeding direction without toner dirt on a drum nor on a charge cleaning roller at the line position. An image sample follows:

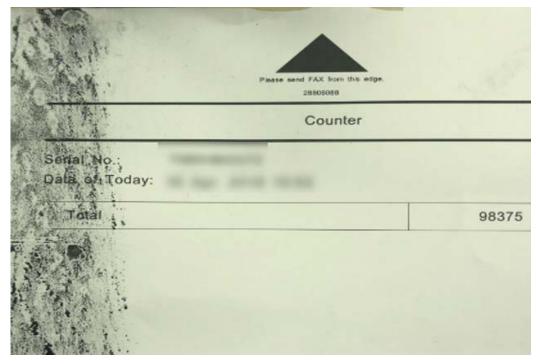
The following(s) may occur after abnormal noise from left side of a machine

- Severe toner scattering or leakage inside of a machine
- Toner drop (dirty) on left side of a print

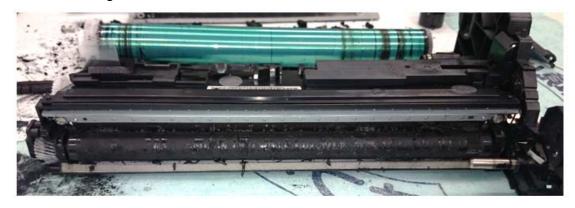
• Toner melting inside of a PCDU

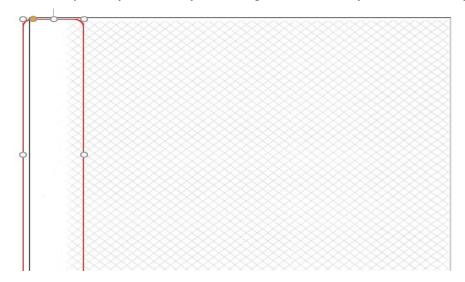
White bands appear on the left edge of the image (captioned in red below).

Note: This is temporarily solved by cleaning the LED array, but occurs again.

A gap develops between the OPC surface and tip of the cleaning blade, allowing toner to slip through and enter the machine's internal airflow. This toner scatters and spreads inside the machine, gradually building up on the LED array. This leads to white blotches (missing toner) along the left edge of the image.

Replace PCDU.
