Model: Brz-MF1	Date: 23-May-16	No.: RD255002b
----------------	-----------------	----------------

Subject: Firmware Release Note: Engine		Prepared by: T. Tachibana	
From: 2nd Tech Service Sect., MFP/Printer Tech Service Dept.			
Classification:	<input type="checkbox"/> Troubleshooting <input type="checkbox"/> Mechanical <input type="checkbox"/> Paper path <input type="checkbox"/> Product Safety	<input type="checkbox"/> Part information <input type="checkbox"/> Electrical <input type="checkbox"/> Transmit/receive <input checked="" type="checkbox"/> Other (Firmware)	<input type="checkbox"/> Action required <input type="checkbox"/> Service manual revision <input type="checkbox"/> Retrofit information <input checked="" type="checkbox"/> Tier 2

This RTB has been issued to announce the firmware release information for the **Engine**.

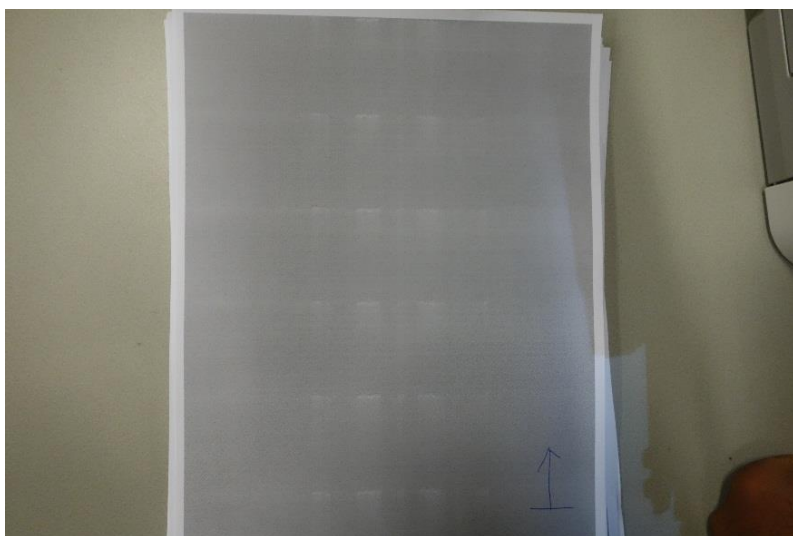
Note: The streaks are most visible in solid and halftone areas.

The plastic bag wrapped around the MFP was not sealed properly. As a result, condensation formed on the surface of the development roller before the development unit was filled with toner. Marks remain on the roller surface after the water evaporated.

The plastic bag used to cover the machine is sealed securely, so as to prevent moisture from forming inside.

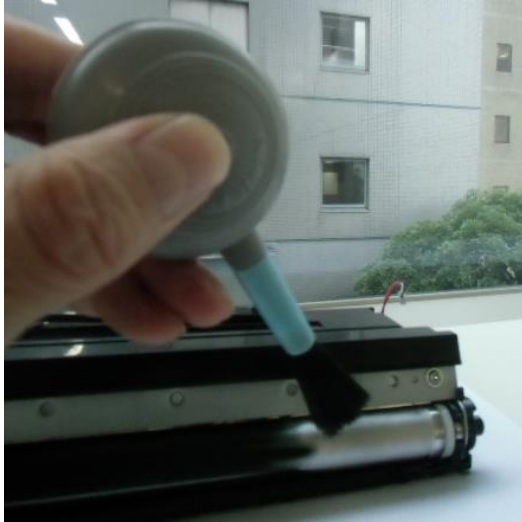
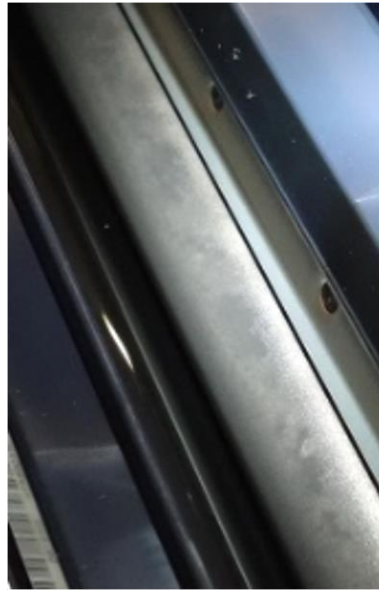
7. Remove the toner covering the development roller surface using an air brush.
Note: You will see marks on the development roller as shown in the photo below.

8. Clean the development roller surface using a soft cloth.

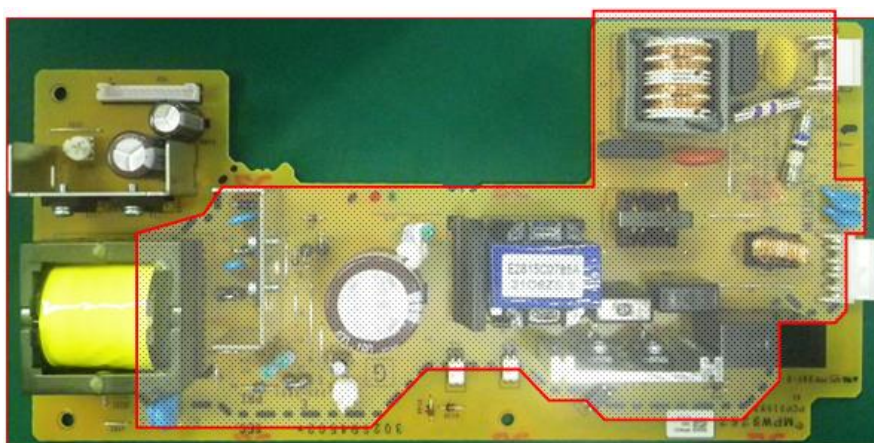
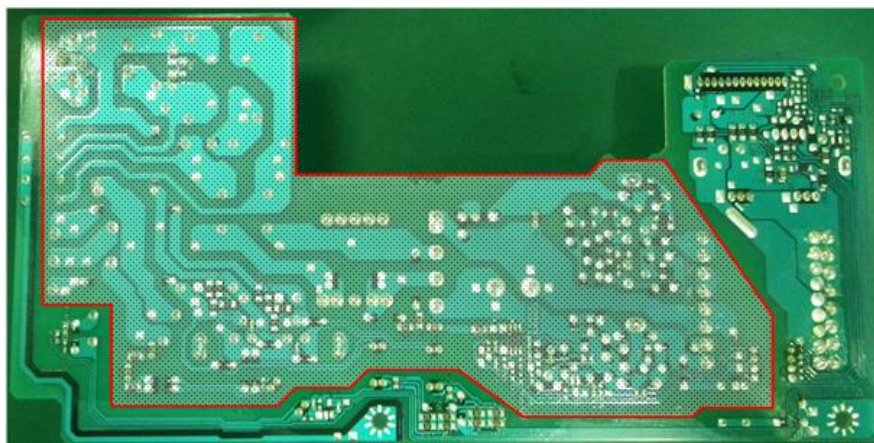
- Turn off the main power switch and unplug the power cord before replacing the PSU.
- Do not touch the areas outlined in red in the following diagrams when replacing the PSU. Residual charge on the board may cause electric shock.

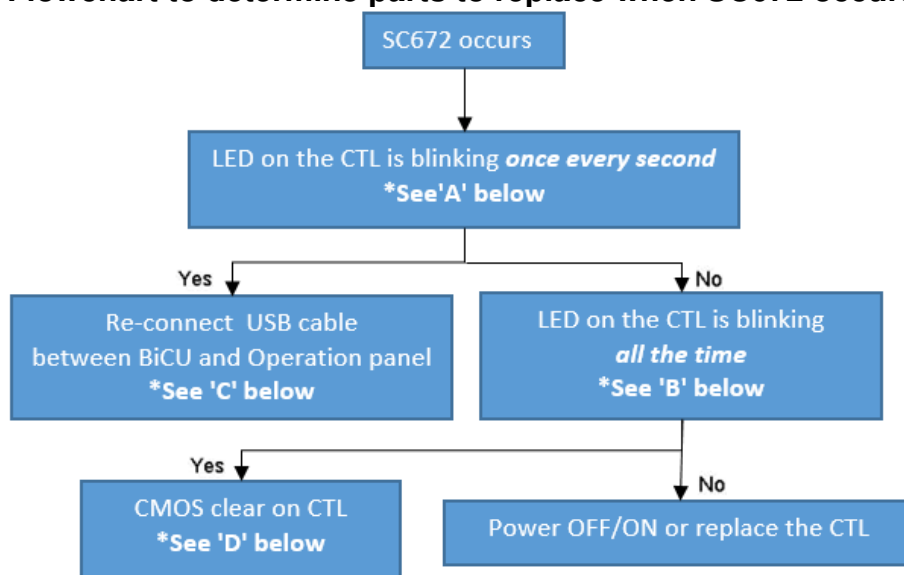
Flowchart to determine parts to replace when SC672 occurs

Possible causes of SC672 include:

- USB communication path failure (USB cable, IPU)
- CTL boot up error and/or operation panel boot up error due to abnormal break in operations of CTL.

- If SC819 (cache error) appears in the SC history, replace the controller board.
- If SC991 (SCS: scs time count level c') appears in the SC history, replace the controller board and USB cable.

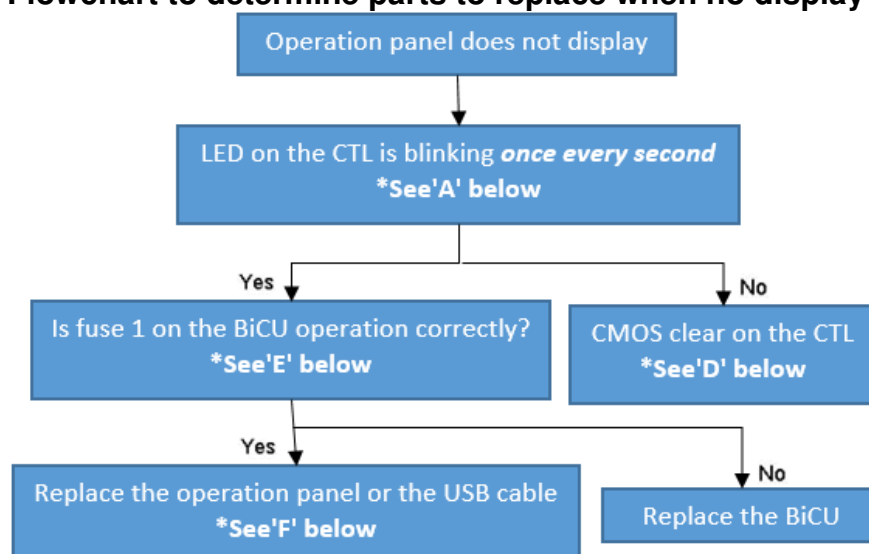
Flowchart to determine parts to replace when no display on operation panel

Possible causes of operation panel cannot light include:

- USB communication path failure (USB cable, IPU)
- Operation panel cannot communicate with CTL due to CTL boot-up error

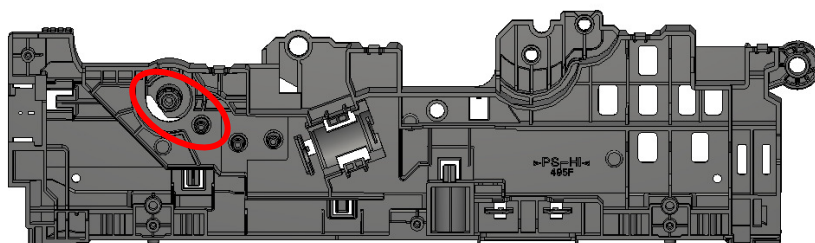
The shafts circled in red have been modified because they may turn white or break. If the shafts are broken, SC501-01(Paper Feed Tray Lift Motor Error (Tray 1)) appears.
