Model: Brz-P1

Technical Bulletin

No.: RM281002c

<i>lics</i> ha	IVe
Subject: Firmware Heekasenslootaplenginta		been corrected or	adeeepared by: T. Tachibana
From: 2nd Tech S	ervice Sect., MFP/Printer Tec	ch Service Dept.	
Classification:	 Troubleshooting Mechanical 	Part information	 Action required Service manual revision
	Paper path	Transmit/receive	Retrofit information
	Product Safety	🛛 Other (Firmware)	🖾 Tier 2

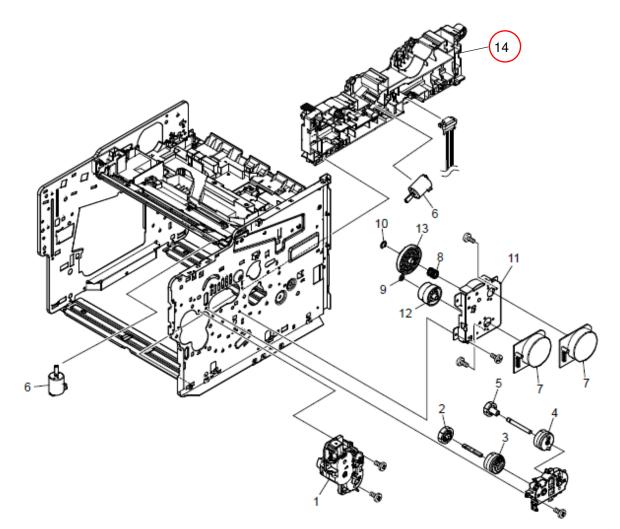
9. Drive Section

The shafts circled in red have been modified because they may turn white or break. If the shafts are broken, SC501-01(Paper Feed Tray Lift Motor Error (Tray 1)) appears.

Old part number	New part number	Description	Q'ty	Int	Page	Index	Note
	M2811182	GUIDE CASSETTE R	0-1	-	20	14

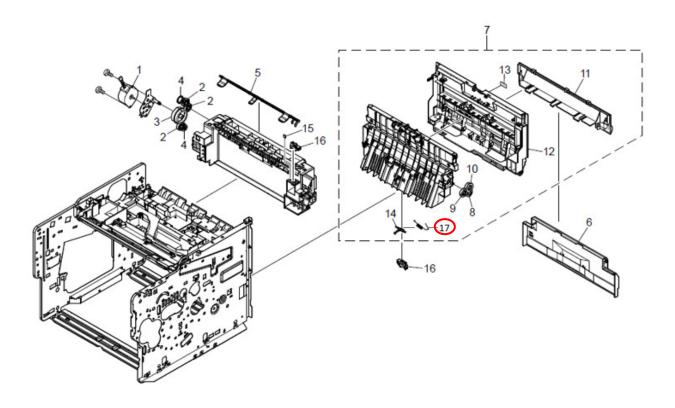
8. Exit Section

Reason: To make it possible to replace the spring individually when a duplex jam occurs (Jam code: 86).

Part number	Description	Q'ty	Int	Page	Index	Note
M2814458	SPRING ACTUATOR DU	1		18	17
