Model: <b>Martini-C4</b>	Date: 30-Apr-09	No.: RD062001
--------------------------	-----------------	---------------

Subject: Printer SP Bit Switch #5-7		Prepared by: Koji KY Yamamoto	
From: 2nd Tech. Support Sec. Service Support Dept.			
Classification:	<input type="checkbox"/> Troubleshooting	<input type="checkbox"/> Part information	<input type="checkbox"/> Action required
	<input type="checkbox"/> Mechanical	<input type="checkbox"/> Electrical	<input checked="" type="checkbox"/> Service manual revision
	<input type="checkbox"/> Paper path	<input type="checkbox"/> Transmit/receive	<input type="checkbox"/> Retrofit information
	<input type="checkbox"/> Product Safety	<input type="checkbox"/> Other ( )	<input type="checkbox"/> Tier 2

Model: MT-C4	Date: 28-May-09	No.: RD062002c
--------------	-----------------	----------------

Subject: Firmware Release Note: Web Support		Prepared by: K. Yamamoto	
From: 1st Overseas Tech Support Sec., 1st PQM Dept.			
Classification:	<input type="checkbox"/> Troubleshooting	<input type="checkbox"/> Part information	<input type="checkbox"/> Action required
	<input type="checkbox"/> Mechanical	<input type="checkbox"/> Electrical	<input type="checkbo

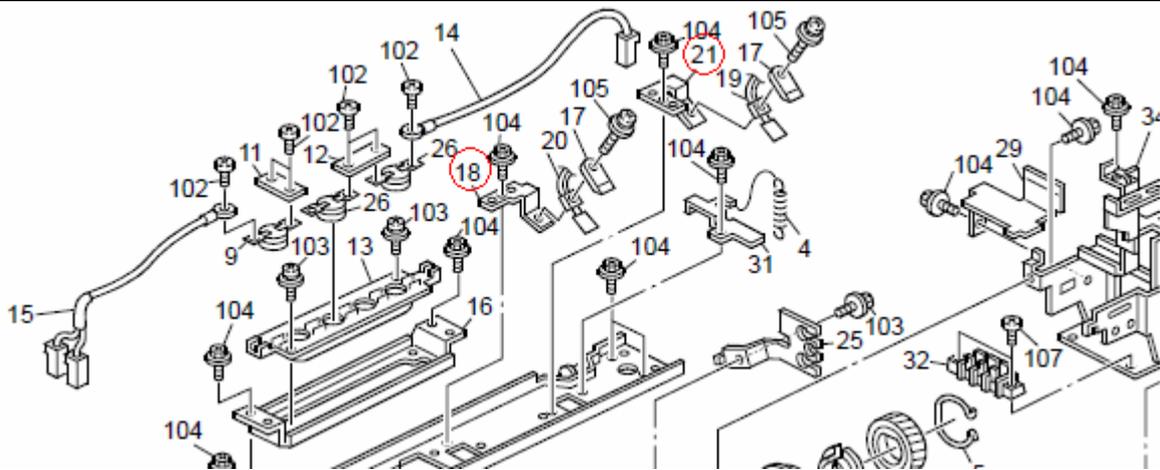
*The distance [A] is different between the new and old brackets .*

1. Clean the middle and rear thermistors.
2. If the SC still occurs even after cleaning the thermistors, replace the thermistor brackets with the new parts in the table below.

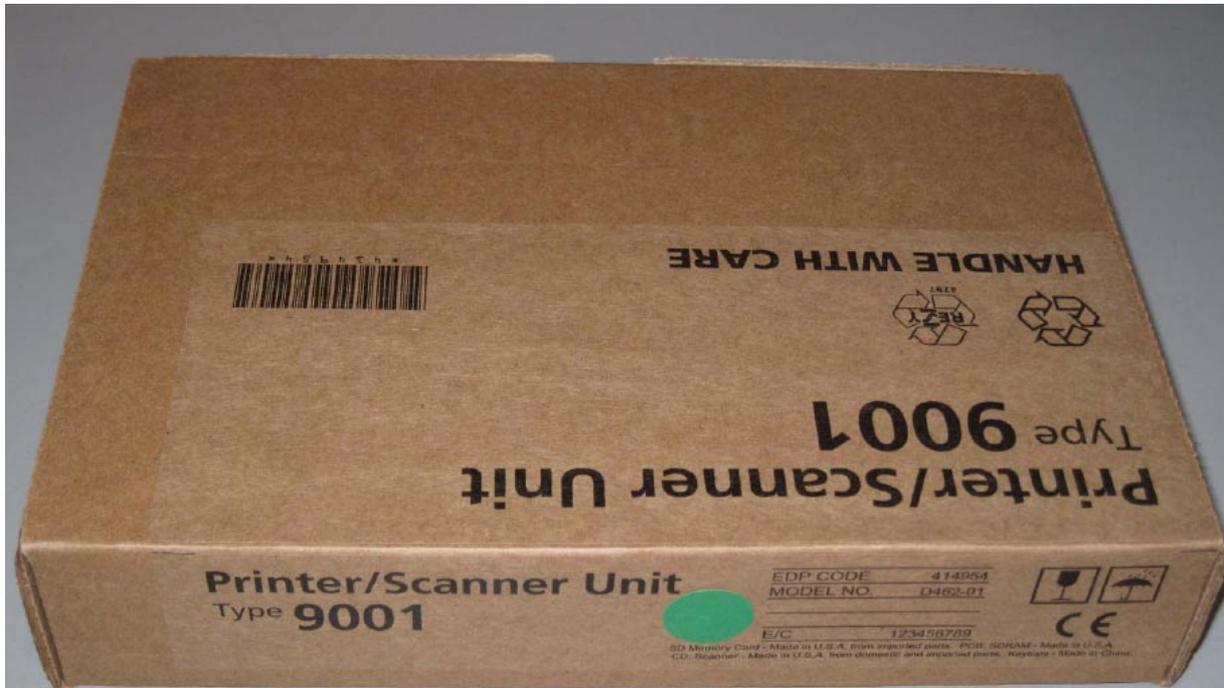
Printer/Scanner Units produced from July 1, 2009, which contain the correct key top, are marked as shown in the photo:

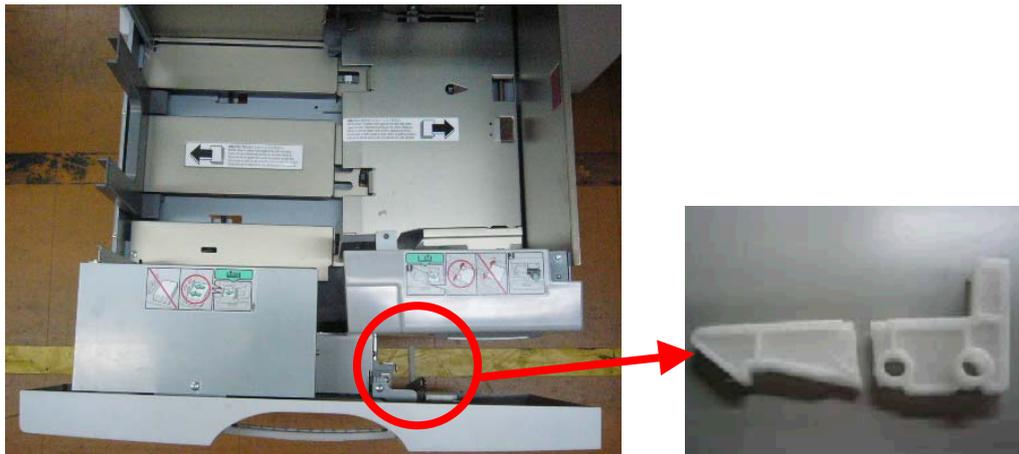
Broken tandem tray stopper (D0626702)

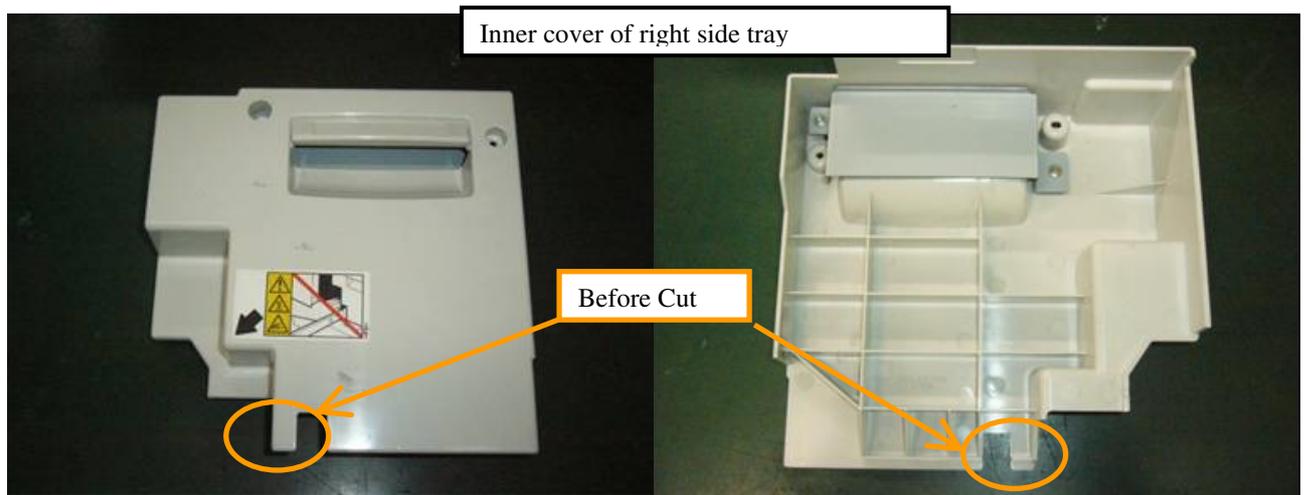
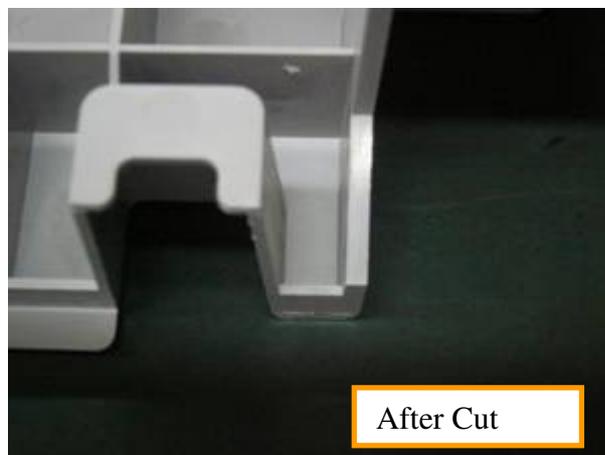
**Note:** This is to prevent the stopper from being damaged again.

1. Confirm that the tandem tray stopper is broken. If it is, replace it.
2. Make a cut-out in the inner cover, as shown in the photo below **or replace with the new inner cover (D0626755).**

3. Advise the user that when closing the tandem tray, **close the right side first.** If you close the left side and right sides together, this can damage the stopper.

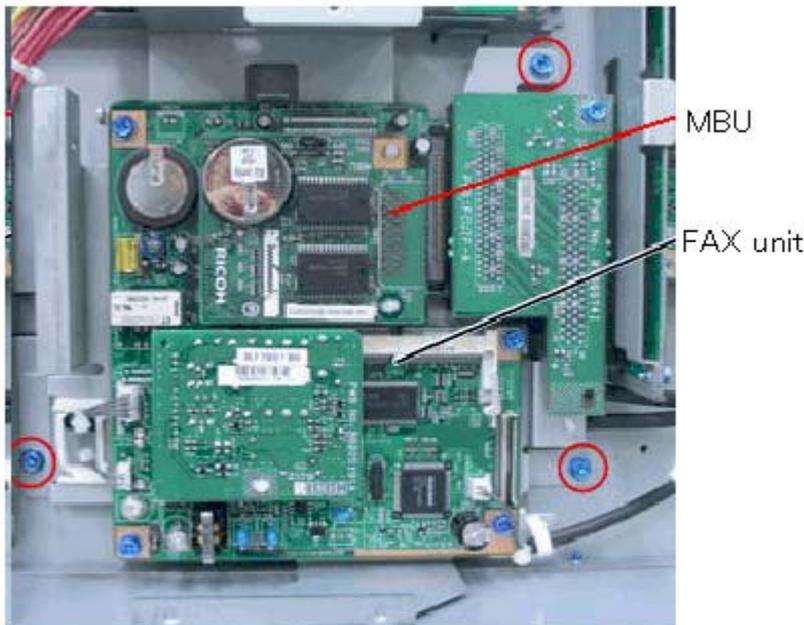
One of the harness clamps attached to the bracket of the fax unit causes the bracket to bend. As a result, the fax unit is also bent, and the MBU connector detaches from the fax unit.
