Model: MT-C5	Date: 17-May -12	No.: RD131001a
--------------	------------------	----------------

Subject: Firmware Release Note: RPCS		Prepared by: M. Yoneda	
From: 2nd Tech Service Sect., MFP/Printer Tech Service Dept.			
Classification:	<input type="checkbox"/> Troubleshooting <input type="checkbox"/> Mechanical <input type="checkbox"/> Paper path <input type="checkbox"/> Product Safety	<input type="checkbox"/> Part information <input type="checkbox"/> Electrical <input type="checkbox"/> Transmit/receive <input checked="" type="checkbox"/> Other (Firmware)	<input type="checkbox"/> Action required <input type="checkbox"/> Service manual revision <input type="checkbox"/> Retrofit information <input checked="" type="checkbox"/> Tier 2

This RTB has been issued to announce the firmware release information for the **RPCS**.

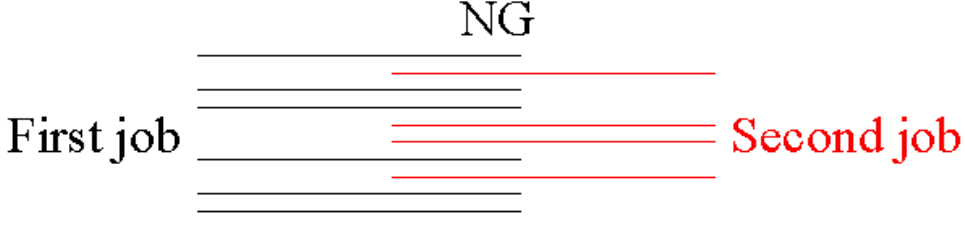
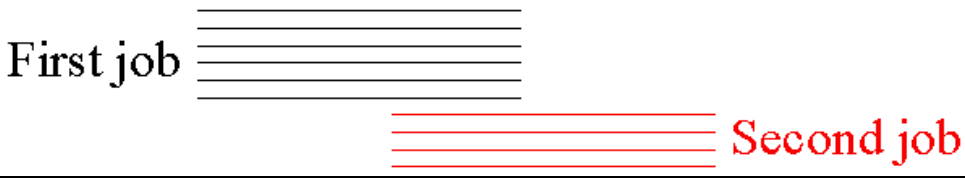
Model: MT-C5		Date: 17-May -12	No.: RD131016g
Version	Modified Points or Symptom Corrected		
05.00.00	<p>Symptom corrected: Two separate FAX jobs are printed out in alternation if one is received (via one line) while the other is already start to print out (having been received via another line).</p> <div style="text-align: center;"> <p>NG</p>

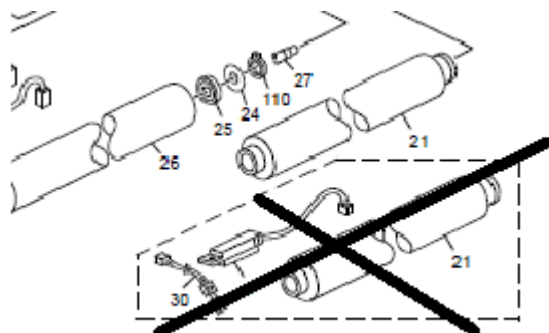
46. Fusing unit 3 (~~D131/D132/D133~~)

Change/Reason: The picture is wrong. There is no part under the cross.

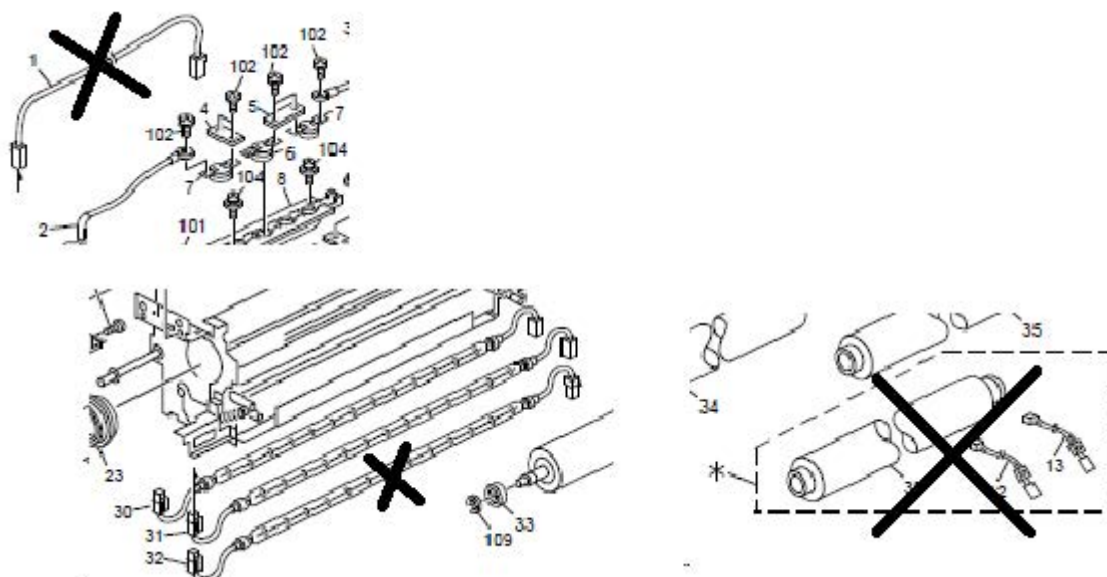
46. Fusing unit 4 (D131/D132/~~D133~~)

Change/Reason: The picture is wrong. There is no part under the cross.

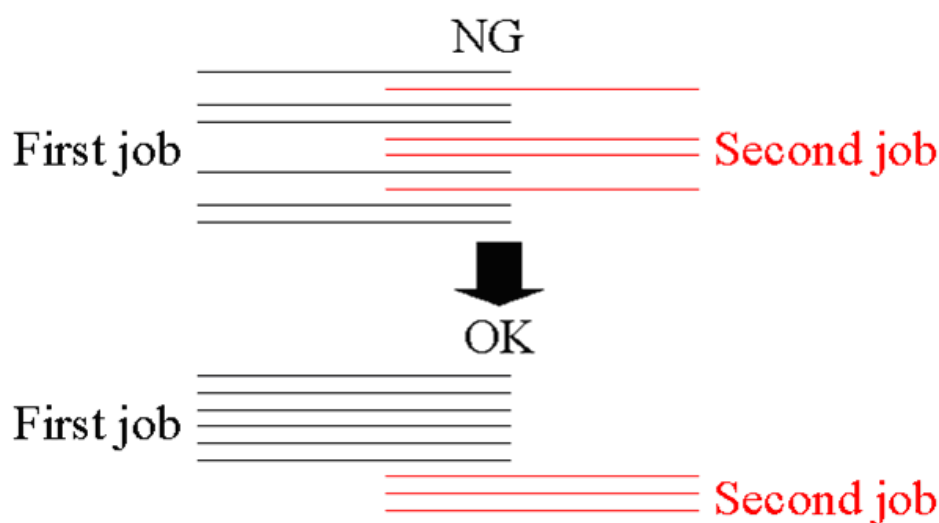
Pages from two separate faxes are printed out in the wrong order if one is received (via one line) while the other has already started to print out (having been received via another line).

FCU firmware bug

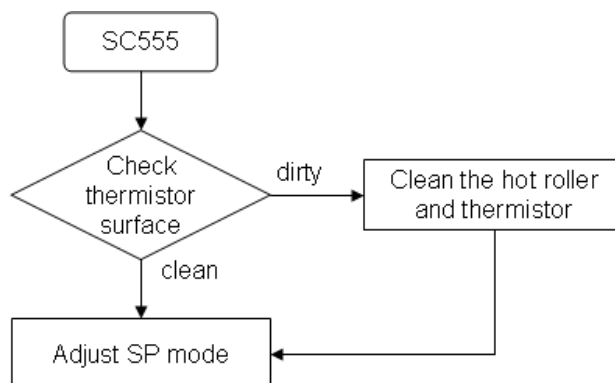
Workflow in the field

The fusing lamps have a tolerance in the temperature distribution. Because of the variation in the parts on this characteristic and some other conditions described below, the fusing temperature could not reach the target level within the programmed time.

1. Check whether the thermistors are clean or dirty.
2. If the thermistors are clean, move to #3.
 - If the thermistors and/or hot roller are expected to reach PM yield before the next service visit (or have already reached yield), **replace them**.
 - If yield will not be reached before the next visit, but the surface of the thermistors and/or hot roller is dirty, clean the toner/dust off the surface.
 - If the surface of the thermistors and/or hot roller often become dirty before reaching yield, replace the cleaning web with the new type.

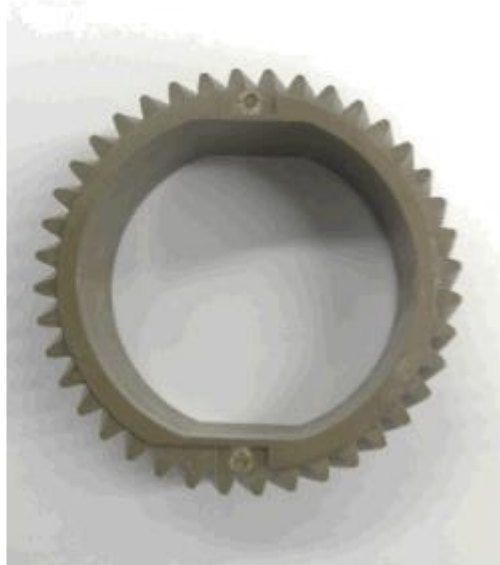
New

The color is changed due to change of the material.

The material of the part is changed and the size of the part is made more accurate to prevent it from breaking or wearing out.

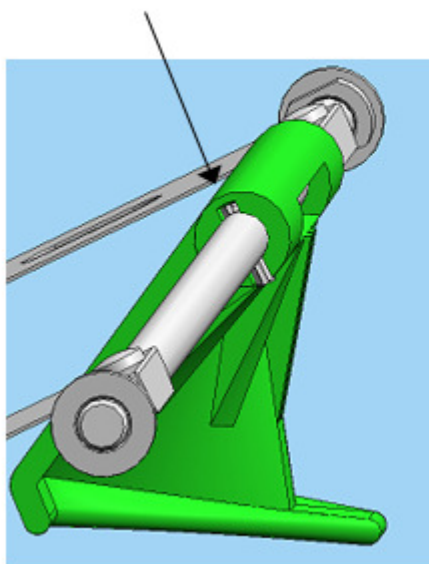
B0654422

This part was broken.
