Model: Cor-C1 / Cor-C1_SOP	Date: 05-Sep-14	No.: RD197002d
-----------------------------------	-----------------	----------------

Subject: Firmware Release Note: browser		Prepared by: H. Morishima	
From: 2nd Tech Service Sect., MFP/Printer Tech Service Dept.			
Classification:	<input type="checkbox"/> Troubleshooting <input type="checkbox"/> Mechanical <input type="checkbox"/> Paper path <input type="checkbox"/> Product Safety	<input type="checkbox"/> Part information <input type="checkbox"/> Electrical <input type="checkbox"/> Transmit/receive <input checked="" type="checkbox"/> Other (Firmware)	<input type="checkbox"/> Action required <input type="checkbox"/> Service manual revision <input type="checkbox"/> Retrofit information <input checked="" type="checkbox"/> Tier 2

This RTB has been issued to announce the firmware release information for the **browser**.

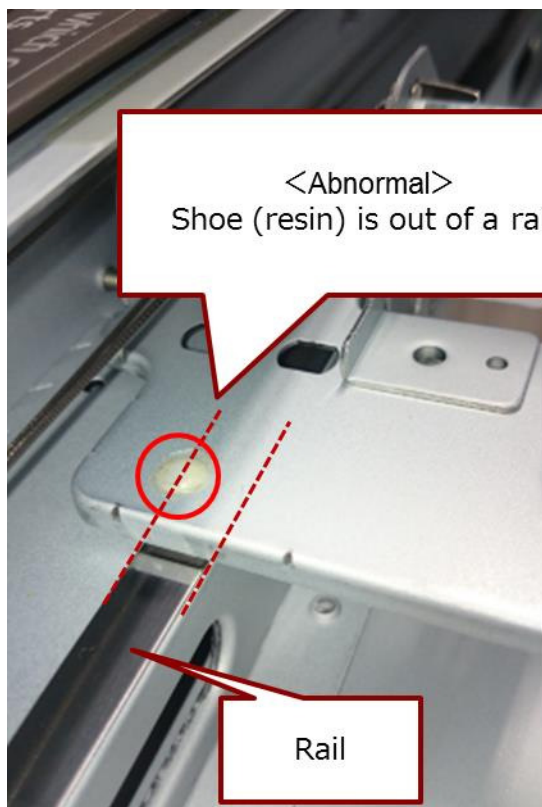
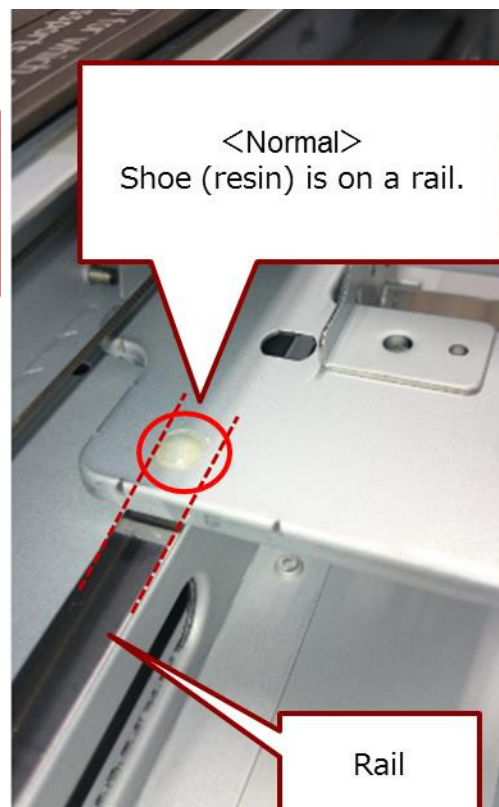
The shoe (resin part circled in red) on the second scanner carriage disengages from the rail, due to shock and/or shaking during machine transport.

4. Carefully lift up the second scanner carriage, and then put the shoe back into the rail.

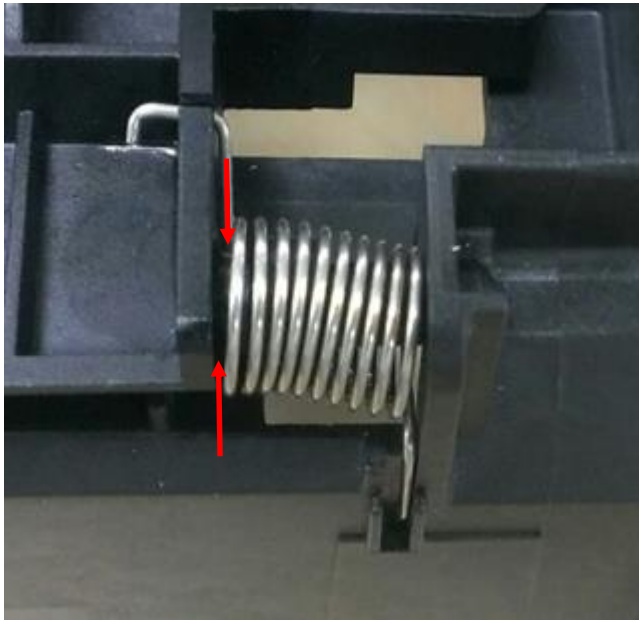
Attach the retaining ring on the **left side of the spring**, as shown.

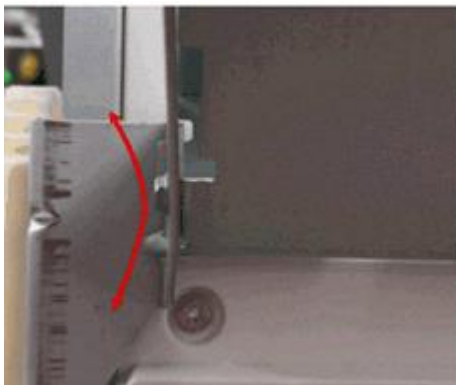
There is a difference in level on the frame of the side plate tray. If the screw is tightened too tightly, the side plate may deform.

Attach the sheet (P/N: D6833644) between the frame and the side plate in the areas circled.

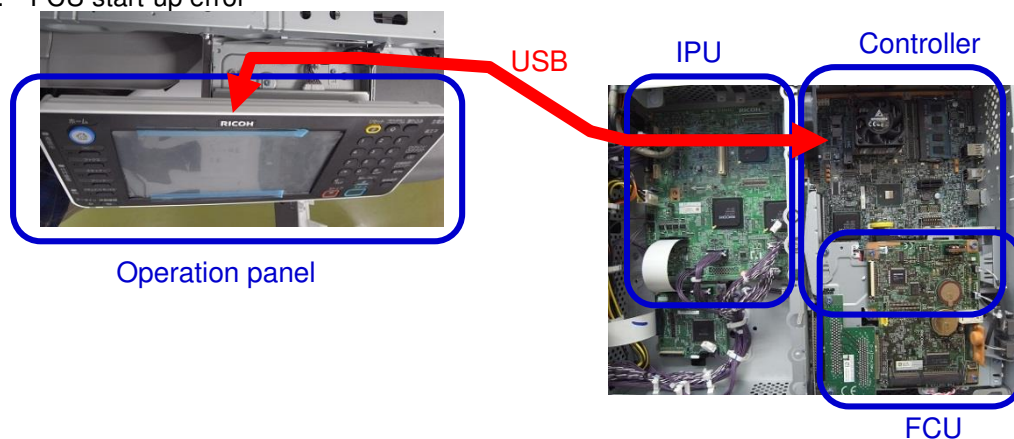
Figure 1: Operation panel, IPU and Controller / FCU

1. Failure of USB communication path (USB cable, IPU)
2. Data corruption of CTL onboard Flash memory
3. Poor supply voltage for CTL onboard ASIC
4. Firmware bug related to the energy saving system
5. Defective CTL onboard converter
6. Defective CTL onboard resistors
7. FCU start-up error

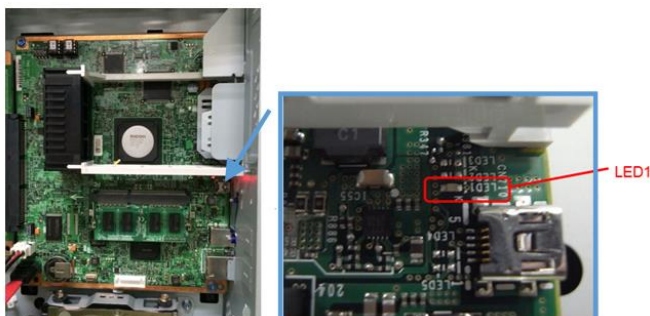
Figure 4: LED 1 on the CTL

No.	Note
LED 1	<p>For CPU</p> <ul style="list-style-type: none"> - LED blinks when the CPU is operating normally. - LED is lit or off when there is a problem with the CPU.

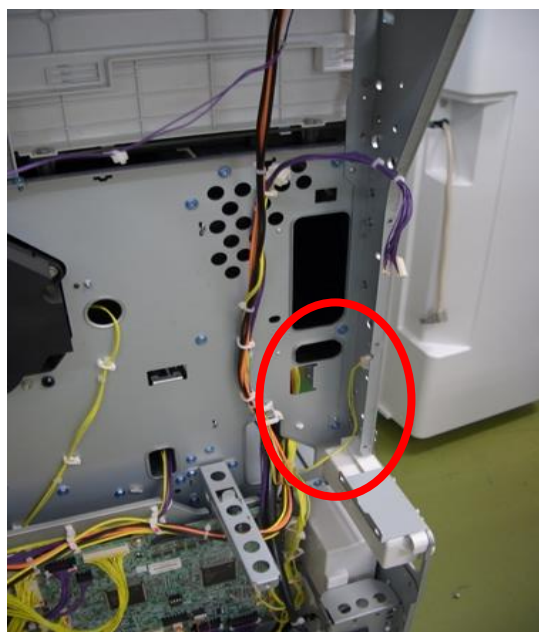
8. Check whether or not the relay harness (circled in red) is caught between the air duct and frame.

- If it is, **replace all parts shown in the table below.**

- If it is not, do the action in the Service Manual, SP tables, pg.1114.

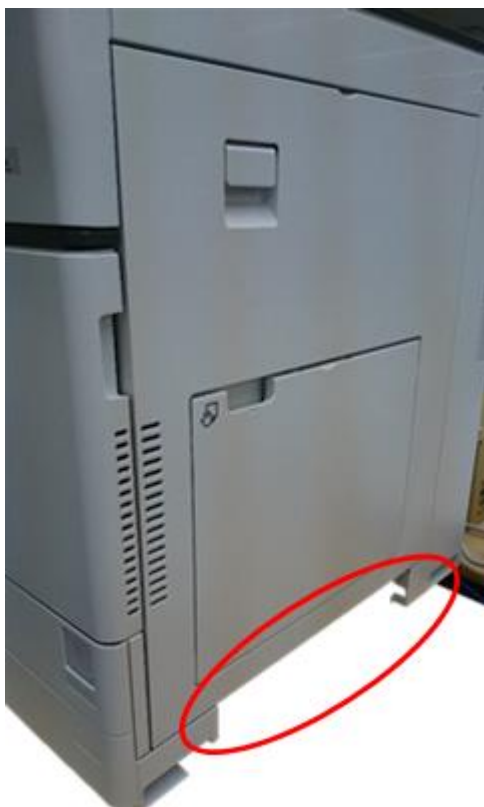
Small insects may get inside the machine from the open space at the bottom right.

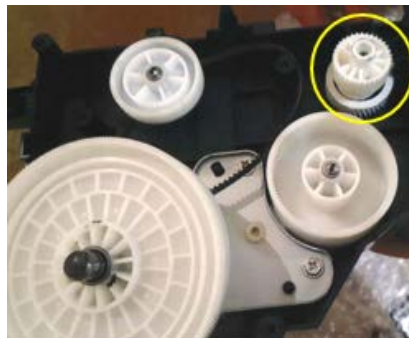
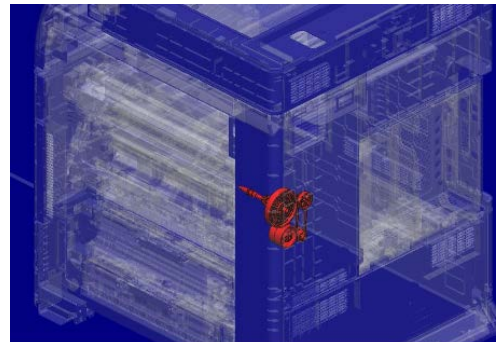
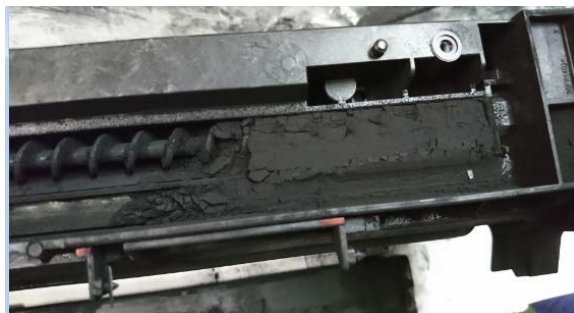
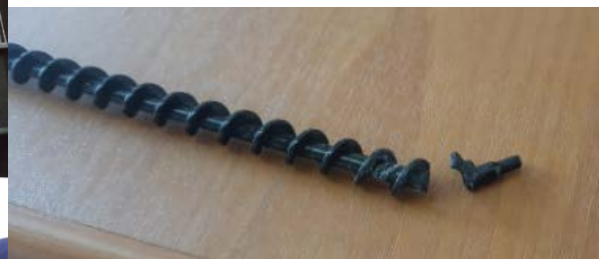
- The PCU drive unit gear (D2021126) breaks due to excessive loads or other factor. As a result, the waste toner (unit) transportation mechanism cannot be driven, and toner coagulates inside the waste toner unit and PCU (Ex., in the PCU upper cover, as shown in the photo).

- The machine is used even after the waste toner bottle is full. As a result, the waste toner coagulates inside the waste toner unit and PCU (Ex., in the PCU upper cover, as shown in the photo).
