| Model: <b>MT-C6</b> | Date: 30-May-16 | No.: RD223005 |

| Subject: Firmware Release Note: Inserter_CFEEDER_E | | Prepared by: K. Moriizumi | |
| From: 1st Tech Service Sect., MFP/Printer Tech Service Dept. | | | |

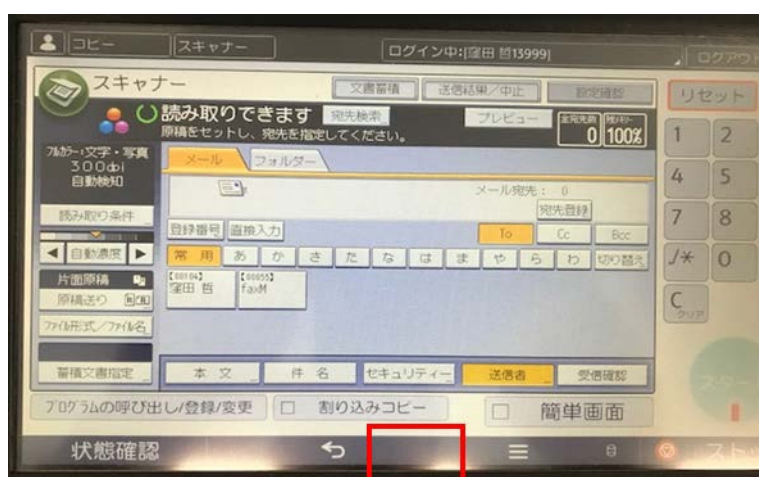
With firmware combination **#3** below, the Home button is not displayed, making it impossible to switch between applications.
