Model: Model PG-C1	Date: 12-May-06	No.: RB229001b
--------------------	-----------------	----------------

Subject: Firmware Release History (System)		Prepared by: A.Ishiyama	
From: 1st Tech. Support Sec. Service Support Dept.			
Classification:	<input type="checkbox"/> Troubleshooting <input type="checkbox"/> Mechanical <input type="checkbox"/> Paper path <input checked="" type="checkbox"/> Other (      )	<input type="checkbox"/> Part information <input type="checkbox"/> Electrical <input type="checkbox"/> Transmit/receive	<input type="checkbox"/> Action required <input type="checkbox"/> Service manual revision <input type="checkbox"/> Retrofit information

This RTB has been issued to announce the firmware release information for System.

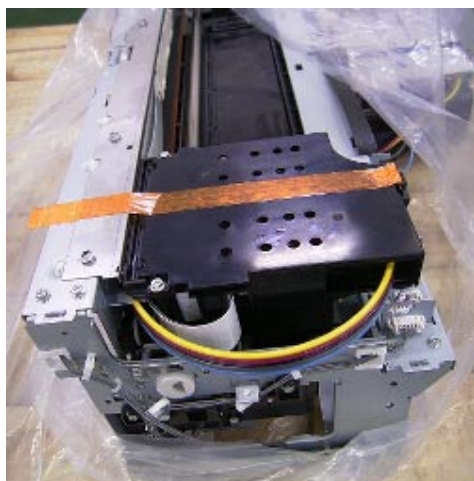
To fix the carriage unit in place more securely, the packaging for the unit will be changed and shipping tape will be added to the carriage unit.

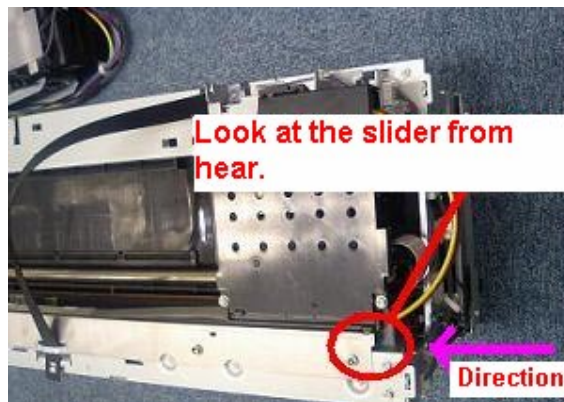
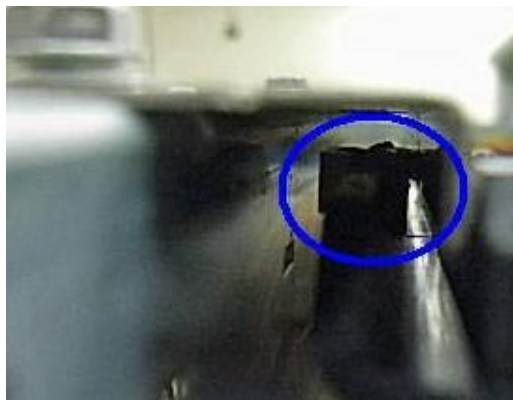
Correct position

**If the carriage slider is in the “incorrect” position shown in the following photo, do Steps 3–5.**

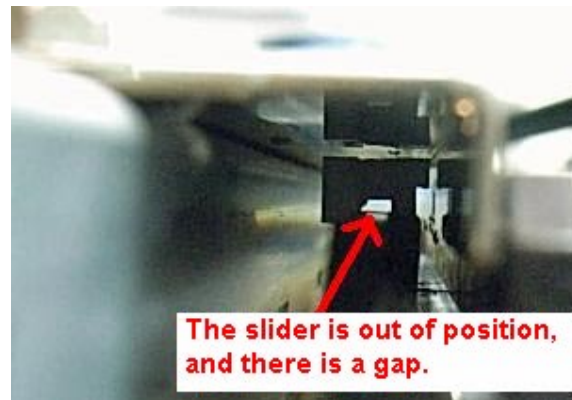
**Incorrect position**

(You can see through the small gap to the other side of the unit)

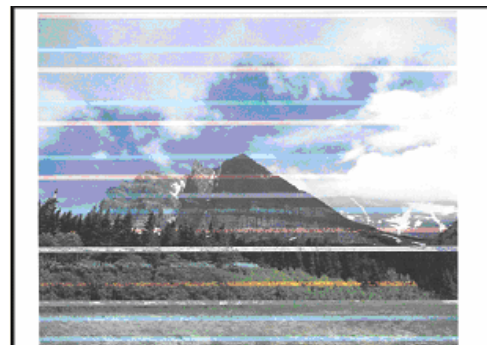
White or colored lines can be solved with head cleaning or refreshing, but the lines sometimes recur.

**Note:** Normally, the lines do not recur after head cleaning or refreshing is performed.
