Model: Di-C1LL	Date: 01-Oct-10	No.: RD112001
----------------	-----------------	---------------

Subject: Firmware Release Note: Printer		Prepared by: M.Saiki	
From: 2nd Overseas Tech Support Sec., 2nd PQM Dept.			
Classification:	<input type="checkbox"/> Troubleshooting	<input type="checkbox"/> Part information	<input type="checkbox"/> Action required
	<input type="checkbox"/> Mechanical	<input type="checkbox"/> Electrical	<input type="checkbox"/> Service manual revision
	<input type="checkbox"/> Paper path	<input type="checkbox"/> Transmit/receive	<input type="checkbox"/> Retrofit information
	<input type="checkbox"/> Product Safety	<input checked="" type="checkbox"/> Other (Firmware)	<input checked="" type="checkbox"/> Tier 2

Model: DI-C1LL		Date: 11-Jul-11	No.: RD112009
Subject: Vibrating noise from mainframe paper feed tray		Prepared by: Masato Saiki	
From: 2nd Overseas Tech Support Sec., 2nd PQM Dept.			
Classification:	<input checked="" type="checkbox"/> Troubleshooting <input type="checkbox"/> Mechanical <input type="checkbox"/> Paper path <input type="checkbox"/> Product Safety	<input type="checkbox"/> Part information <input type="checkbox"/> Electrical <input type="chec

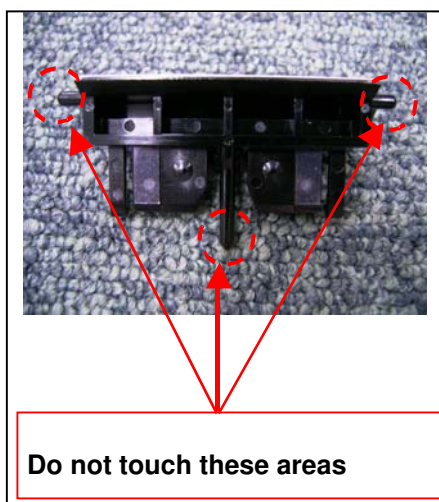
A loud vibration is heard while paper is being fed from Paper Feed Tray 1 or 2.

The friction is high between the paper and the friction pad, and a vibration is generated. This vibration is transmitted via the friction pad holder to the paper tray, where it resonates and creates a loud noise.

If this symptom is reported, replace the friction pad with the following:

P/N D1052722 FRICTION PAD:SERVICE PARTS:ASS'Y

Important: When you replace the friction pad, make sure to handle the new part very carefully. Do not touch the areas shown in the photo below. This is to prevent the grease from getting on the surface of the feeding pad. If the grease sticks to the pad, a double-feed paper jam may occur.

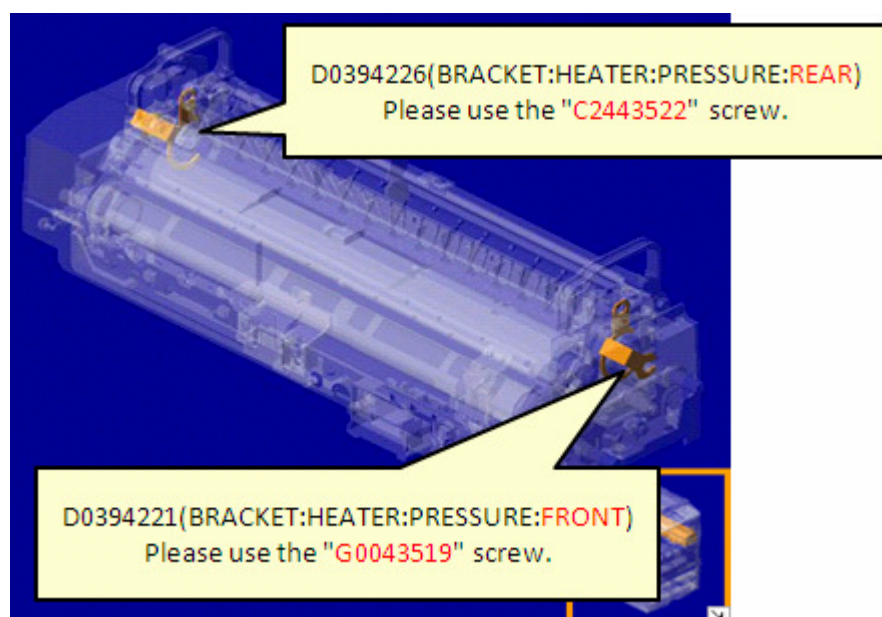
- The shape of the rear bracket for the pressure heater was changed.
- The screw for the bracket was changed to a different type.

Reason: To optimize the clearance between the base of the pressure heater and inner wall of the pressure roller.

Important: If the old **rear** bracket needs to be replaced, make sure to install the two new parts shown above (bracket and screw) **together as a set**. Note that the old screw (G0043519) can still be used for the front bracket.
