Model: Di-C1/C1L	Date: 09-Dec-08	No.: RD038001d
------------------	-----------------	----------------

Subject: Firmware Release Note: Engine		Prepared by: M. Saiki	
From: 2nd Overseas Tech Support Sec., 2nd PQM Dept.			
Classification:	<input type="checkbox"/> Troubleshooting	<input type="checkbox"/> Part information	<input type="checkbox"/> Action required
	<input type="checkbox"/> Mechanical	<input type="checkbox"/> Electrical	<input type="checkbox"/> Service manual revision
	<input type="checkbox"/> Paper path	<input type="checkbox"/> Transmit/receive	<input type="checkbox"/> Retrofit information
	<input checked="" type="checkbox"/> Other (      )

This RTB has been issued to announce the firmware release information for the **Engine of the Model Di-C1 and Di-C1L**.

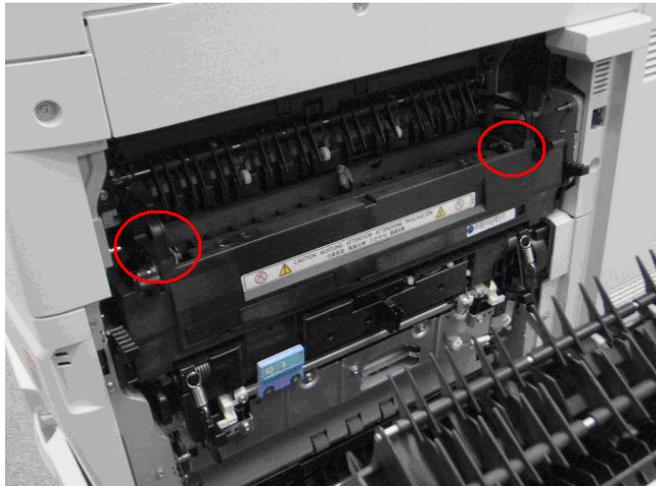
If there is a gap between the metal plates shown in the photo below, this means the pressure roller stay has been bent, so replace the pressure roller stay (P/N D0394183).

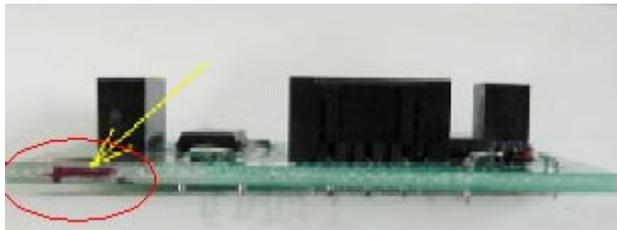
Inside some 1-bin trays manufactured in September and October 2008, there are cracks in the soldering points and surfaces of C1-C7 and R6 on the PCB: COMO board. As a result, the signal from the transferring sensor is distorted.

**Note:** The modified PCB has a red marking on its underside, as shown in the photo.

The resistors and capacitors were replaced on all affected PCBs.

If the symptom is reported, replace the PCB with the modified one:

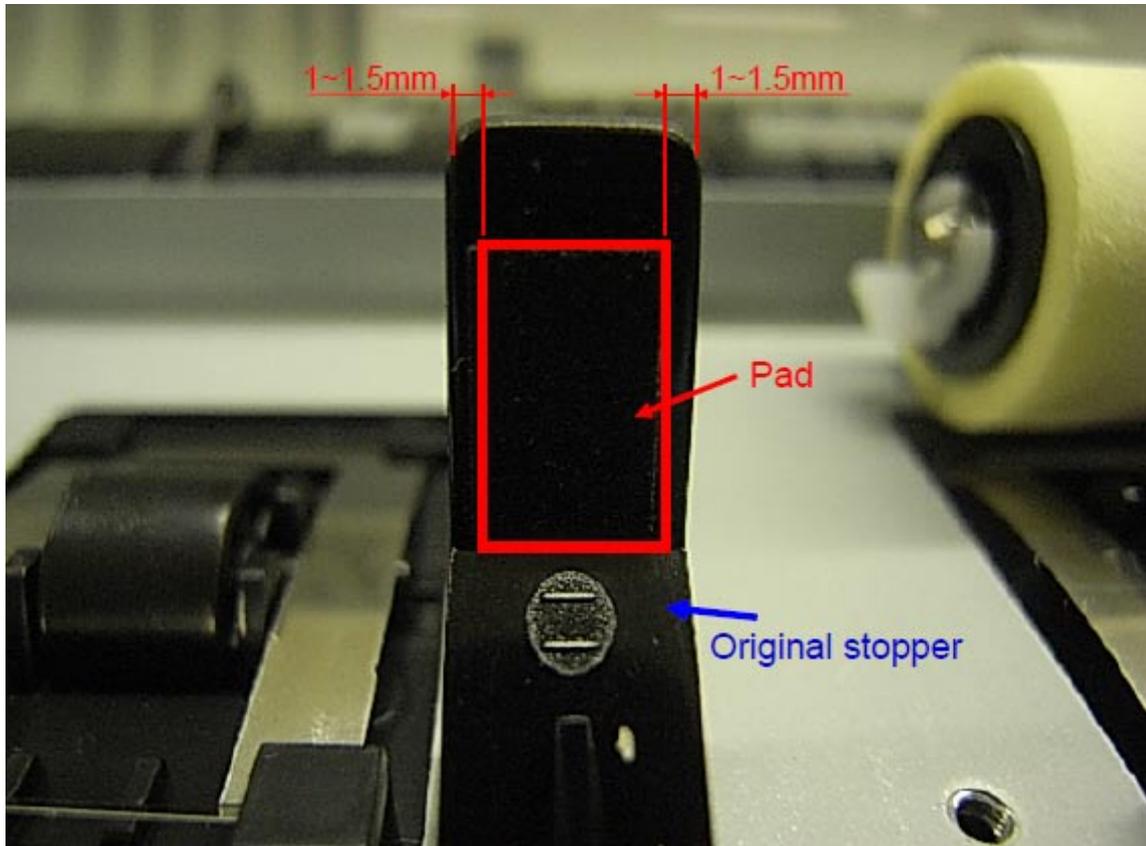
A 'P' Jam' occurs when the leading edge of the original hits and hooks up on the upper edge of the original stopper pads and bends inside. As a result, the original will be stuck and cause a 'P Jam'. This happens because the scale of the stay (***Stay: Separation (B7891161)***) is incorrect, and it cannot be lowered enough. Pads on the stopper, which are positioned at about the same height as the center of the leading edge of the incoming original, then interfere with the paper feed path.

**In the field:****If the symptom is reported, replace the stopper pad with the modified one (D3662416).****Important:**

- **In order to replace the stopper pad, you must first remove the original feed unit and original feed-in guide in the ARDF. See the Service Manual for the procedure.**
- **Be sure to attach the pads in the correct position (see the photo below).**

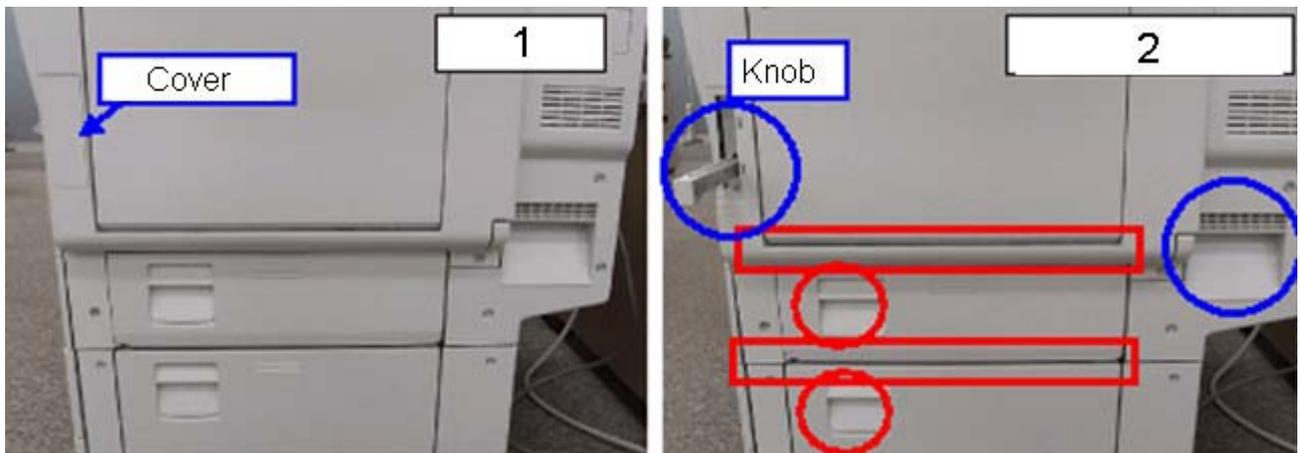
When moving the machine, open the cover on the rear side of the machine (see Photo 1) and pull out the knob. **Hold the machine by this knob and the area circled in blue** (see Photo 2). **Never hold the machine by the edges circled in red or any other areas.** If you do, you may damage the machine.

2. If the symptom is reported, and the brackets for the vertical transport covers are damaged or deformed, replace both brackets (Front: P/N D0392938, Rear: P/N D0392939).

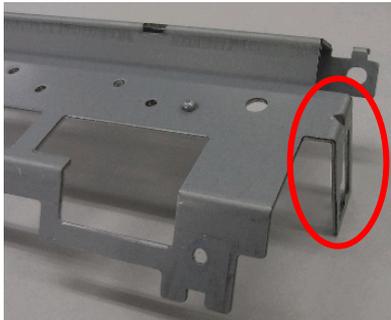
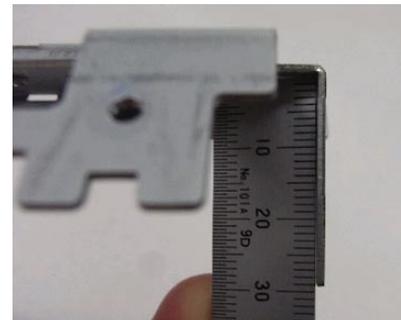
**OK:**

- Do the following whenever you replace any components of the fusing unit. This is to make sure that the fusing stay is not bent or deformed.
- If the fusing stay is bent or deformed as shown below, the fusing roller may be in the wrong position. As a result, the thermistor or surface of the fusing belt can be damaged, which will cause SC543 and/or mechanical noise.

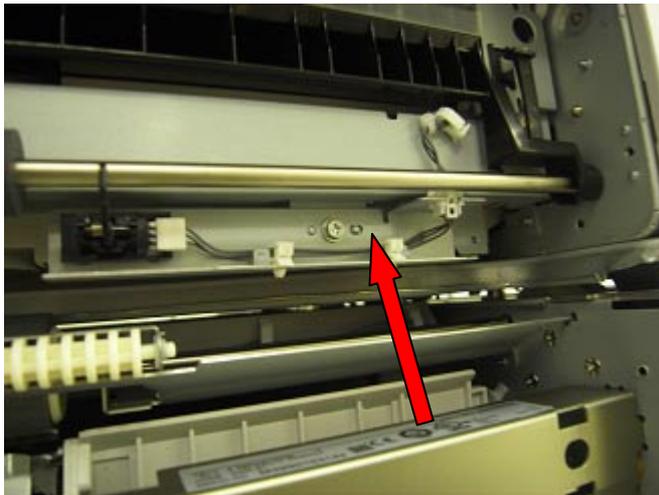
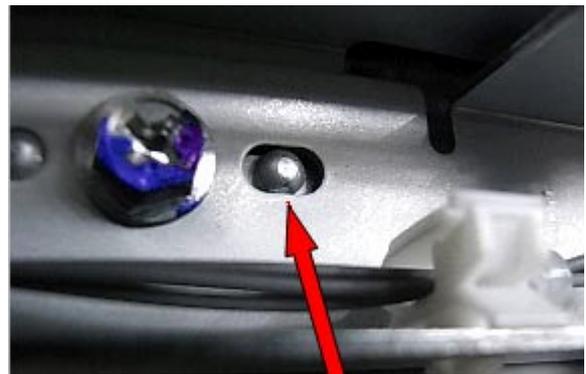
1. Press down on the vertical transport sensor bracket in the area around the embossing (bead) shown below.
2. If there is some play between this area of the bracket and the frame underneath it, replace the bracket with P/N D0392929.

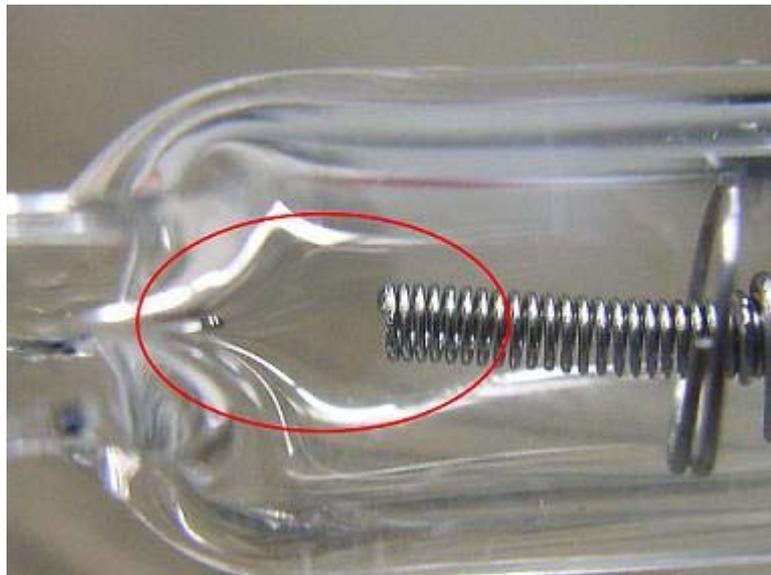
The fusing lamp (P/N AX440292) breaks, triggering SC552 or SC555.

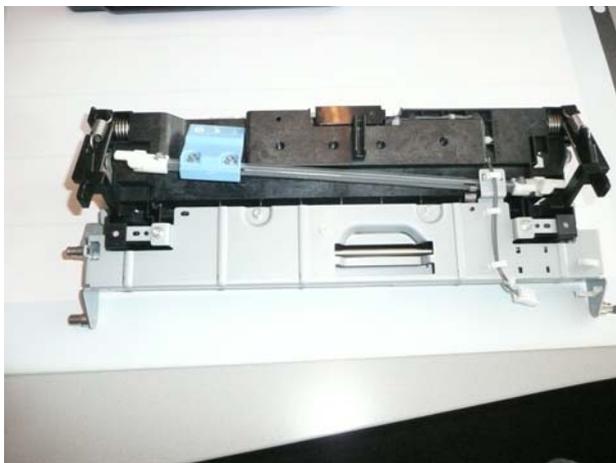
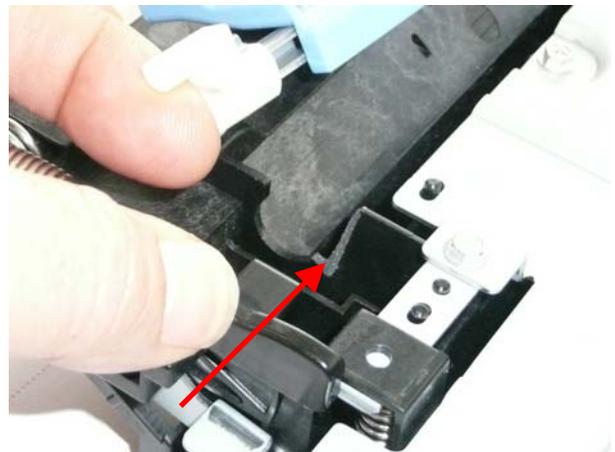
The transfer unit guide plate (P/N D0396221) breaks at the hinge side, moving the blue release grip (P/N D0396239) out of position.
