Model: DI-C1.5	Date: 15-Dec-10	No.: RD104001d
----------------	-----------------	----------------

Subject: Firmware Release Note: Engine		Prepared by: R. Takemura	
From: 1st Tech Service Sect., MFP/Printer Tech Service Dept.			
Classification:	<input type="checkbox"/> Troubleshooting <input type="checkbox"/> Mechanical <input type="checkbox"/> Paper path <input type="checkbox"/> Product Safety	<input type="checkbox"/> Part information <input type="checkbox"/> Electrical <input type="checkbox"/> Transmit/receive <input checked="" type="checkbox"/> Other (Firmware)	<input type="checkbox"/> Action required <input type="checkbox"/> Service manual revision <input type="checkbox"/> Retrofit information <input checked="" type="checkbox"/> Tier 2

This RTB has been issued to announce the firmware release information for the **Engine**.

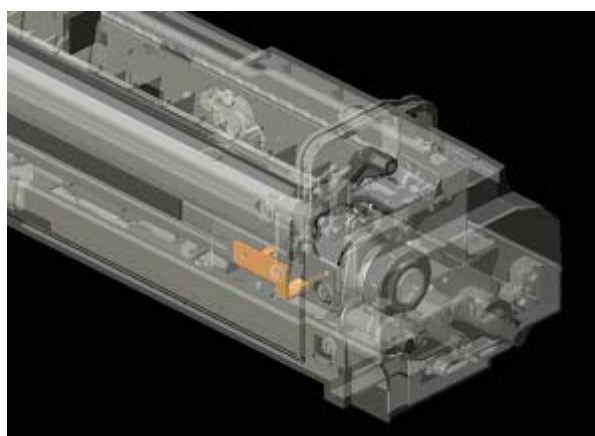
D1054191: Discharge Brush: Pressure Roller

The discharge brush is not reattached to the fusing unit after the cleaning roller option is replaced. As a result, the toner charges the surface of the pressure roller.

When you replace the cleaning roller option (***D1054380***):

- Make sure to remove the discharge brush from the fusing unit first, and then reattach it after installing the new cleaning roller option.
- Make sure the discharge brush is secured to the bracket.

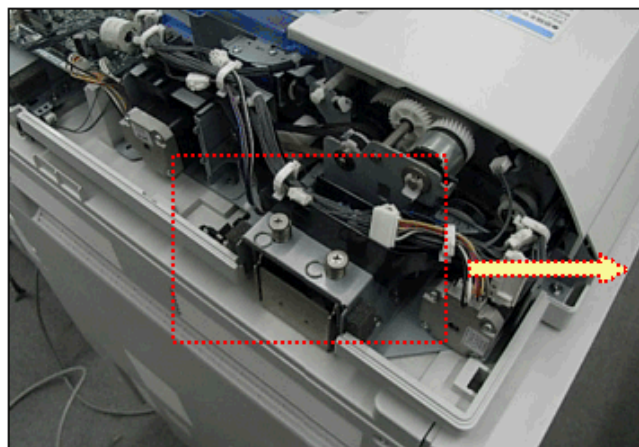
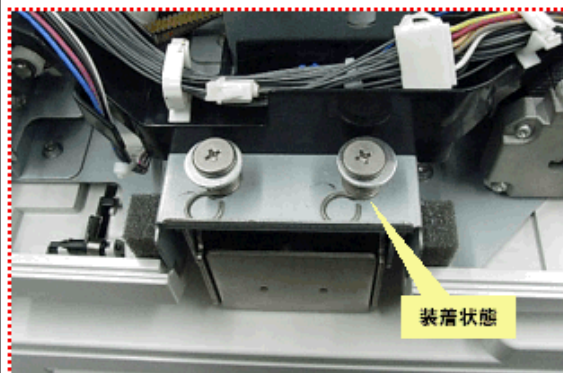
If a thick spacer is used, the pressure at the front side may increase too much. Make sure that jams or dog ears do not occur after installing the spacers.

Replace Hinge: Left (D3661271) with the new part (D5411271).

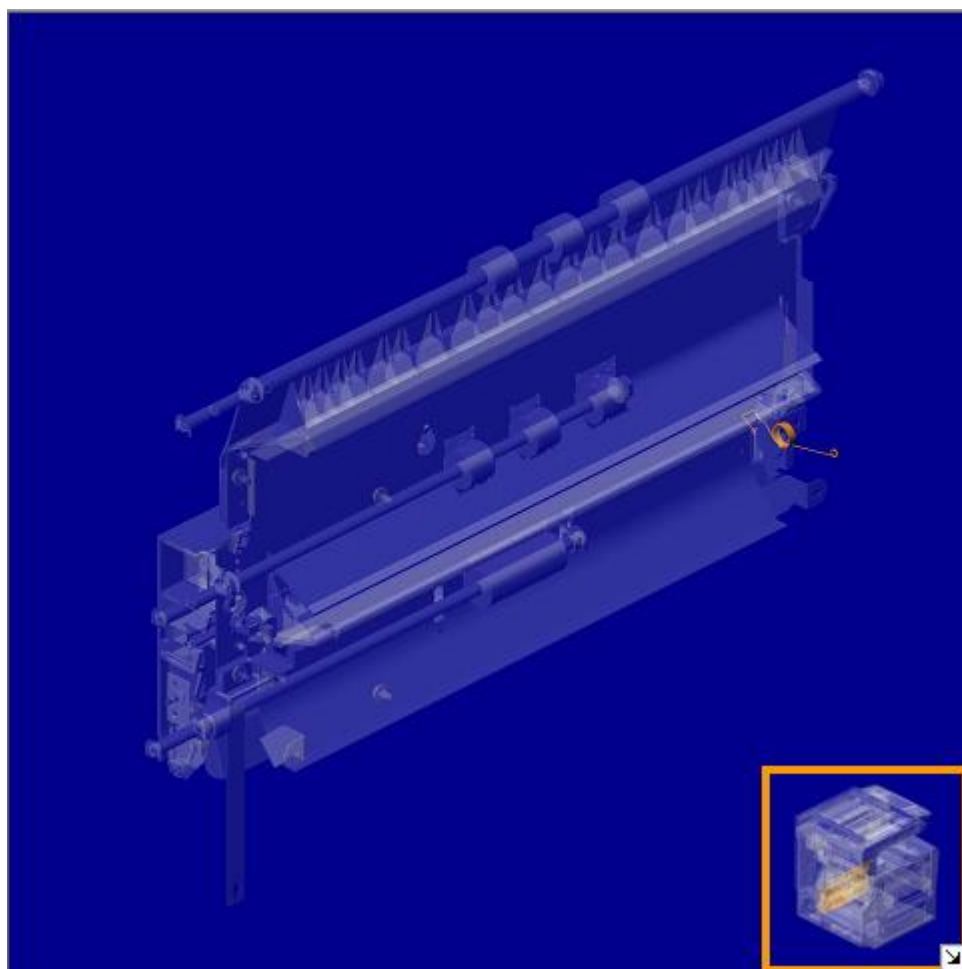
Reason: To prevent damage to the duplex unit guide plate.

Reason
Ensure safety margin.

Old Part Number	New Part Number	Description	Q'ty	Int	Page	Index	Note
	D1052929	TORSION SPRING:VERTICAL TRANSPORT:GUIDE PLATE	1	-	39		Add
