Model: Z-C1:GW	Date: 12-Nov-10	No.: RM028001a
----------------	-----------------	----------------

Subject: Firmware Release Note:Web Uapl		Prepared by: T. Kiyohara	
From: MFP/Printer Tech Service Dept., 2nd Tech Service Sect.			
Classification:	<input type="checkbox"/> Troubleshooting	<input type="checkbox"/> Part information	<input type="checkbox"/> Action required
	<input type="checkbox"/> Mechanical	<input type="checkbox"/> Electrical	<input type="checkbox"/> Service manual revision
	<input type="checkbox"/> Paper path	<input type="checkbox"/> Transmit/receive	<input type="checkbox"/> Retrofit information
	<input type="checkbox"/> Product Safety	<input checked="" type="checkbox"/> Other ()	<input checked="" type="checkbox"/> Tier 2

Model: Z-C1		Date: 3-Apr-15	No.: RM028050a
Subject: The pressure roller damage may occur at an early stage.		Prepared by: Hayato Someya	
From: 1st Tech. Support Sec. Service Support Dept.			
Classification:	<input checked="" type="checkbox"/> Troubleshooting <input type="checkbox"/> Mechanical <input type="checkbox"/> Paper path <input type="checkbox"/> Product Safety	<input type="checkbox"/> Part information <input type="checkbox"/> Electrical <inp

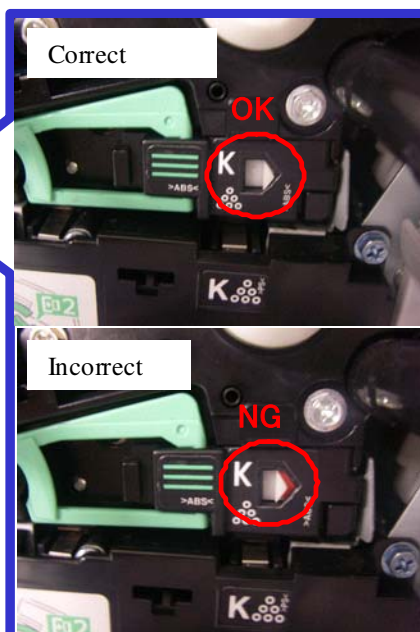
6. Check the pentagon-shaped window for all four colors. If you can see a red area, as shown in the "Incorrect" photo below, this means the unit was not *installed* correctly.

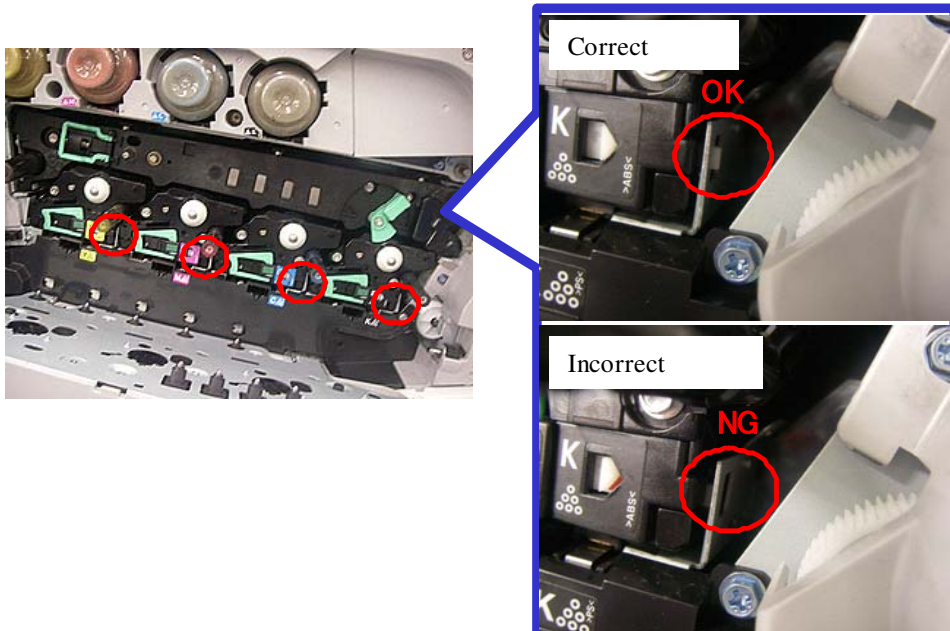
7. Make sure that the white locking tab on the PDCU (circled in red below) is inside the hole in the bracket. Do this for all four PDCUs.

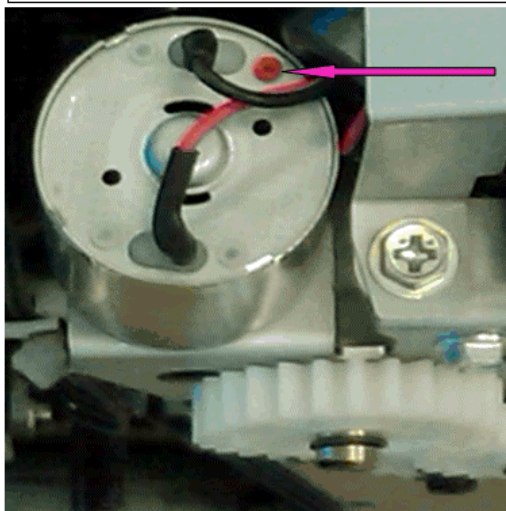
Correct position of the wires attached to the toner hopper motor.

The BLACK wire is connected to the pin next to the red mark (arrow pointing at)

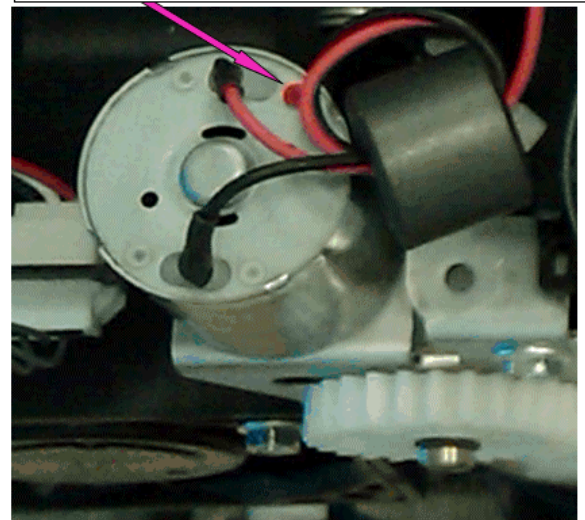
WRONG position of the wires attached to the hopper motor

The RED wire is connected to the pin next to the red mark (arrow pointing at)

- 1-2 If the wires are in the "WRONG" position shown in the photo above, replace the toner hopper motor.

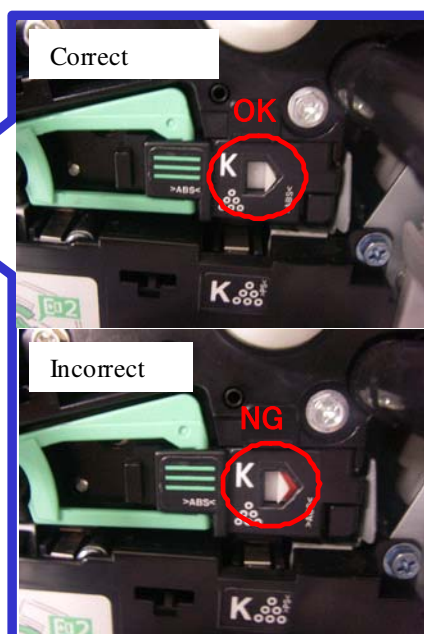
3-2. Check the pentagon-shaped window for all four colors. If you can see a red area, as shown in the "Incorrect" photo below, this means the unit was not installed correctly.

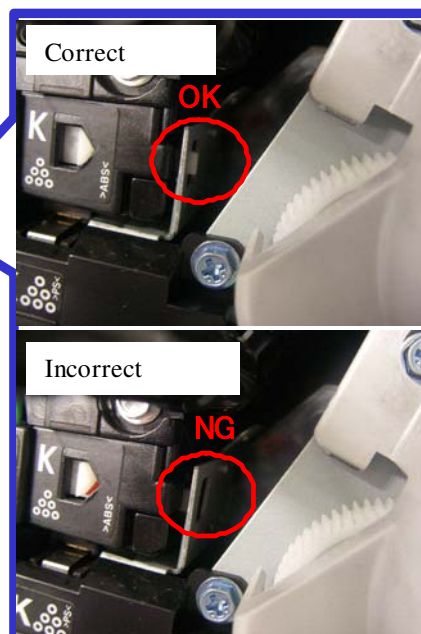
- 3-3. Make sure that the white locking tab on the PDCU (circled in red below) is inside the hole in the bracket. Do this for all four PDCUs.

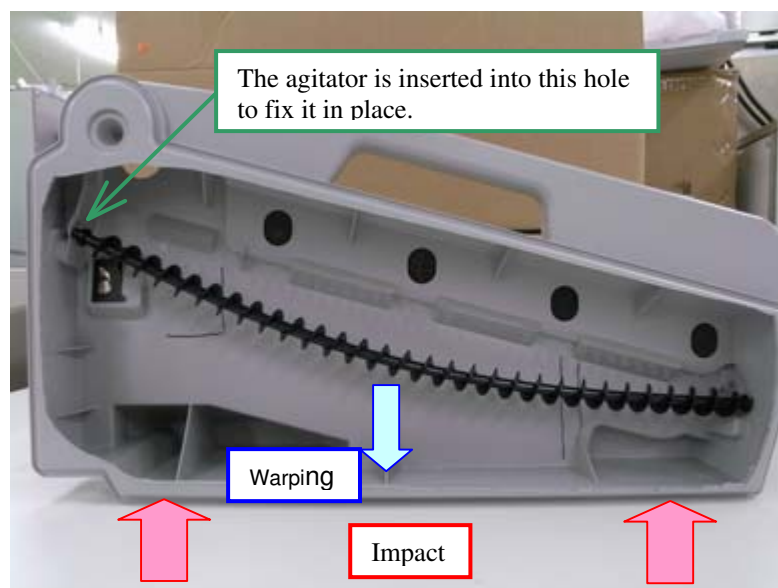
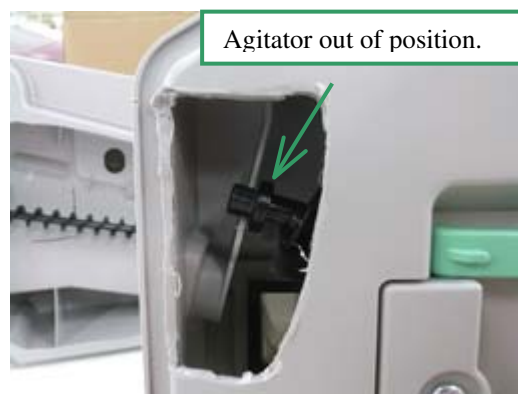
The waste toner bottle is subjected to strong impact forces on its bottom surface, which causes the agitator to warp/bend. As a result, the tip of the agitator pops out of its hole in the case (see the photos below).

Note: This does not occur when the bottle is subjected to strong impact forces on its side surfaces. This is because there is no space for the agitator to warp/bend.

A snap ring was added, so that the tip of the agitator cannot pop out of the hole.

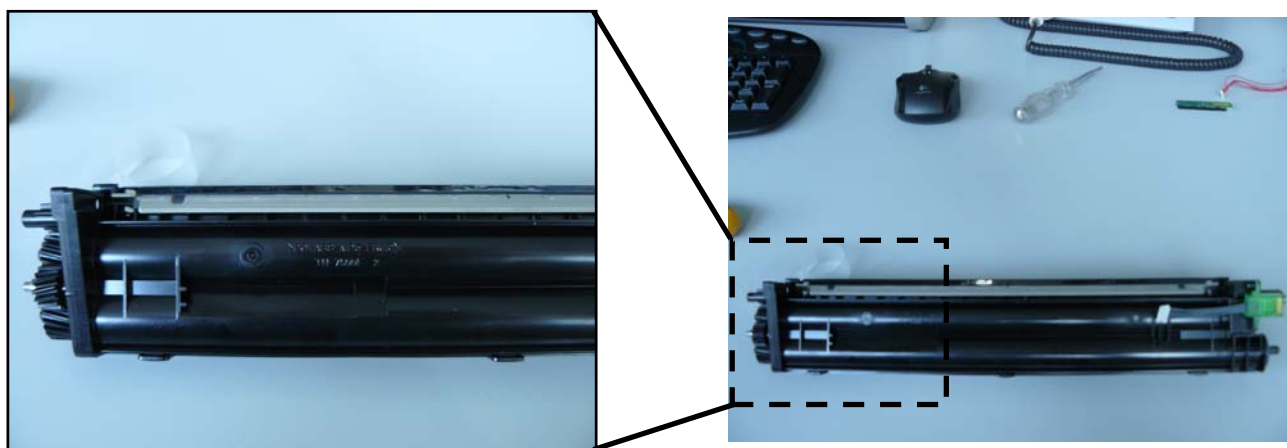
Symptom: The TD sensor is missing from the development unit :Bk

Action: Attach a TD sensor

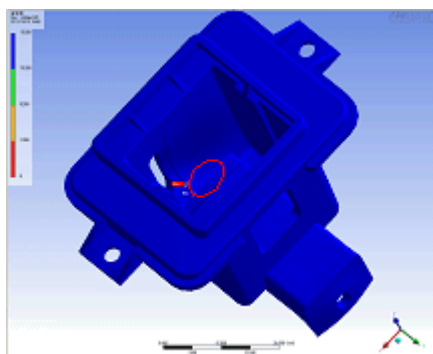
- Holder: Hinge left (M0261730) was broken.

Stress concentrates on the red circle in the picture and the break starts from there.

Replace the LEFT Hinge Holder (**see the procedure below**).

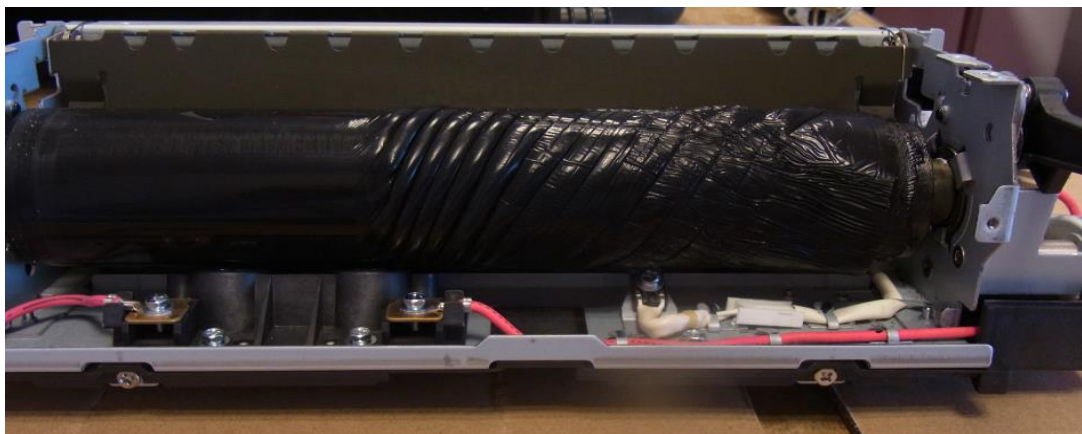
The pressure roller may be damaged as shown below before its yield.

“Auto OFF” in User Tools mode is kept at the “disabled” setting. As a result, the machine is in a condition ready to print 24 hrs/day, 7 days/wk. The continual heat stress causes the roller to deform as shown in the photo.

- 1) Request the customer to keep the main power switch ON only while in the office (ON first thing in the morning, OFF when leaving for the night).
- 2) If this is not acceptable, request the customer to use Low Power mode or OFF mode.
Note: This will free the customer from having to turn the machine ON/OFF manually, while preventing damage to the pressure roller.

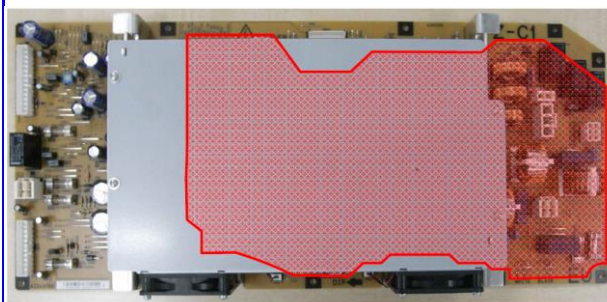
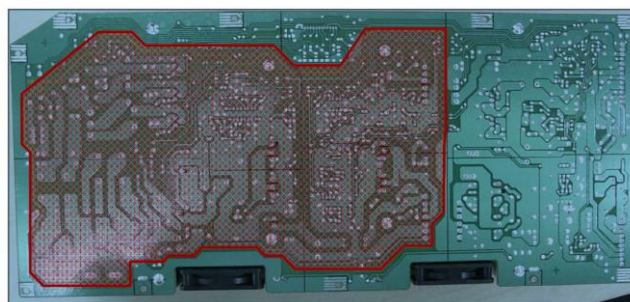
NEVER touch the areas outlined in red in the photos below to prevent electric shock caused by residual charge.

Residual charge of about 100V-400V remains on the PSU board for several months even when the board has been removed from the machine after turning off the machine power and unplugging the power cord.

The areas outlined in red on the bracket shows where a residual charge of about 100V-400V remains on the PSU board under the bracket.

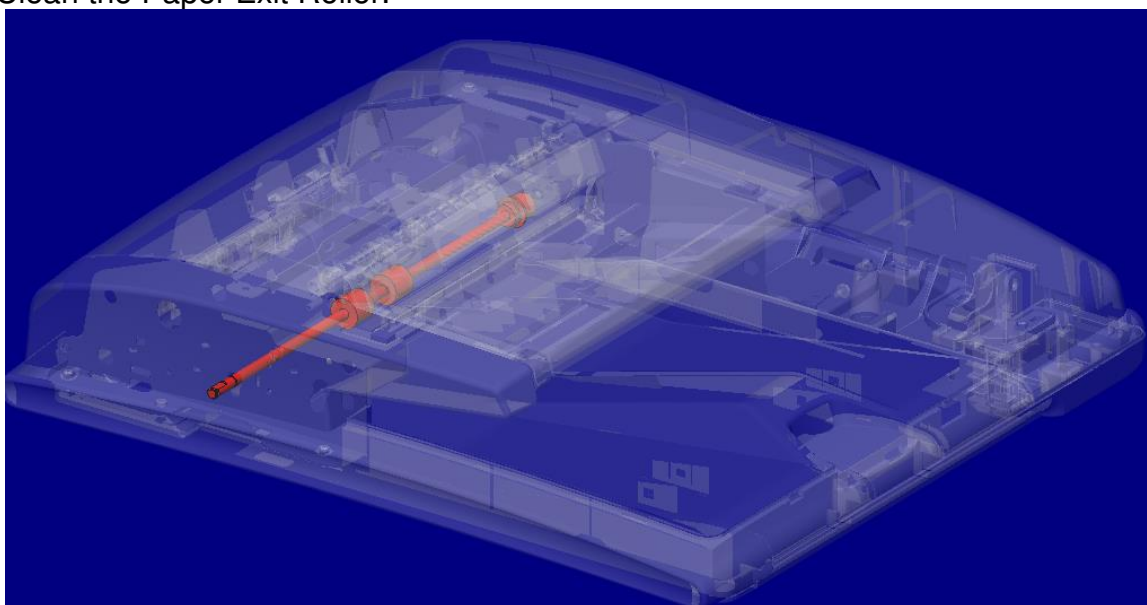
- Paper dust accumulates on the Paper Exit Roller. As a result, the roller cannot feed the paper effectively.
- The Torque Limiter of the Reverse Roller is too tight and/or the pressure of the Plate Spring is too high. As a result, the Reverse Roller feeds the paper with too much force.
- The Gate Pawl (reverse) is damaged or its movement is impeded by a foreign object.
- A substance has accumulated on the Reverse Sensor.
- A substance has accumulated on the Reverse Sensor Feeler.

- Clean the Paper Exit Roller.
