Model: Model AT-C1	Date: 29-May-06	No.: RB230001j
--------------------	-----------------	----------------

Subject: Firmware Release History (Engine)		Prepared by: H. Tamaki	
From: 1st Overseas Tech Support Sec., 1st PQM Dept.			
Classification:	<input type="checkbox"/> Troubleshooting	<input type="checkbox"/> Part information	<input type="checkbox"/> Action required
	<input type="checkbox"/> Mechanical	<input type="checkbox"/> Electrical	<input type="checkbox"/> Service manual revision
	<input type="checkbox"/> Paper path	<input type="checkbox"/> Transmit/receive	<input type="checkbox"/> Retrofit information
	<input type="checkbox"/> Product Safety	<input checked="" type="checkbox"/> Other ()

This RTB has been issued to announce the module release information for the **Engine**.

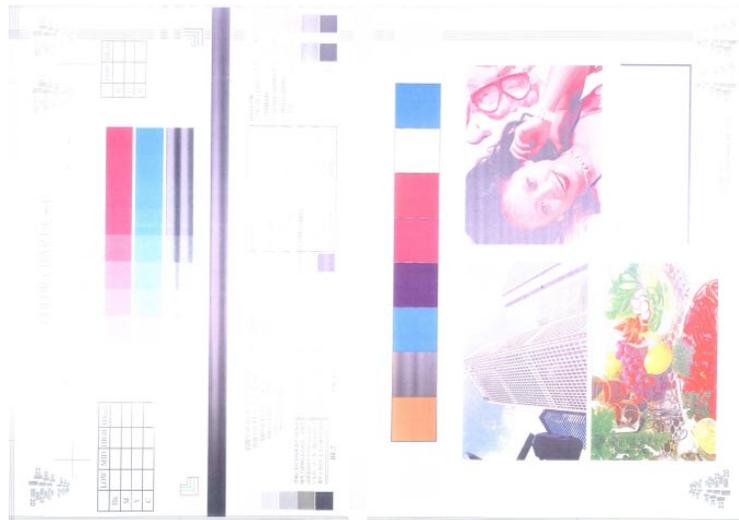
Low image density

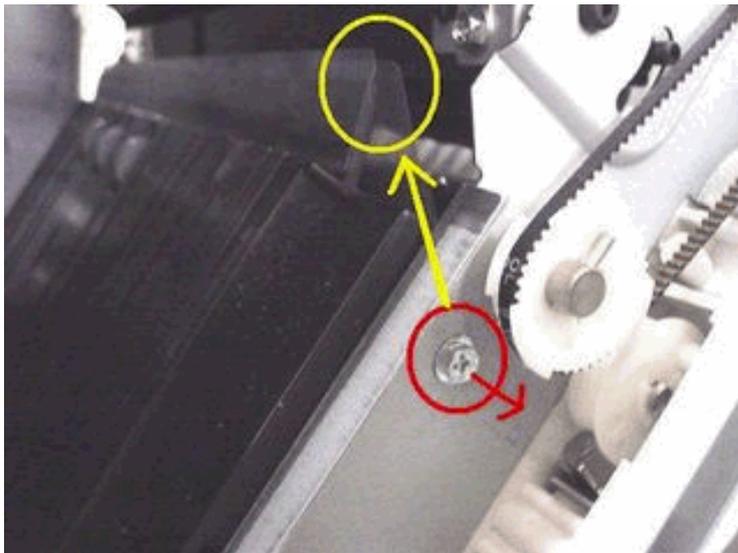
Note: The gap between these two Mylars may decrease when the screw is pushed in the direction of the red arrow.

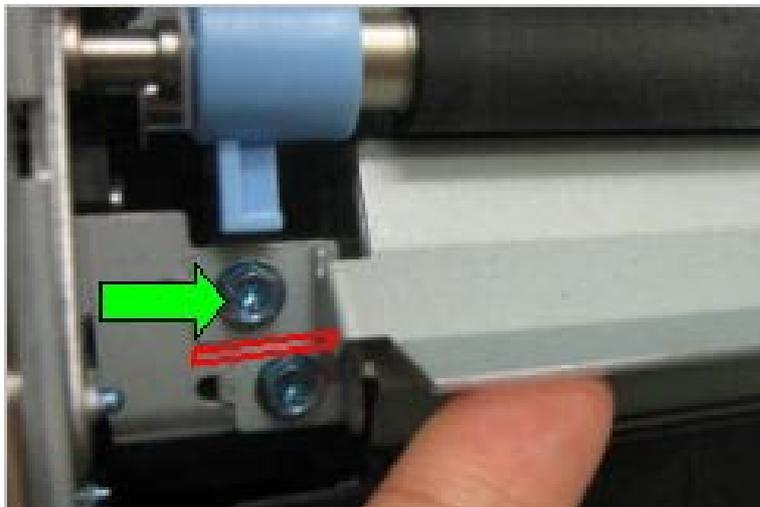
1. Measure the gap between the guide plates marked by the red rectangle in the photo.
2. If the gap is 1mm or less, loosen the two screws marked by the green arrow (front x 1, rear x 1). Then, tighten these screws again while you lift the plate.

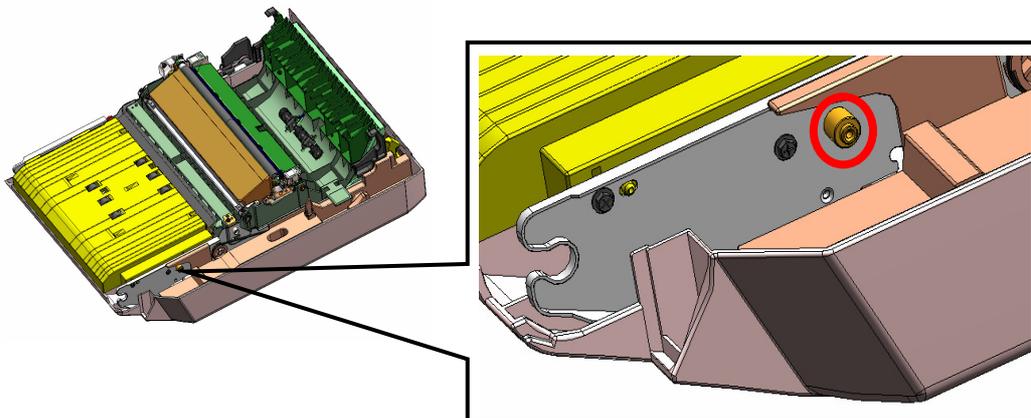
1. If the duplex link or peen on the mainframe is broken, do **Procedure A** below.
2. If the peen on the duplex unit is broken, do **Procedure B** below.

Note: The illustration shows the peen on the duplex unit.

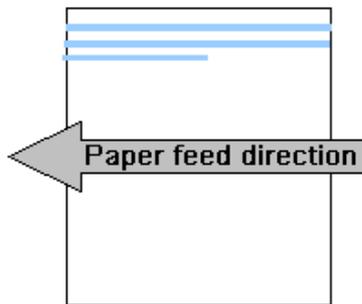
Horizontal black or colored lines, dirty background

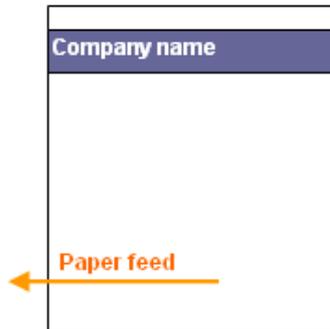
Note: If the customer makes many copies/prints of images that contain a band in the same area of the image, as shown in the illustration below, this can cause a cleaning failure to occur earlier than usual. This makes it easier for the charge roller to become dirty, even before the 80k mark.

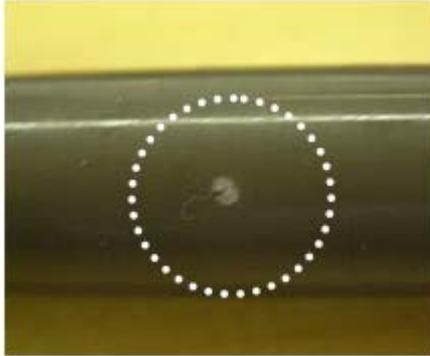
- When you clean the roller surface:
 - Be sure to wipe the surface gently. If you wipe it too strongly, parts of the roller's surface layer may peel off (The white layer underneath will be visible).

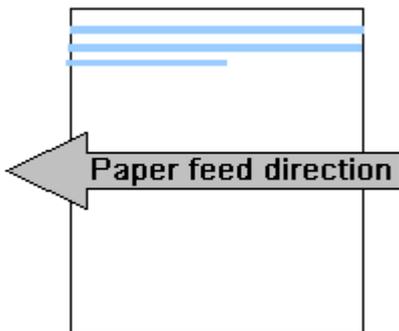
Horizontal black or colored lines

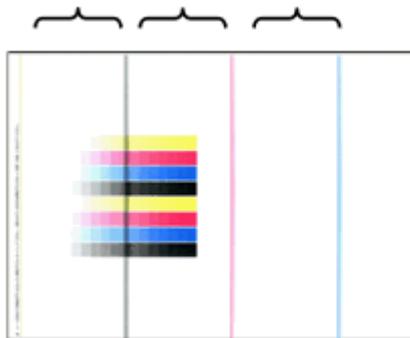
110mm interval vertical line
(Drum unit interval)

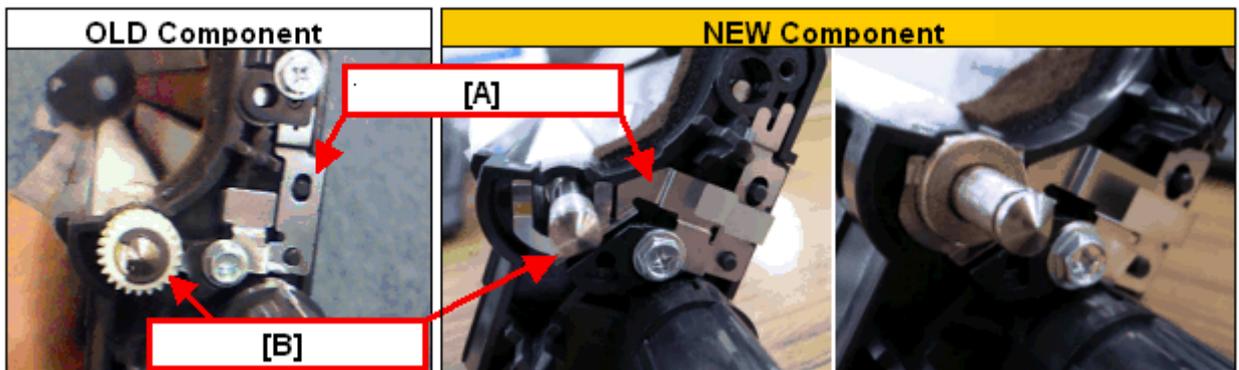
- The shape of the GND plate [A] was changed so that there is another contact point between the GND plate and the lubricant application shaft [B].
