Model: AT-C2.5	Date: 22-Oct-10	No.: RD087001n
----------------	-----------------	----------------

Subject: Firmware Release Note: System/Copy		Prepared by: Y. Taniguchi	
From: 1st Tech Service Sect., MFP/Printer Tech Service Dept			
Classification:	<input type="checkbox"/> Troubleshooting <input type="checkbox"/> Mechanical <input type="checkbox"/> Paper path <input type="checkbox"/> Product Safety	<input type="checkbox"/> Part information <input type="checkbox"/> Electrical <input type="checkbox"/> Transmit/receive <input checked="" type="checkbox"/> Other (Firmware)	<input type="checkbox"/> Action required <input type="checkbox"/> Service manual revision <input type="checkbox"/> Retrofit information <input checked="" type="checkbox"/> Tier 2

This RTB has been issued to announce the firmware release information for the **System/Copy**.

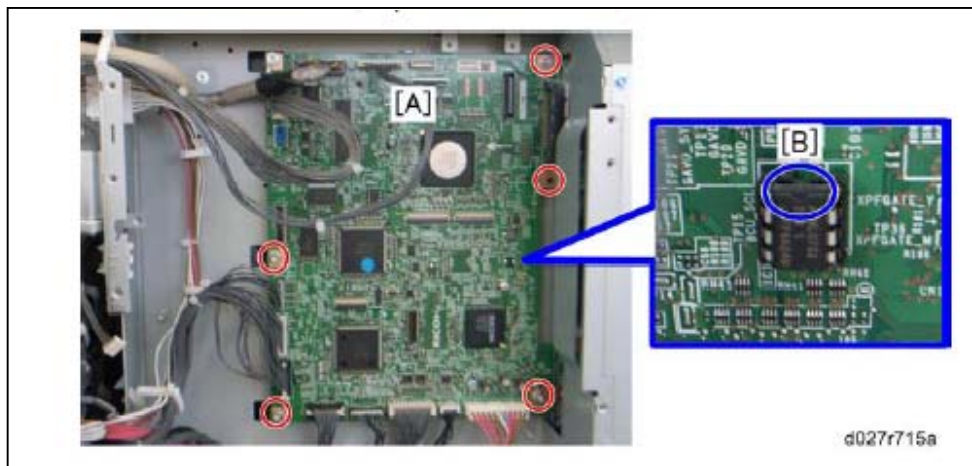
***The NVRAM on the BICU is shown above as [B] on the BICU board [A] (See Pg. 313 in the FSM)***

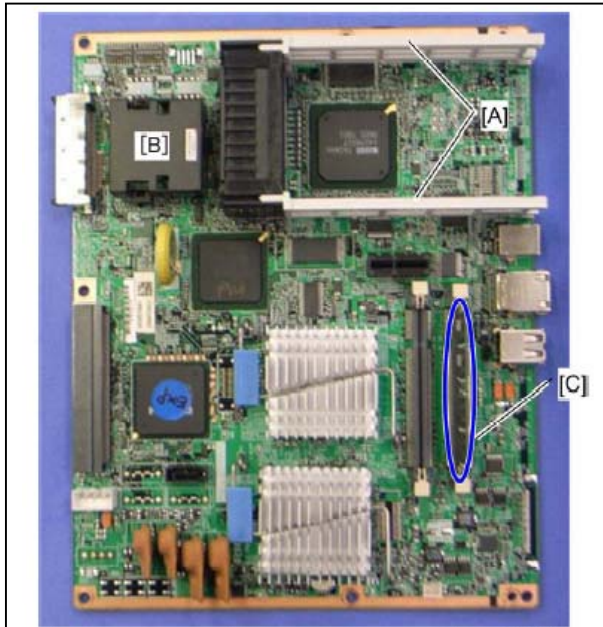
**The NVRAM on the Controller Board is shown as [B] in the above photograph (See Pg. 318 in the FSM).**

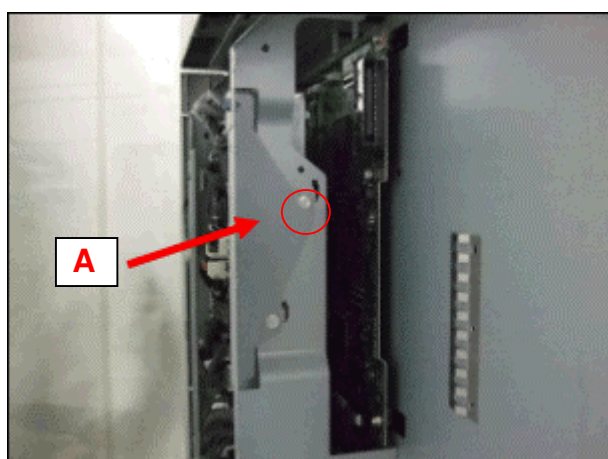
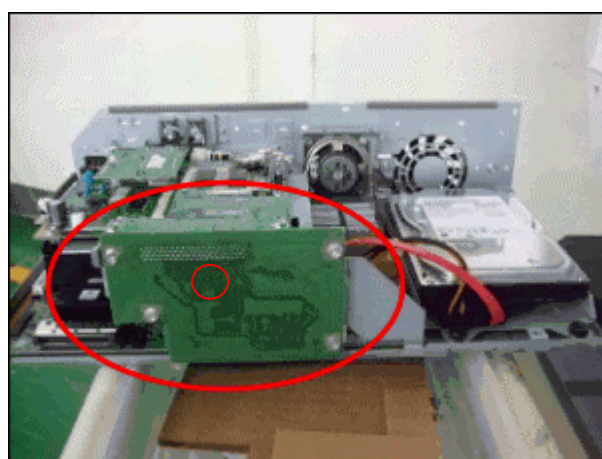
The screw [A] shown below touches the fax I/F board, causing a short circuit.

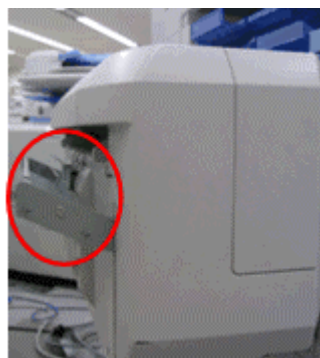
SC798 is displayed when the SR3050 (D372) is unpacked or installed, ***or later during machine operation if the lift sensor switch or motor was damaged during machine installation.***

- ***The section of the exit tray circled in the photo below is contacted (hit) during the shipping process, or***
- ***The customer lifts the tray all the way up***

- ***If the symptom occurs at machine installation, do Procedure 1 below.***
- ***If the symptom occurs during machine operation after installation, do Procedure 2 below.***

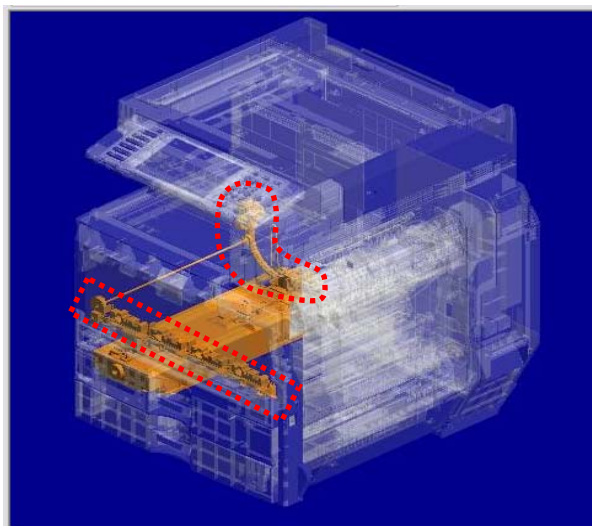
Mechanical noise is heard at the front (D0896481) and rear (D0896540) of the machine.

**Note:** If the noise goes unnoticed, the waste toner can overflow into the development unit or transfer belt-cleaning unit. In such cases, the machine may stop and display SC errors related to driven units.

Engine firmware bug

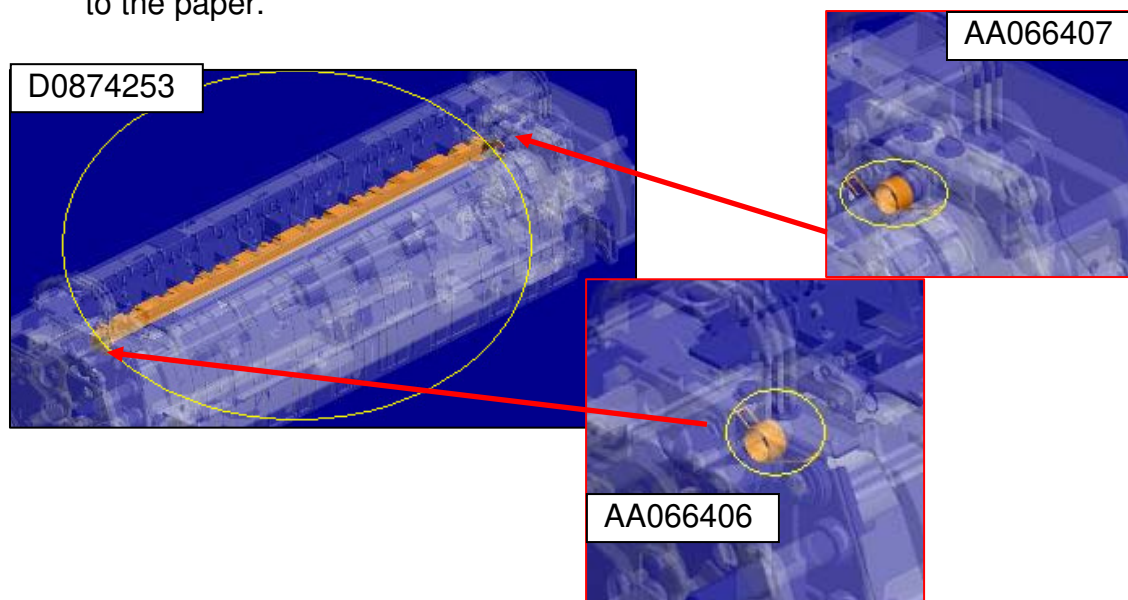
2) The shapes of the fusing exit guide and plate were changed.

**Reason:** To ensure that condensation that can form on the stripper plate is not transferred to the paper.

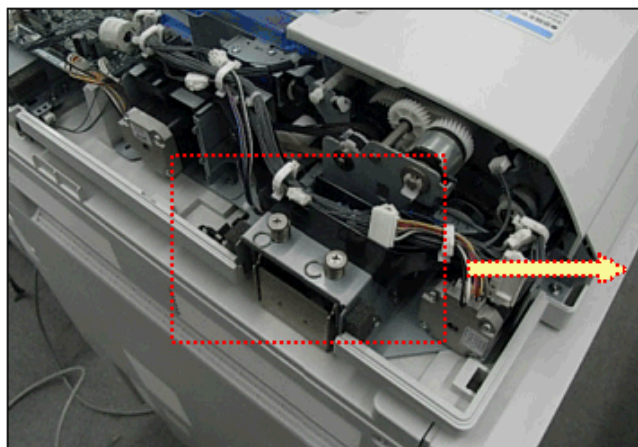
If a thick spacer is used, the pressure at the front side may increase too much. Make sure that jams or dog ears do not occur after installing the spacers.

Replace Hinge: Left (D3661271) with the new part (D5411271).

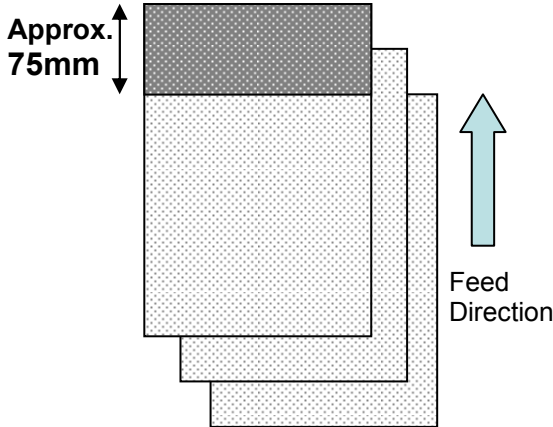
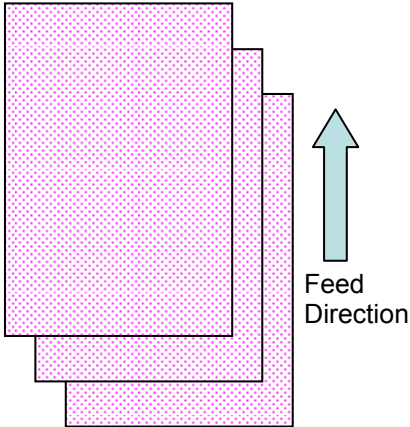
Black	Color (CMY)

<p>The area that gets dirtiest is the leading edge of the first sheet. This is because the charge on the drum during the first rotation is lower than later rotations.</p>	<p>All pages are uniformly dirty, since the leading edge of the first sheet contacts the drum from the drum's second or later rotations. This is different from B/W printing, due to the difference in timing in the image creation process.</p>
