Model: AT-C3	Date: 15-Feb-12	No.: RD142001a
--------------	-----------------	----------------

Subject: Firmware Release Note: PowerSaving Sys		Prepared by: S. Hayami	
From: 1st Tech Service Sect., MFP/Printer Tech Service Dept.			
Classification:	<input type="checkbox"/> Troubleshooting <input type="checkbox"/> Mechanical <input type="checkbox"/> Paper path <input type="checkbox"/> Product Safety	<input type="checkbox"/> Part information <input type="checkbox"/> Electrical <input type="checkbox"/> Transmit/receive <input checked="" type="checkbox"/> Other (Firmware)	<input type="checkbox"/> Action required <input type="checkbox"/> Service manual revision <input type="checkbox"/> Retrofit information <input checked="" type="checkbox"/> Tier 2

This RTB has been issued to announce the firmware release information for the **PowerSaving Sys.**

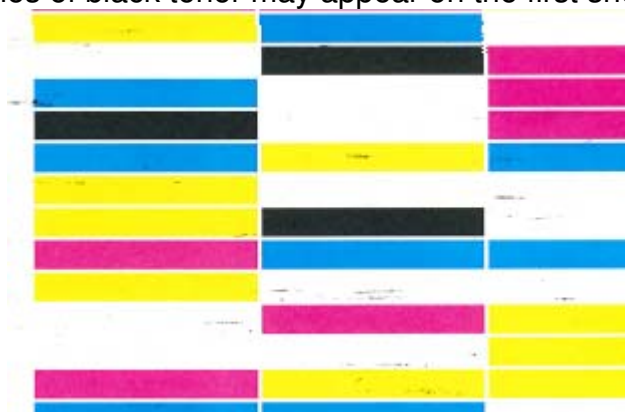
Granules of black toner may appear on the first sheet printed out (see the example below).

The toner is stored under high-temperature conditions, which causes some of the toner to aggregate. These toner particles are not mixed properly with the carrier, and as a result, this toner is not charged properly.

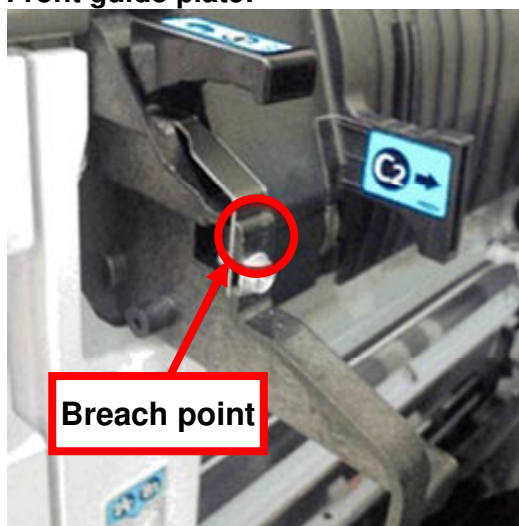
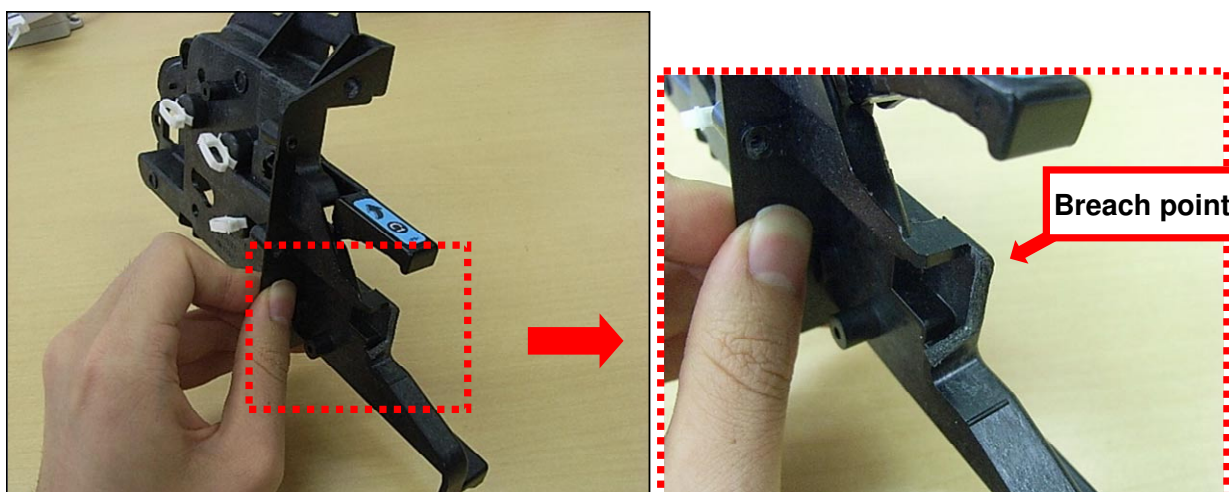
Front guide plate:

The user pulls out the unit with force, breaking the stopper that supports the unit, and in some cases, the front guide plate as well.

In order to distribute the stress more widely, the shape of the stopper was changed as follows, from September 2012 mass production.

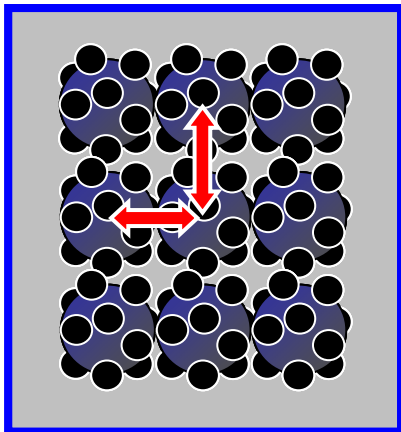
Distance between carrier particles ("x") is **normal** for actual amount of toner ("y"):

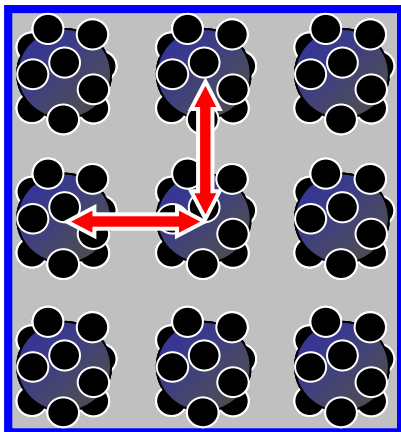
Under the conditions mentioned above (low temp., low humidity, carrier is relatively fresh), the carrier tends to take on a higher electrical charge than the target. As a result, the carrier particles are farther apart from one another, causing the machine to judge the toner concentration to be higher than it actually is.

Distance between carrier particles is **too large** (>"x") for that same amount of toner ("y"):

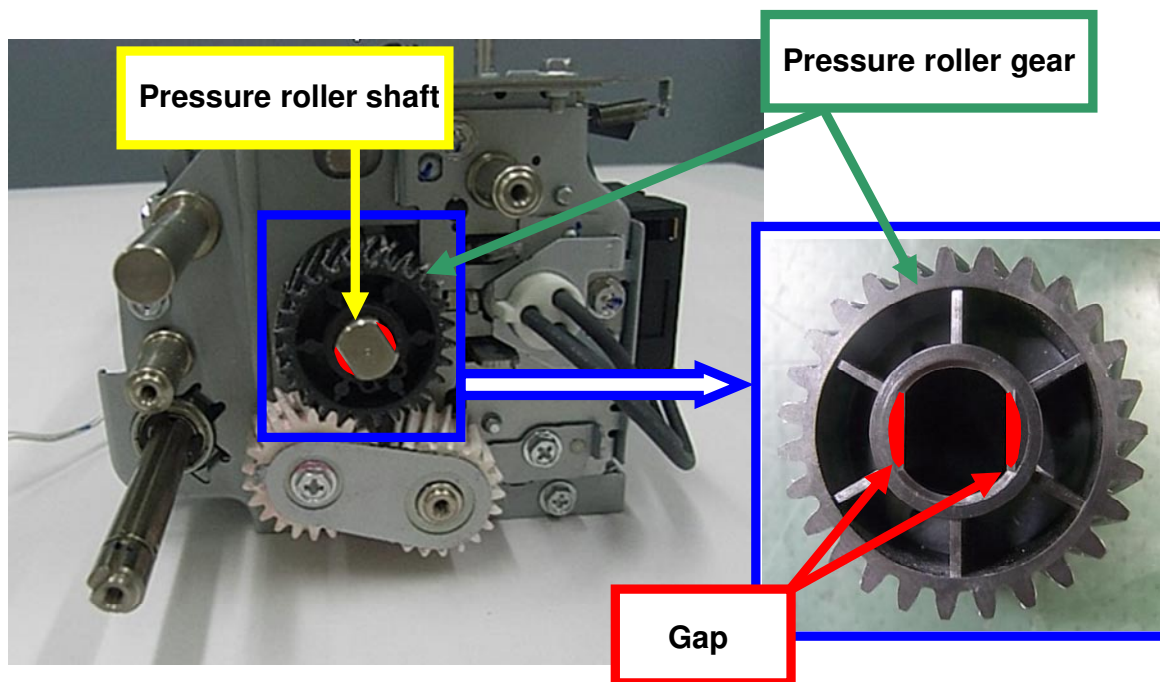
Gaps between the pressure roller gear and pressure roller shaft (marked in red below) may allow the shaft to slip inside the gear opening.

2. Permanent solution: The inside diameter of the pressure roller gear was changed to decrease the gaps.

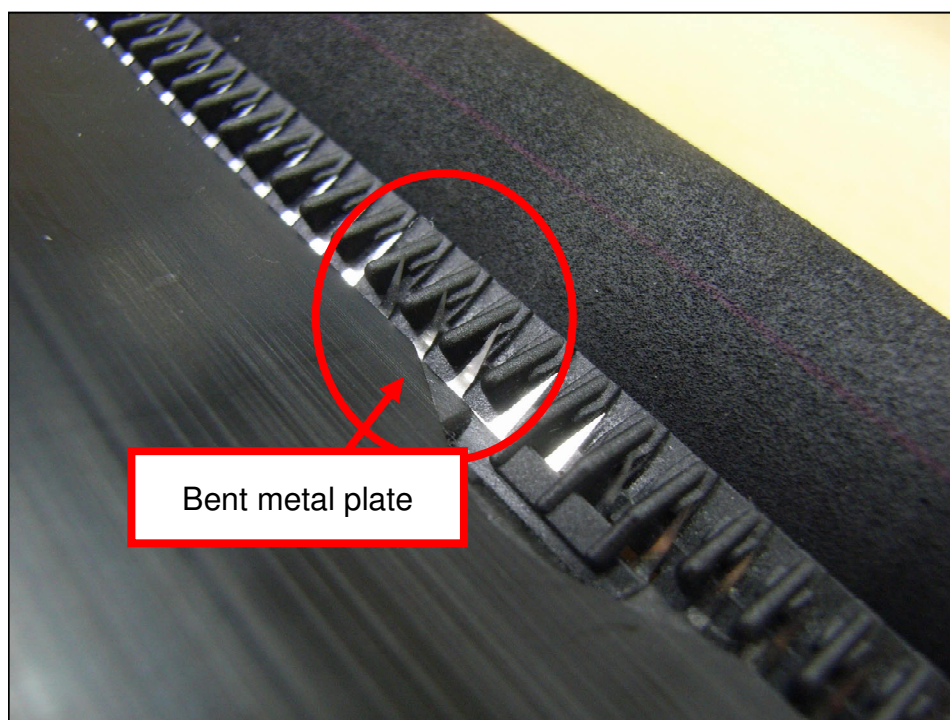
Sometimes, the head of the metallic anti-static plate in the paper transfer roller unit does not touch the plastic guide tightly enough. As a result, paper or the user's clothes may catch on the head area of this plate and the head of the plate is slightly bent. When the metallic plate is bent and the head of it sticks out into the paper path, passing paper encourages the bending and the plate becomes as shown below.

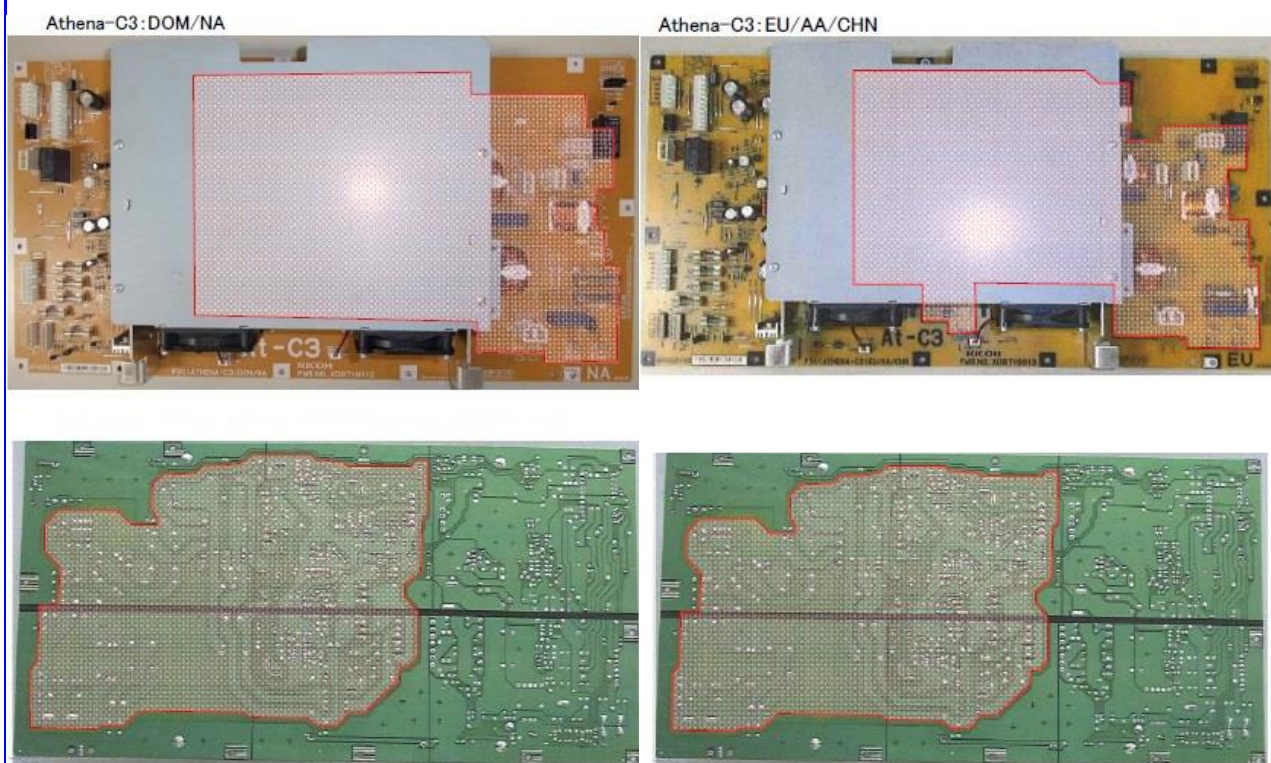
Residual charge of about 100V-400V remains on the PSU board for several months even when the board has been removed from the machine after turning off the machine power and unplugging the power cord.

The areas outlined in red on the bracket mean the residual charge of about 100V-400V remains on the PSU board under the bracket.
