Model: GR-C1	Date: 21-Mar-12	No.: RD117001b
--------------	-----------------	----------------

Subject: Firmware Release Note: (Java VM v10 for eDC)		Prepared by: H. Tamaki	
From: 1st Tech Service Sect., MFP/Printer Tech Service Dept.			
Classification:	<input type="checkbox"/> Troubleshooting	<input type="checkbox"/> Part information	<input type="checkbox"/> Action required
	<input type="checkbox"/> Mechanical	<input type="checkbox"/> Electrical	<input type="checkbox"/> Service manual revision
	<input type="checkbox"/> Paper path	<input type="checkbox"/> Transmit/receive	<input type="checkbox"/> Retrofit information
	<input type="checkbox"/> Product Safety	<input checked="" type="checkbox"/> Other (Firmware)	<input checked="" type="checkbox"/> Tier 2

This RTB has been issued to announce the firmware release information for the **Java VM v10 for eDC**.

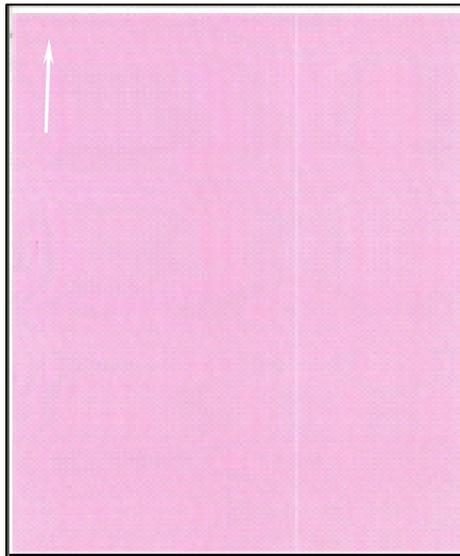
A white line is visible on the printout, as shown in the example below.

6. Do Steps 3 and 4 two more times (a total of three times).
7. Reinstall all parts you removed.
8. Print out five or more sheets and check the image quality. If this does not solve the symptom, replace the PCDU.

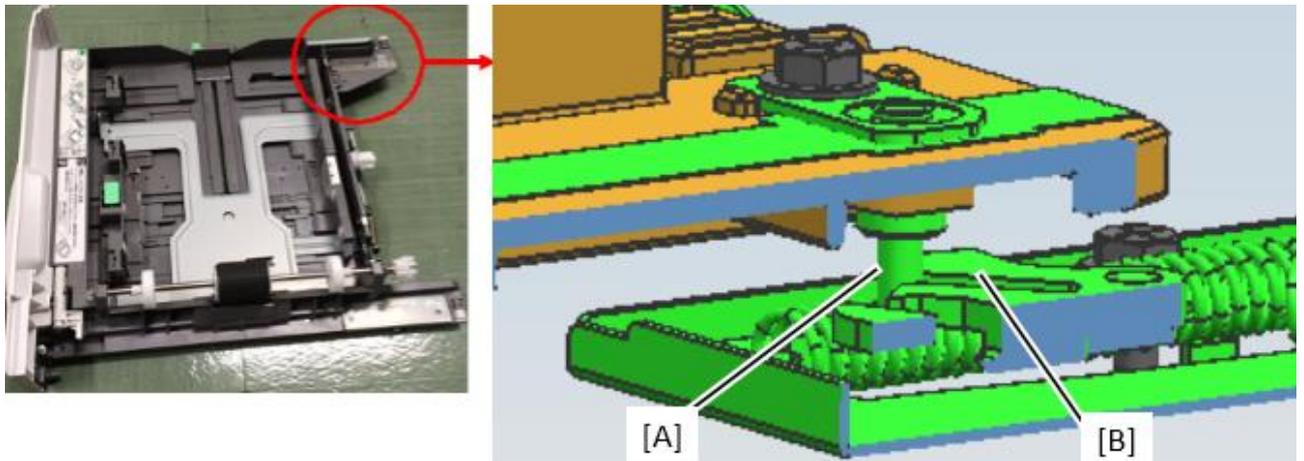
The user closes the tray with force, which causes the stretch pin [A] to ride up on the stretch unit [B]. The mechanical interference between these parts prevents the tray from being pulled out.

- 1. Pull out the the paper tray as far as possible.

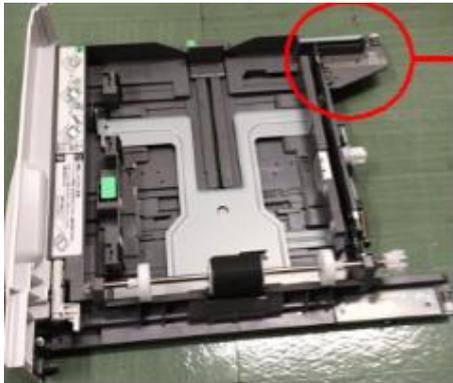
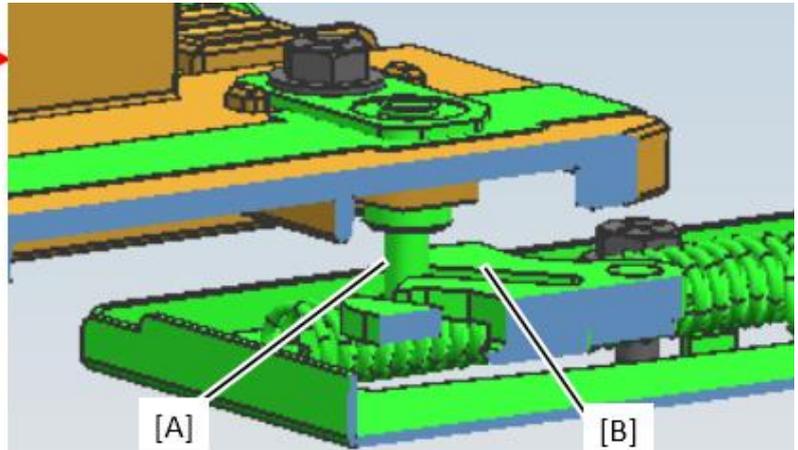
The user closes the tray with force, which causes the stretch pin [A] to ride up on the stretch unit [B]. The mechanical interference between these parts prevents the tray from being pulled out.

1. Remove the screw and the pin originally installed [A]. And then attach the countermeasure part [B].

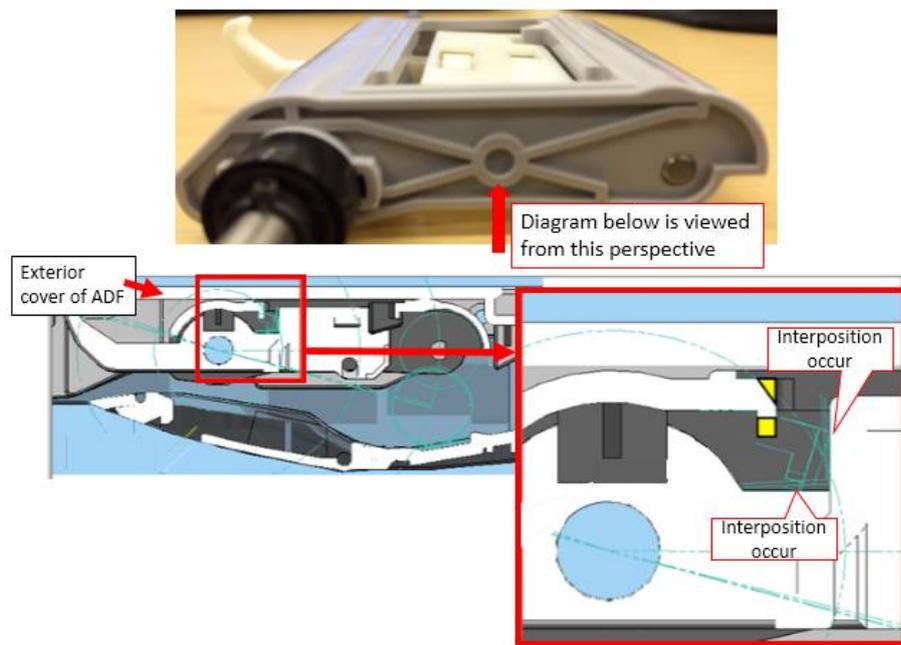
1. The customer uses an unsupported thin paper type (approx. 0.33gsm or thinner), which causes the ADF feed unit to interfere with the movement of the pick-up roller. As a result, the pick-up roller cannot be lowered to the proper position.

- **If the customer is using an unsupported thin paper type** (approx. 0.33gsm or thinner), replace the ADF feed unit (P/N D6062122; HOLDER:PICKUP ROLLER).
- **In all other cases**, do the **Procedure** on the next page.

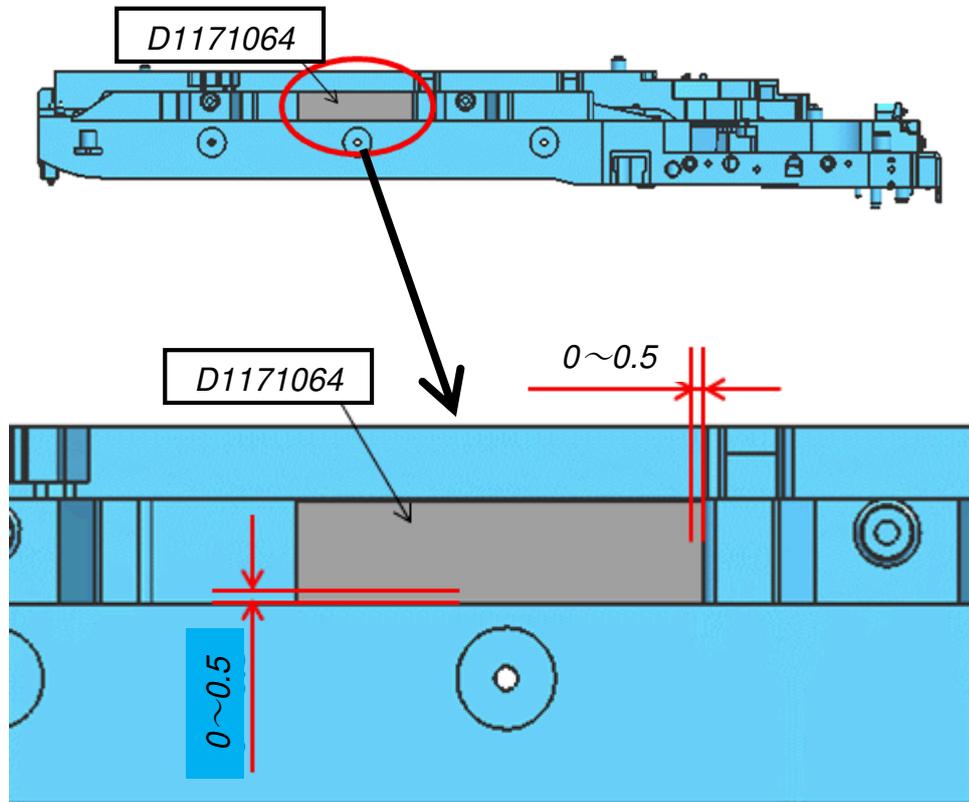
The exit cover is pressed down with force when closed. This causes the cover to bend inward (downward) and move the laser unit slightly from its original position. As a result, the paths of the yellow and/or magenta beams are shifted.

**In the field:**  
**Replace the exit cover and attach the seal to the machine, as shown above.**

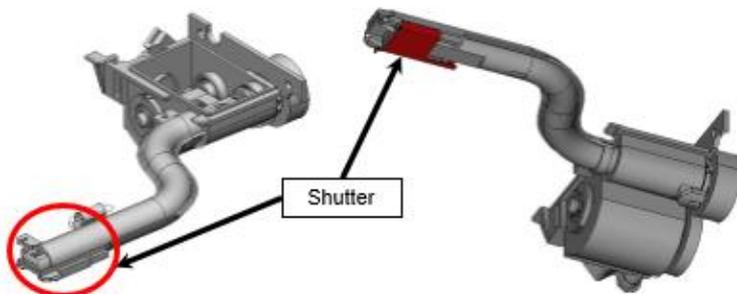
Toner concentration drops due to suspension of toner supply to the development unit after the coil in the toner supply hopper is twisted and broken. **This occurs after the PDCU is replaced or just after the machine is installed.**

Depending on how the PDCU is installed, in some cases, the toner hopper shutter may not open. If the toner hopper is then driven with the shutter closed, more toner is inside the tube, which places a greater load on the coil. This can cause the coil to warp and break.

Replace the target color's toner hopper and check the PCDU installation procedure.

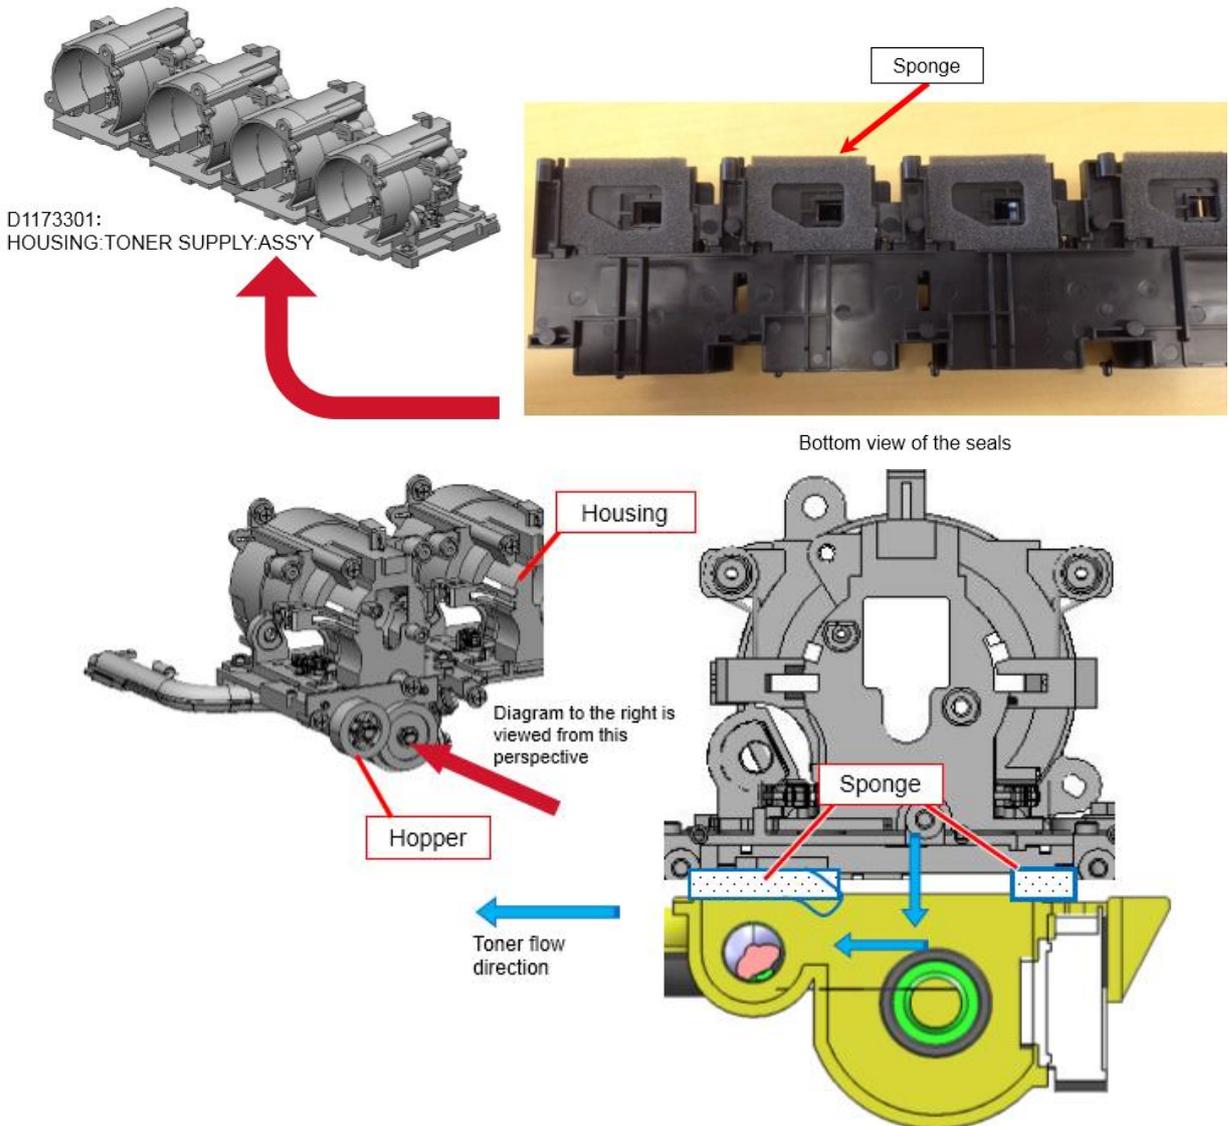
The sealing sponge attached by adhesive to the bottom of the toner housing (seal in between the hopper and housing) peels off, blocking the toner supply path inside the hopper and thereby reducing the amount of toner that can get through.

Sponge seals attached by adhesive to the bottom of the housing peel off, blocking the flow of toner inside the hopper, thereby reducing the amount that is supplied.

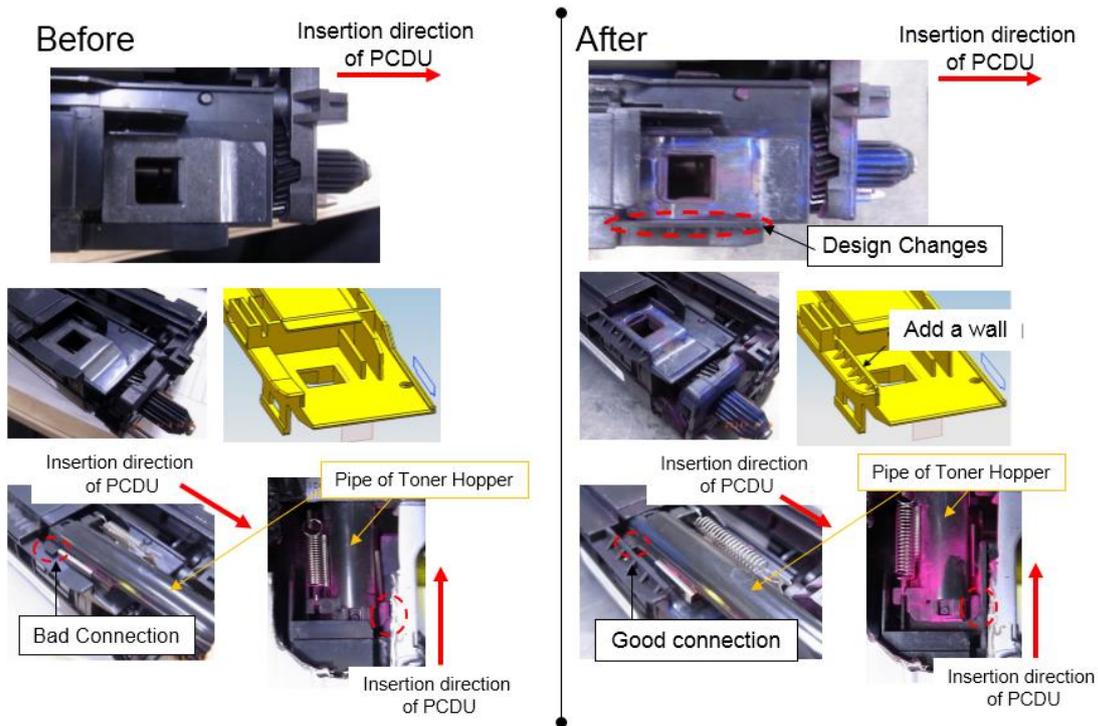
**Cause 1: Initial symptom**

The PCDU was modified so that even with variations in production, the shutter will open when the unit is installed.

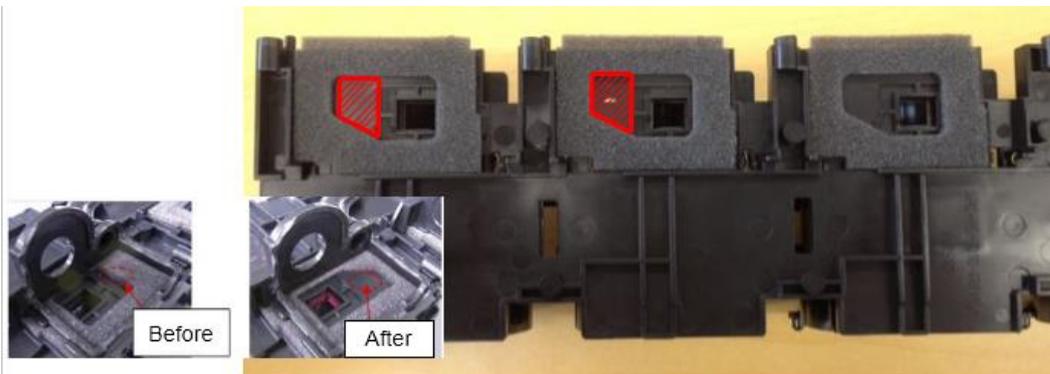
**Cause 2: Symptom occurring with time**

The area shown in red was removed from the sponge, which will prevent any blockage of the toner supply path.

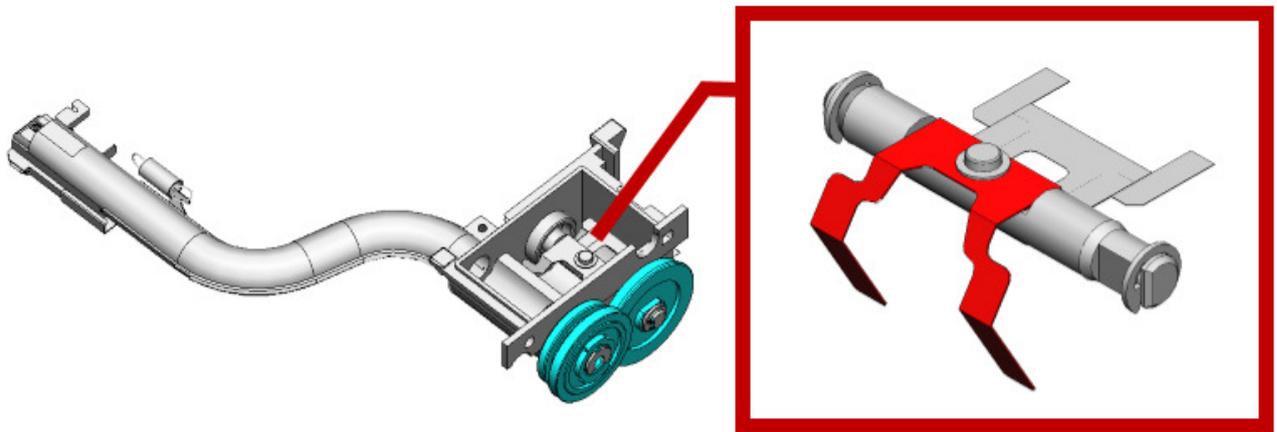
- For the GR-C2, the toner hopper was modified as shown below. The Mylar highlighted in red was added to improve the toner agitation power.
- This change reduces the occurrence of symptoms that develop over time.

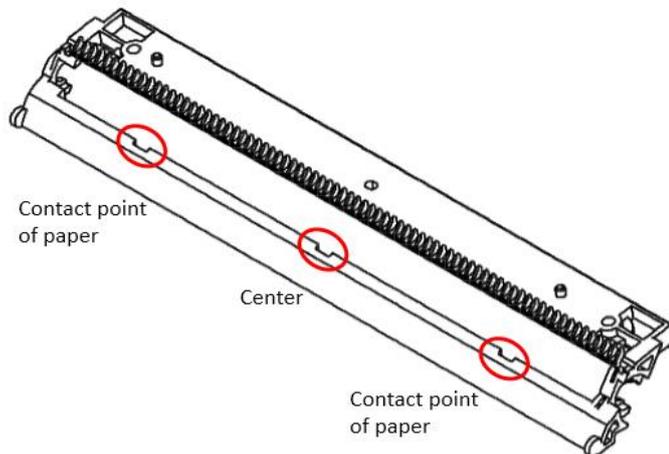
The molded part of the Transfer/Separation unit (with the mylar attached) has three cutouts.

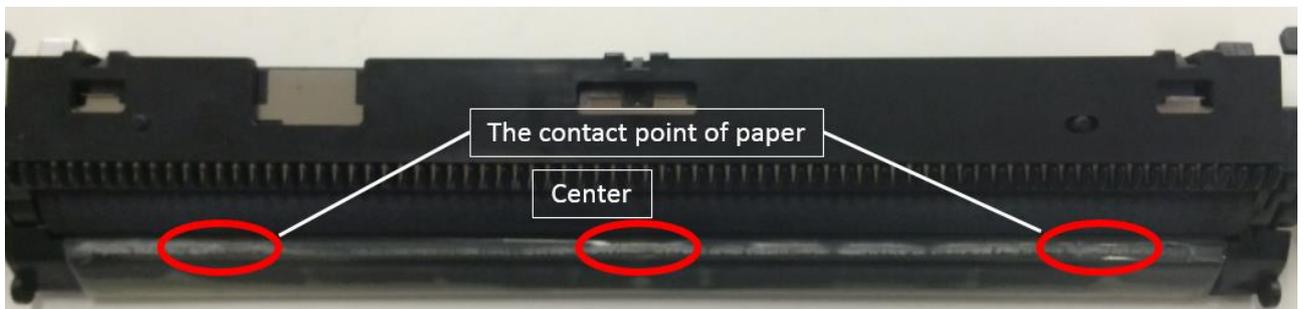
If a customer uses a paper with rough edges, the mylar is gradually damaged at the center and at the contact points of the paper side edges (shown in the pictures), and then the mylar peels off from the molded part.

At a result of this, mylar damage causes Jam 017.

Replace the Transfer/Separation Unit with the new unit,
