Model: GR-C2_SOP	Date: 30-Jul-15	No.: RD196005
------------------	-----------------	---------------

Subject: Firmware Release Note: PowerSaving Sys		Prepared by: C. Shimaji	
From: 2nd Tech Service Sect., MFP/Printer Tech Service Dept.			
Classification:	<input type="checkbox"/> Troubleshooting <input type="checkbox"/> Mechanical <input type="checkbox"/> Paper path <input type="checkbox"/> Product Safety	<input type="checkbox"/> Part information <input type="checkbox"/> Electrical <input type="checkbox"/> Transmit/receive <input checked="" type="checkbox"/> Other (Firmware)	<input type="checkbox"/> Action required <input type="checkbox"/> Service manual revision <input type="checkbox"/> Retrofit information <input checked="" type="checkbox"/> Tier 2

This RTB has been issued to announce the firmware release information for the **PowerSaving Sys.**

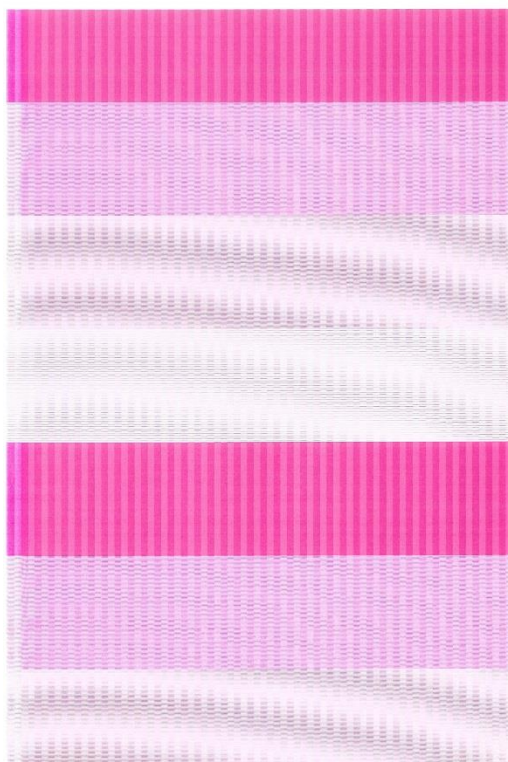
Replacing the laser unit can cause the light intensity of channels 1 and 2 to become uneven.

Notice that the beams (channel 1 and channel 2) are arranged alternately.

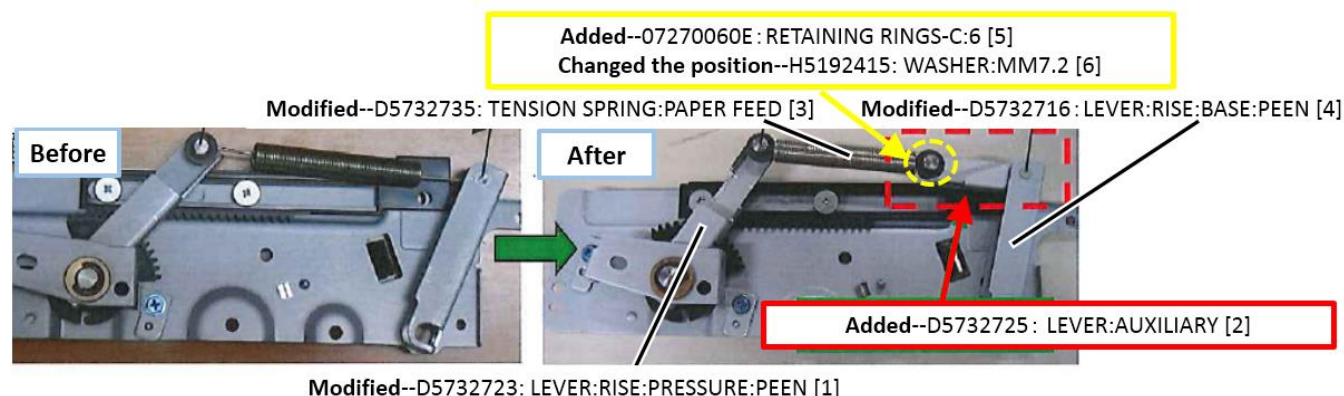
Tension spring breaks, causing the base plate of the paper tray to not move properly followed by failure in detecting paper within the specified time.

Replace the following parts as a set.

#	Description	Old part number	New part number	Old Q'ty	New Q'ty	Int	Note
1	LEVER:RISE:PRESSURE:PEEN	D5732721	D5732723	1	1	X/O	Replace as a set
2	LEVER:AUXILIARY		D5732725	-	1		
3	TENSION SPRING:PAPER FEED	D5732734	D5732735	1	1	X/O	
4	LEVER:RISE:BASE:PEEN	D5732710	D5732716	1	1	X/O	
5	RETAINING RINGS-C:6	07270060E	07270060E	-	1	-	
6	WASHER:MM7.2	H5192415	H5192415	1*	1*	-

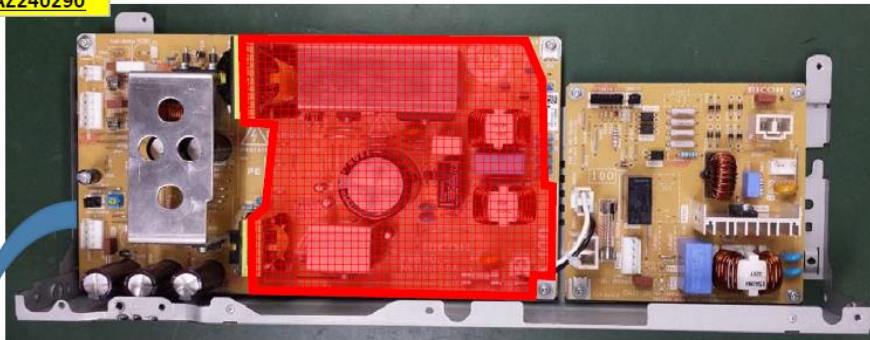
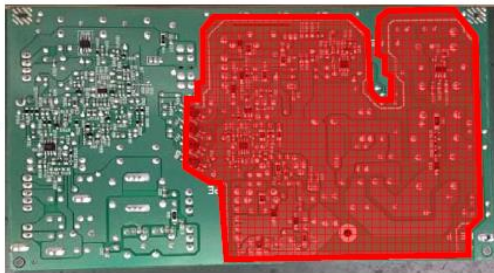
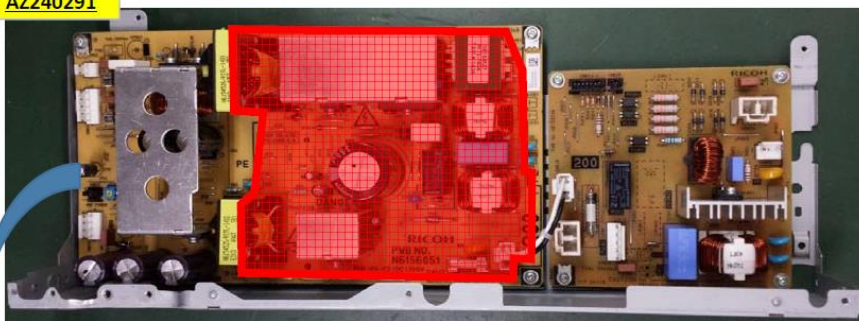
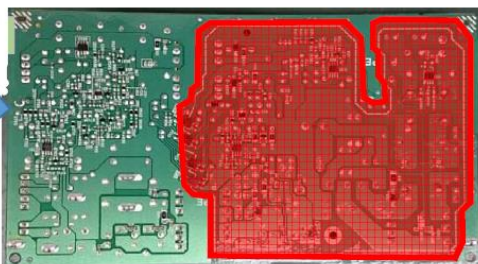
**NEVER touch** the areas outlined in red in the photos below to prevent electric shock caused by residual charge.

The procedure to discharge residual charge from the machine by unplugging the power cord from the AC wall outlet and pressing the main power switch works only for the DC circuits on this board. Residual charge remains in the AC circuits.

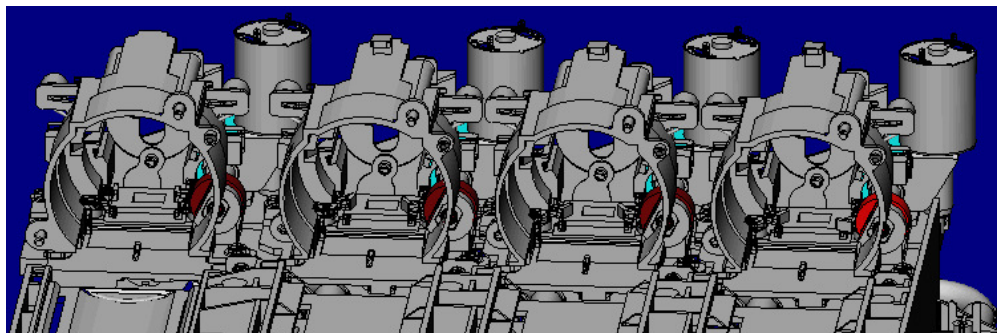
The toner bottle does not rotate correctly at the machine installation due to factory error. As a result of this error, the toner bottle rotation gear (highlighted in red) is out of position.

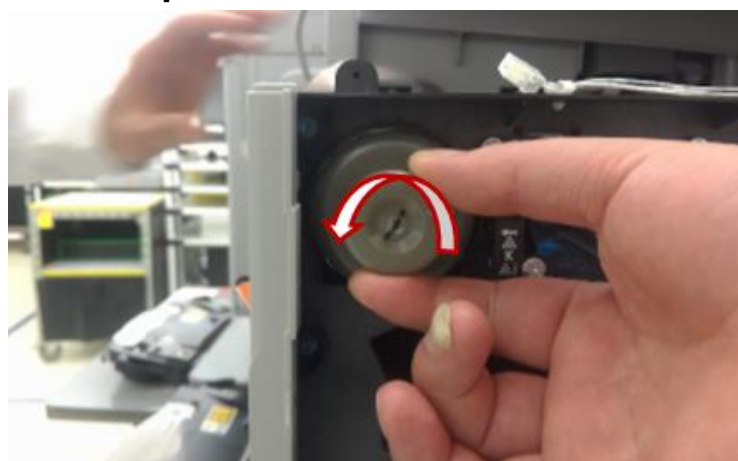
## Check if the gear out of position

- **If the gear is out of position (incorrect)**  
The toner bottle rotates in a counterclockwise direction.
- **If the gear is NOT out of position (correct)**  
The toner bottle does NOT rotate.

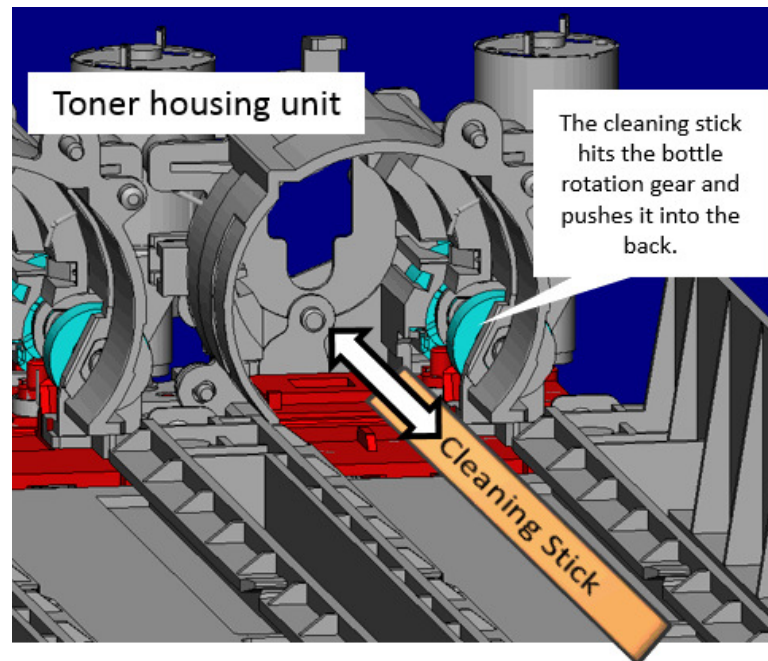
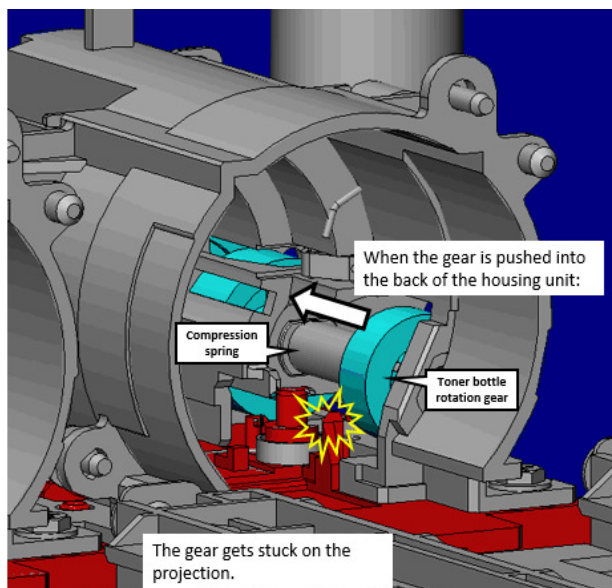
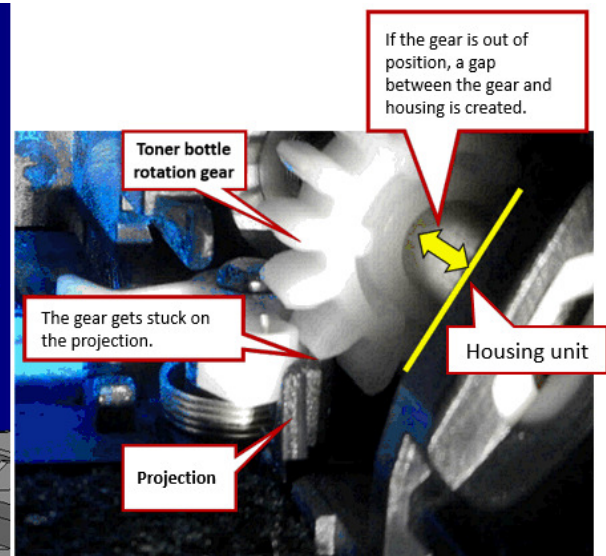
The factory performs random inspections, during which some pages are printed to check the image quality. During the final process of this inspection, the factory cleans up all color toner still remaining in the housing unit using a cleaning stick. When the stick is inserted, it hits the "bottle rotation gear" and pushes it into the back, causing the gear to contact the projection on the toner housing unit (see the figures below) and get stuck.

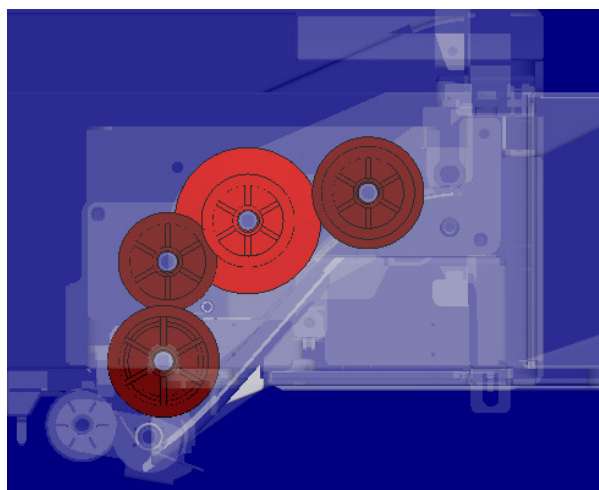
The viscosity of the grease applied to the shafts of the four gears (see below) increases under low-temperature (12C) conditions. As a result, the friction between the gear and mainframe increases, triggering the noise and/or Jam21.

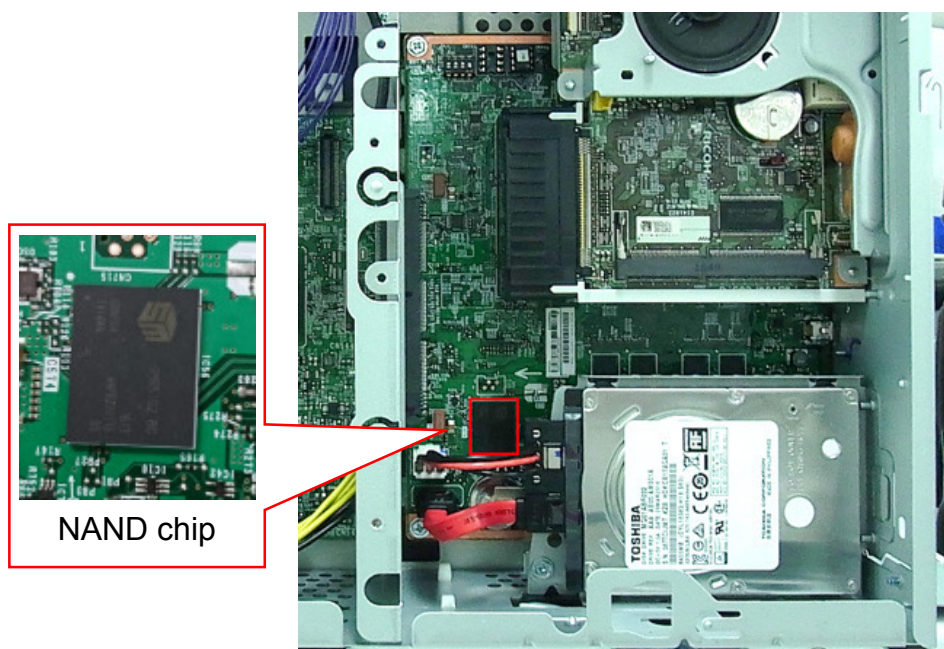
Defective NAND chips are used on controller boards produced between Aug 2016 to April 2017 (see **Affected Models** below). A software bug is in the NAND chip. As a result of this bug, the chip cannot perform a restore after the System Reset, which triggers the SC.
