| Model: AT-C2 | Date: 10-Sep-08 | No.: RD025001b |

| Subject: Firmware Release Note: Language Install | | Prepared by: T.Kiyohara | |

| Model: AT-C2 | Date: 16-Sep-08 | No.: RD025002h |

| Subject: Firmware Release Note: Engine | | Prepared by: Y.Urushihara | |

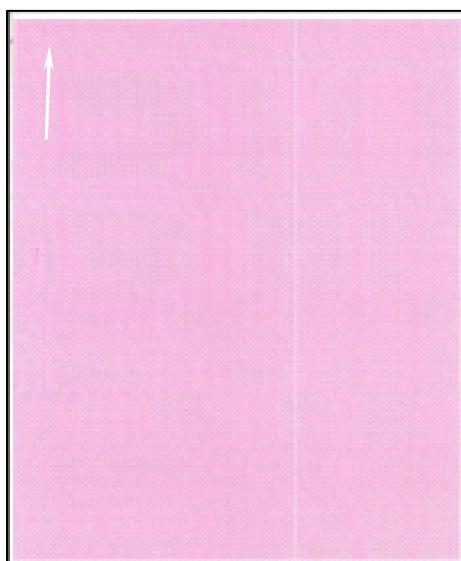
A white line is visible on the printout, as shown in the sample below:

The LD glass is dirty with toner, a foreign substance has been mixed in with the toner inside the development unit, or the toner inside the development unit has caked.

5. Print out five or more sheets of the 2-by-2 sample, and check the image quality. If this does not solve the problem, replace the developer.

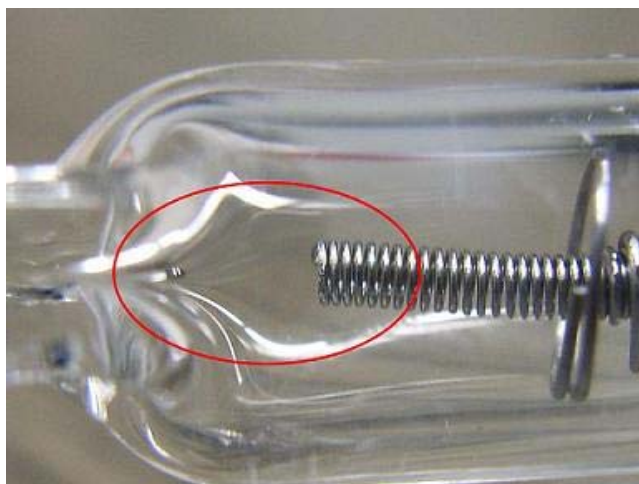
Affected models: AT-C2 Asia model, China model, and EU model.

While the machine is in the Standby (Ready) condition, the temperature of the tungsten wire in the lamp tends to weaken the wire. If the total time spent in the Ready condition is long enough, eventually the wire breaks.

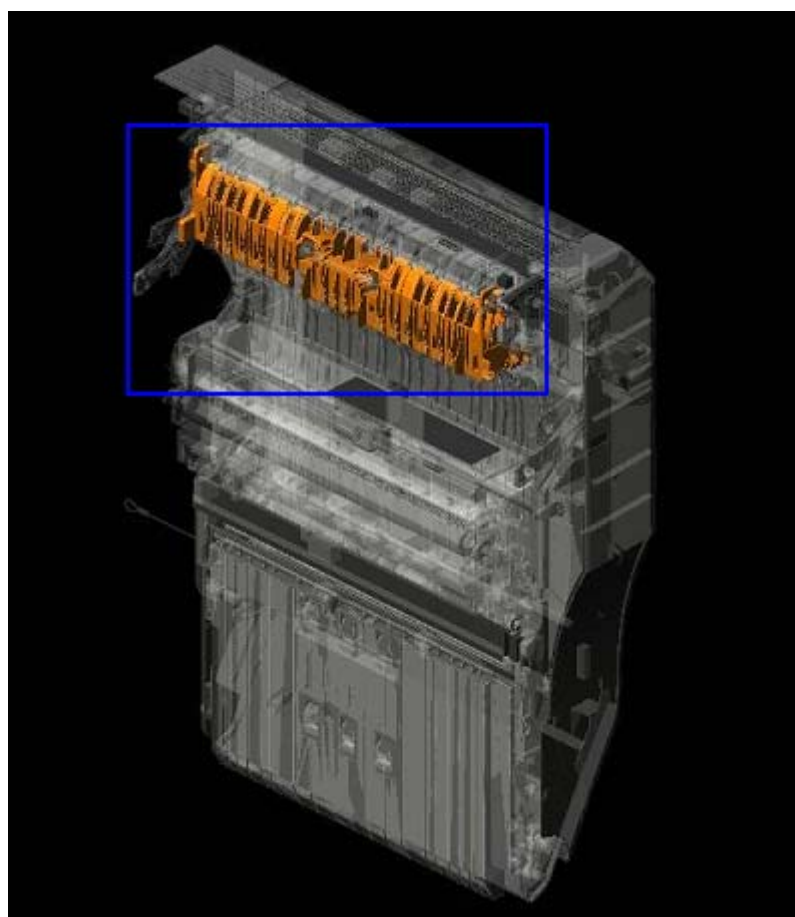
High temperature and a mechanical load cause the fusing entrance guide plate to bend.

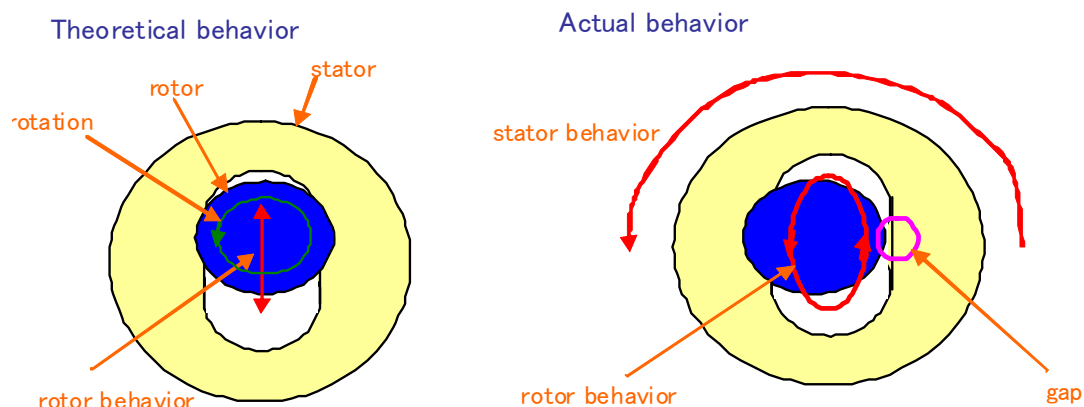
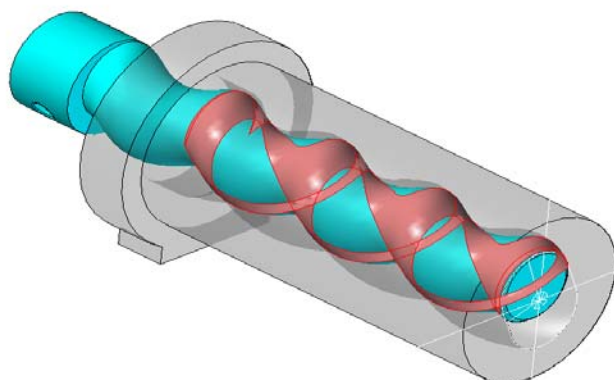
Pump unit

The rotor inside the pump unit moves in an elliptical pattern (instead of straight up and down), as shown in the illustration on the right below. This causes a gap to form between the rotor and stator. As a result, toner is not supplied correctly from the toner bottle to the development unit, and the machine incorrectly detects the Toner End condition.

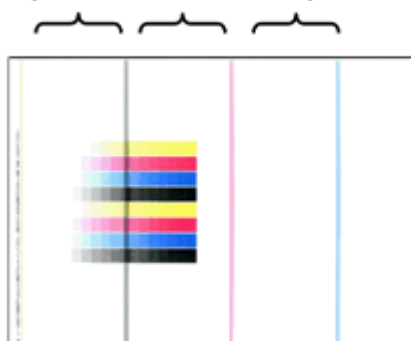
110mm interval vertical line
(Drum unit interval)

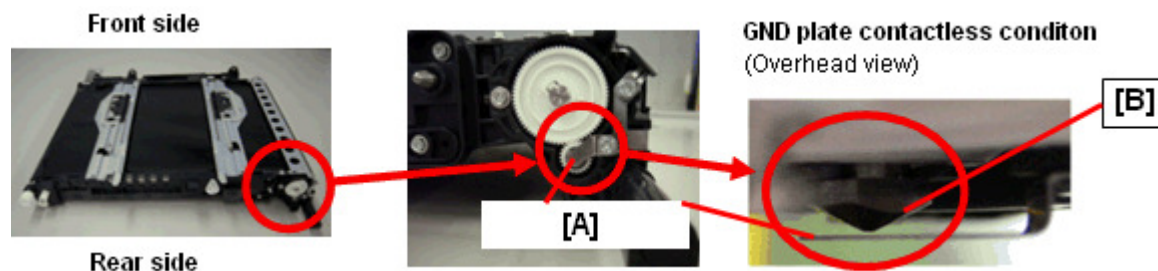
Sometimes, the GND plate at the rear side of the ITB cleaning unit [A] does not touch the lubrication application shaft [B]. As a result, a minor electrical leak occurs, which can trigger electrical noise. Sometimes, this effect appears as lines at 110mm intervals.

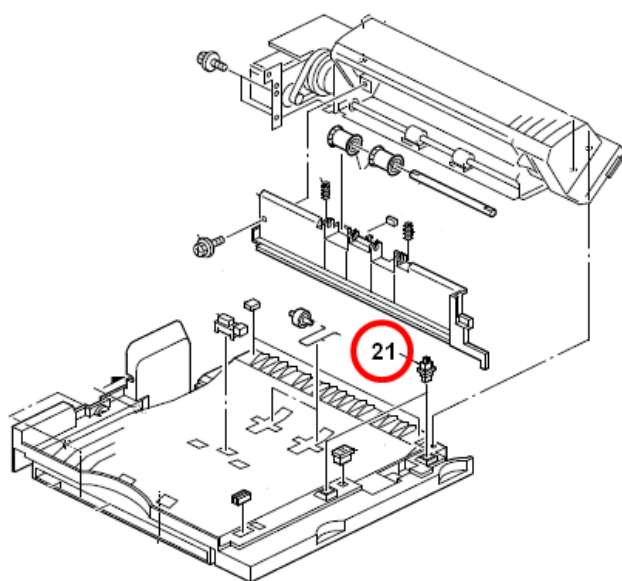
Jam 1 (Cover open) occurs frequently in the BU3030 Bridge unit.
 If you replace the push switch in the red circle below, this symptom occurs again.

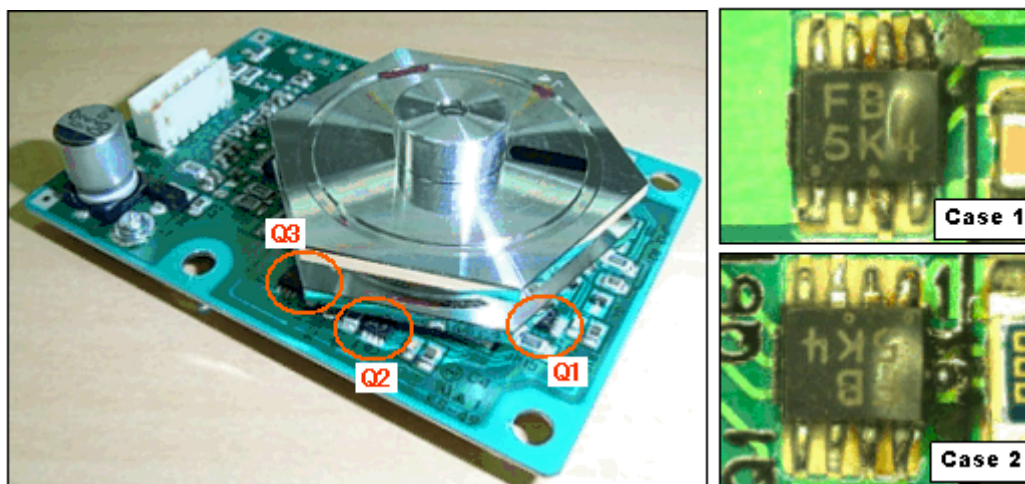
Note: The circuit breaks in the three areas circled in red below.

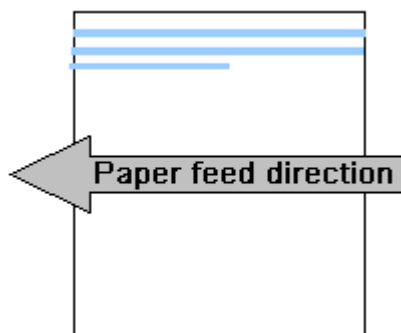
Horizontal black or colored lines, dirty background

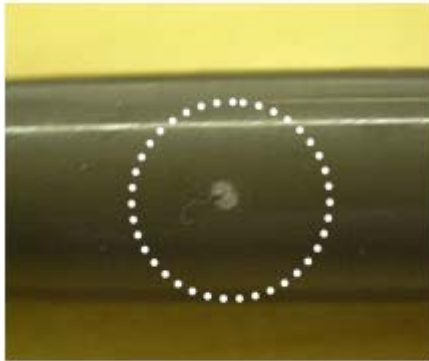
- Be sure to wipe the surface gently. If you wipe it too strongly, parts of the roller's surface layer may peel off (The white layer underneath will be visible).

- DO NOT use alcohol on the cloth. This will cause irreversible damage to the roller surface, so only use a water-damp cloth.
- Make sure that the Melanin roller does not get wet at all during this procedure.
