Model: Z-C2	Date: 08-Jan-14	No.: RD193001
-------------	-----------------	---------------

Subject: Firmware Release Note: Engine		Prepared by: Y. Urushihara	
From: 1st Tech Service Sect., MFP/Printer Tech Service Dept			
Classification:	<input type="checkbox"/> Troubleshooting <input type="checkbox"/> Mechanical <input type="checkbox"/> Paper path <input type="checkbox"/> Product Safety	<input type="checkbox"/> Part information <input type="checkbox"/> Electrical <input type="checkbox"/> Transmit/receive <input checked="" type="checkbox"/> Other (Firmware)	<input type="checkbox"/> Action required <input type="checkbox"/> Service manual revision <input type="checkbox"/> Retrofit information <input checked="" type="checkbox"/> Tier 2

Model: Z-C2		Date: 30-Mar-15	No.: RM028050
Subject: Pressure roller damage may occur at an early stage.		Prepared by: Y.Urushihara	
From: 1st Tech. Support Sec. Service Support Dept.			
Classification:	<input checked="" type="checkbox"/> Troubleshooting <input type="checkbox"/> Mechanical <input type="checkbox"/> Paper path <input type="checkbox"/> Product Safety	<input type="checkbox"/> Part information <input type="checkbox"/> Electrical <input type=

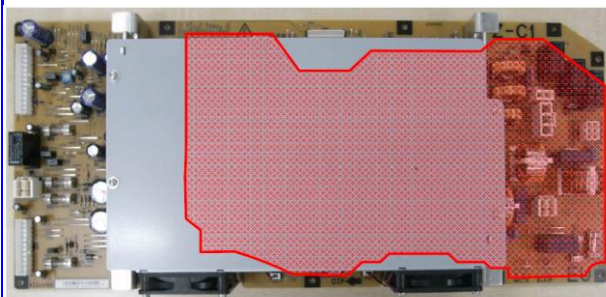
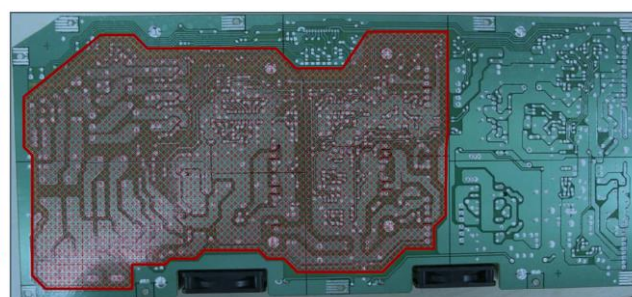
**NEVER touch** the areas outlined in red in the photos below to prevent electric shock caused by residual charge.

Residual charge of about 100V-400V remains in the AC circuits on the PSU board for several months even when the board has been removed from the machine after turning off the machine power and unplugging the power cord.

***The areas outlined in red on the bracket show where a residual charge of about 100V-400V remains on the PSU board under the bracket.***

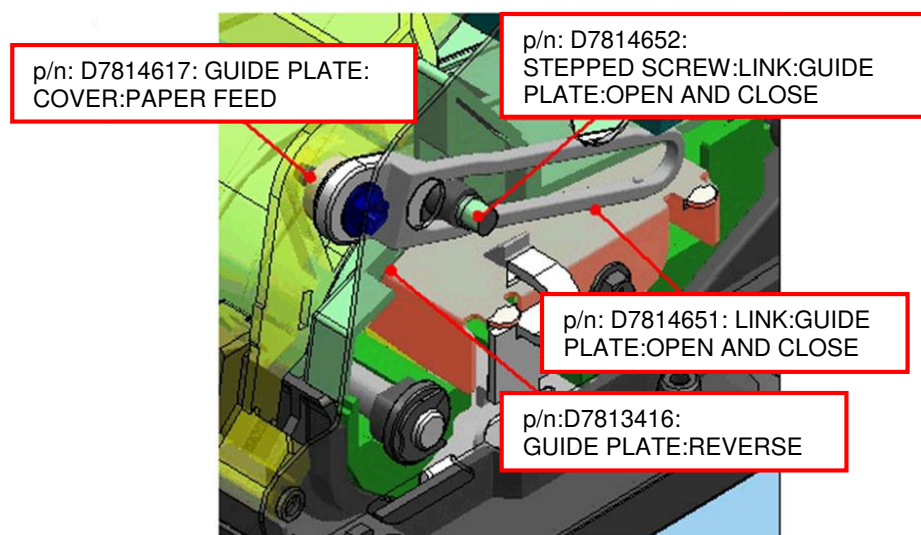
### After the modification

A linking part was added (in between the guide plate and side plate) to prevent the cover from opening too much.

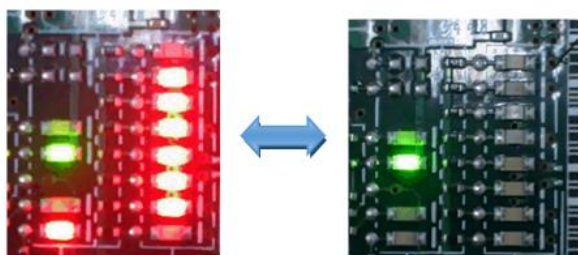
Figure 4: LEDs 2 to 7 blinking every 5 seconds

In the case of a defective DIMM, LEDs 2 to 7 blink at every 5 seconds.

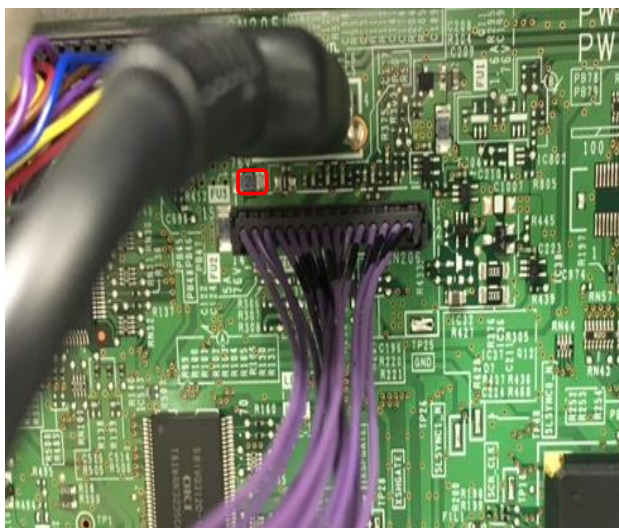
Figure 5: Fuse 3 on the IPU

Check that the resistance of fuse 3 is below 1Ω.
