Model: Apollon-C1	Date: 21-Jul-06	No.: RB222001b
-------------------	-----------------	----------------

Subject: Firmware Release History (Web Uapl)		Prepared by: T.Kiyohara	
From: 1st Tech. Support Sec. Service Support Dept.			
Classification:	<input type="checkbox"/> Troubleshooting	<input type="checkbox"/> Part information	<input type="checkbox"/> Action required
	<input type="checkbox"/> Mechanical	<input type="checkbox"/> Electrical	<input type="checkbox"/> Service manual revision
	<input type="checkbox"/> Paper path	<input type="checkbox"/> Transmit/receive	<input type="checkbox"/> Retrofit information
	<input checked="" type="checkbox"/> Other ( )

Model: Apollon-C1c/d		Date: 8-Mar-07	No.: RB222021
Subject: Rattling noise from paper separation area		Prepared by: K. Takagi	
From: 1st Tech. Support Sec. Service Support Dept.			
Classification:	<input checked="" type="checkbox"/> Troubleshooting <input type="checkbox"/> Mechanical <input type="checkbox"/> Paper path <input type="checkbox"/> Product Safety	<input type="checkbox"/> Part information <input type="checkbox"/> Electrical <input type="checkbox"/> Transmit/receive <input type="checkbox"/> Other (     )	<input type="ch

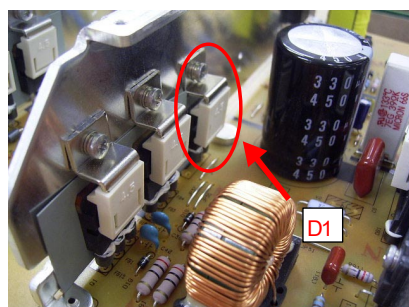
The main power switch is turned off suddenly (without first turning off the operation switch), unconformity occurs at the time of movement stop/start in the circuit, resulting in unexpected current flow. As a result, a diode on the PSU is damaged.

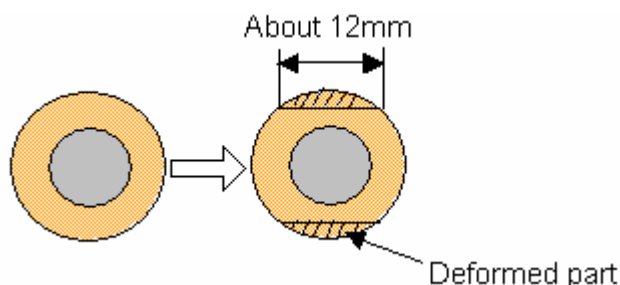
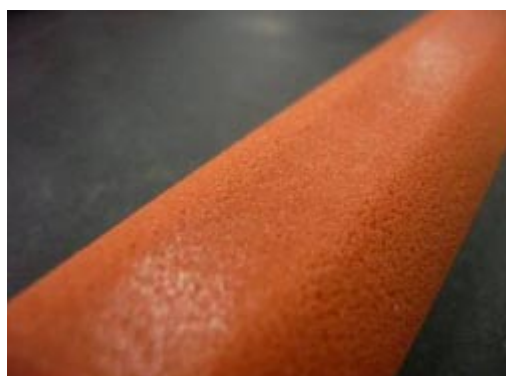
The machine is used under the following conditions, which minimizes the frequency at which the fusing roller is rotated/idled. Also, the idling home position is constant. As a result, the same area of the fusing roller surface is exposed to the heating roller for long periods of time, which flattens out this area.

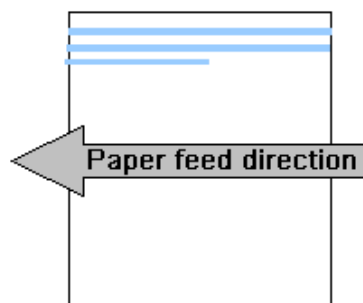
Horizontal black or colored lines, dirty background

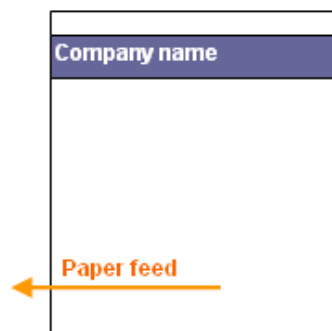
**Note:** If the customer makes many copies/prints of images that contain a band in the same area of the image, as shown in the illustration below, this can cause a cleaning failure to occur earlier than usual. This makes it easier for the charge roller to become dirty, even before the 80k mark.

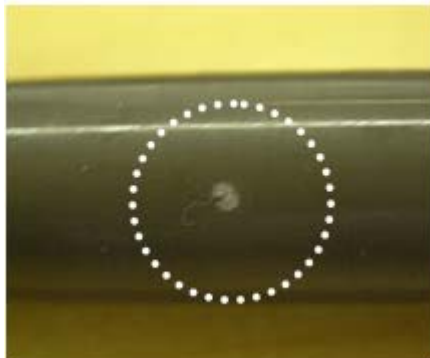
- When you clean the roller surface:
  - Be sure to wipe the surface gently. If you wipe it too strongly, parts of the roller's surface layer may peel off (The white layer underneath will be visible).

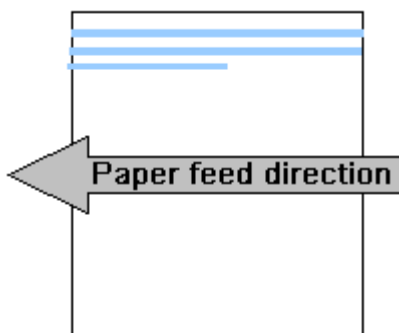
Horizontal black or colored lines

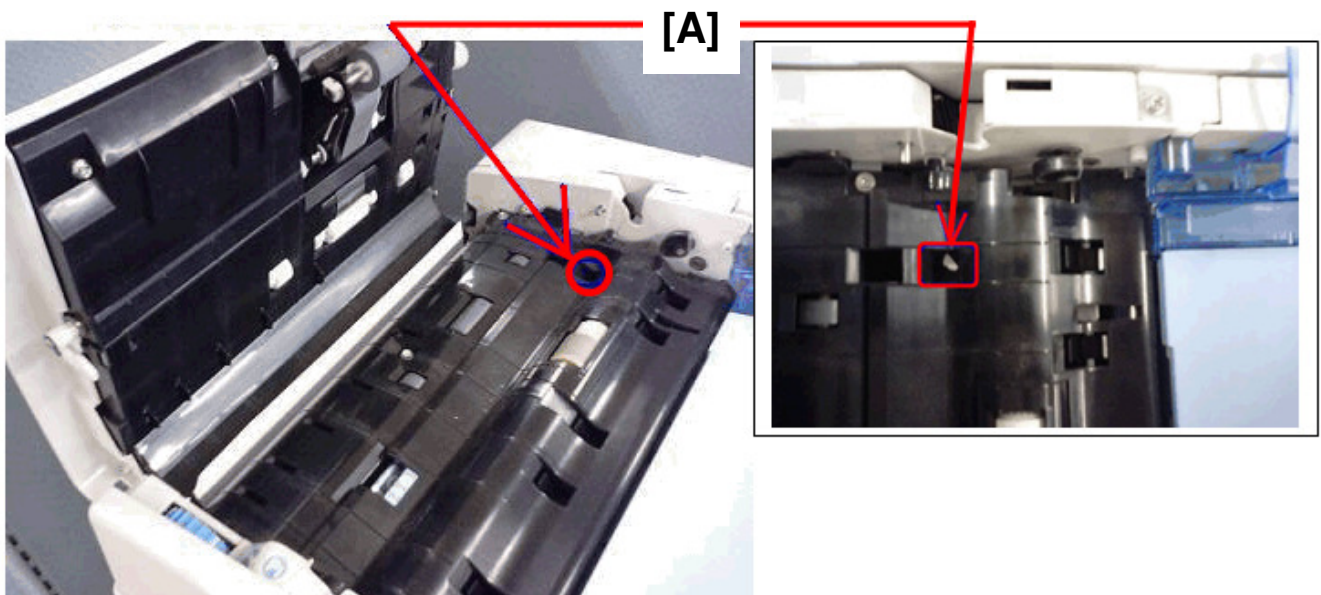
Shavings from the eraser or punched chads can sometimes cover the original separation sensor in the opening shown below [A], causing a sensor misdetection.

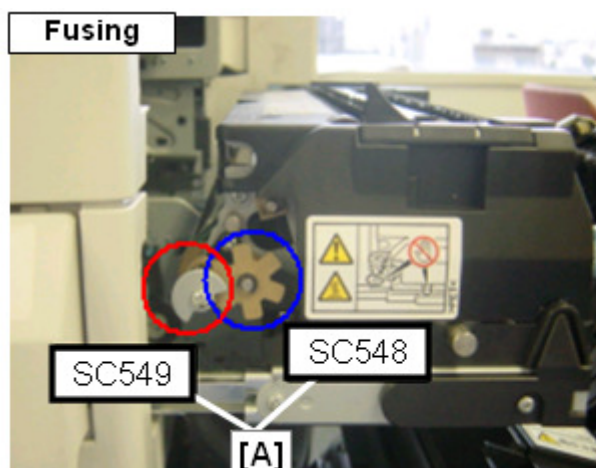
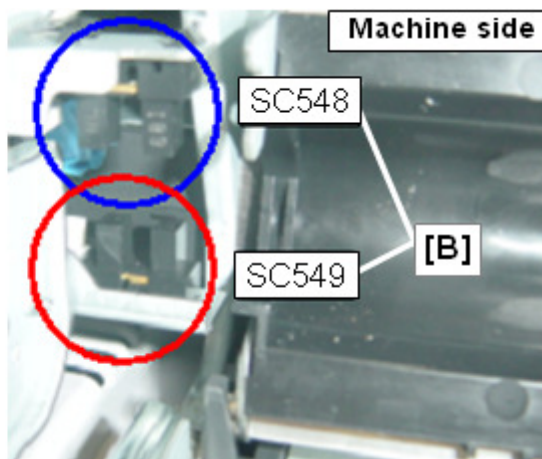
- 1) Engine firmware bug: A rotation detection error occurs while the fusing unit is rotating.
- 2) The fusing unit is tilted slightly when it is attached. This causes the encoders [A] to contact the sensors in the machine [B].

Replace the fusing unit encoder [A] and two sensors [B] on the machine side.
