Model: AP-C2.5	Date: 22-Oct-10	No.: RD089002h
----------------	-----------------	----------------

Subject: Firmware Release Note: Engine		Prepared by: Y. Taniguchi	
From: 1st Tech Service Sect., MFP/Printer Tech Service Dept			
Classification:	<input type="checkbox"/> Troubleshooting	<input type="checkbox"/> Part information	<input type="checkbox"/> Action required
	<input type="checkbox"/> Mechanical	<input type="checkbox"/> Electrical	<input type="checkbox"/> Service manual revision
	<input type="checkbox"/> Paper path	<input type="checkbox"/> Transmit/receive	<input type="checkbox"/> Retrofit information
	<input type="checkbox"/> Product Safety	<input checked="" type="checkbox"/> Other (Firmware)	<input checked="" type="checkbox"/> Tier 2

This RTB has been issued to announce the firmware release information for the **Engine**.

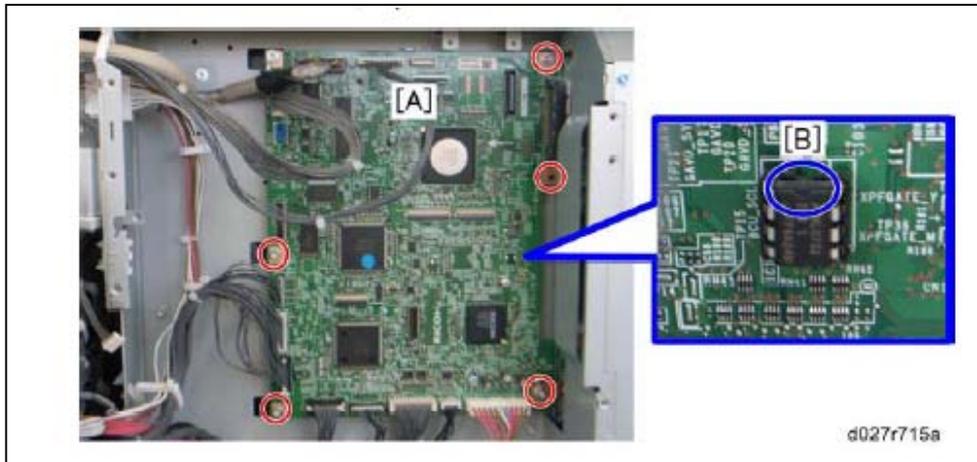
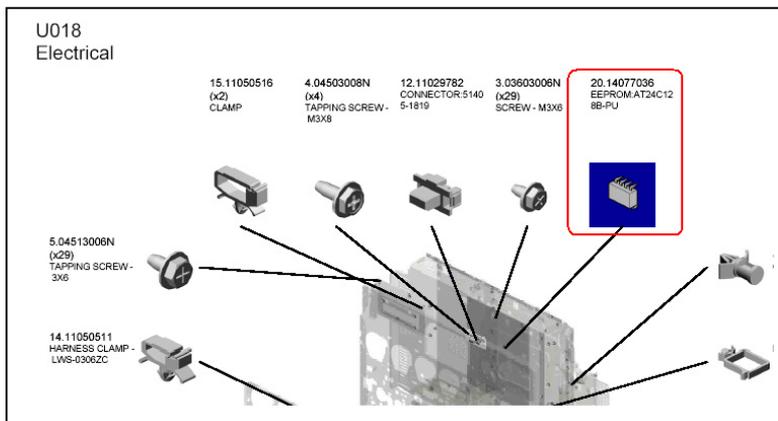
(1) NVRAM on the BICU

The NVRAM on the BICU is shown above as [B] on the BICU board [A] (See Pg. 295 in the FSM)

The NVRAM on the BICU is called 'EEPROM' in the parts catalog on page "U018 Electrical".

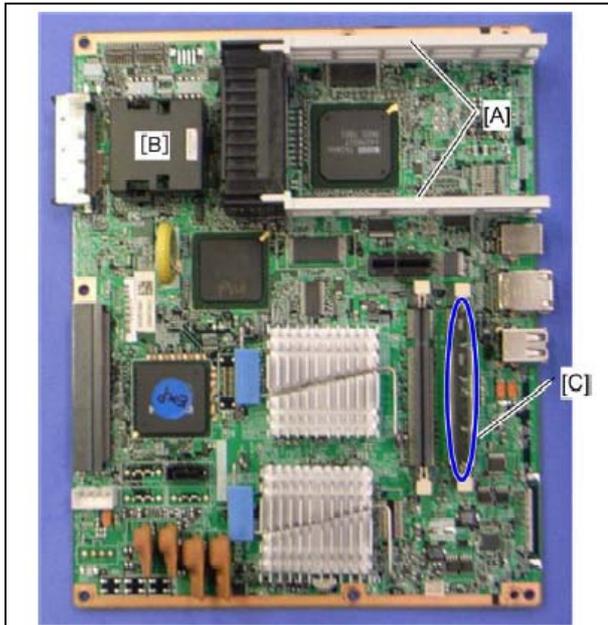
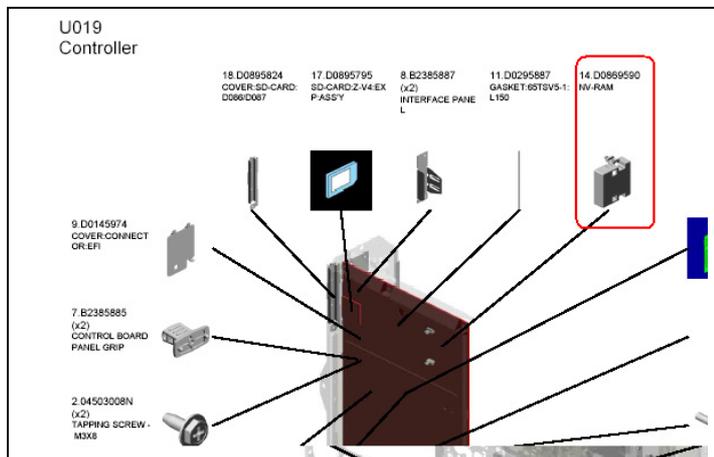
(2) NVRAM on the Controller Board

The NVRAM on the Controller Board is shown as [B] in the above photograph (See Pg. 300 in the FSM).

The NVRAM on the Controller Board is also called 'NVRAM' in the parts catalog on page "U019 Controller".

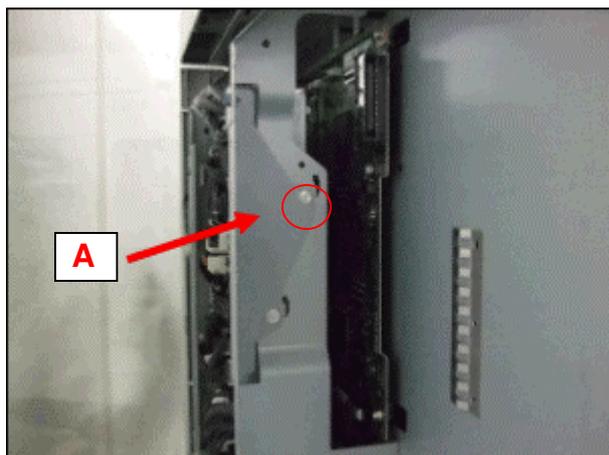
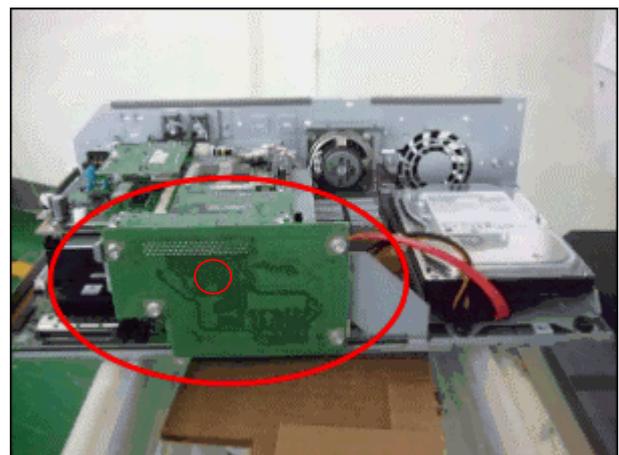
The screw [A] shown below touches the fax I/F board, causing a short circuit.

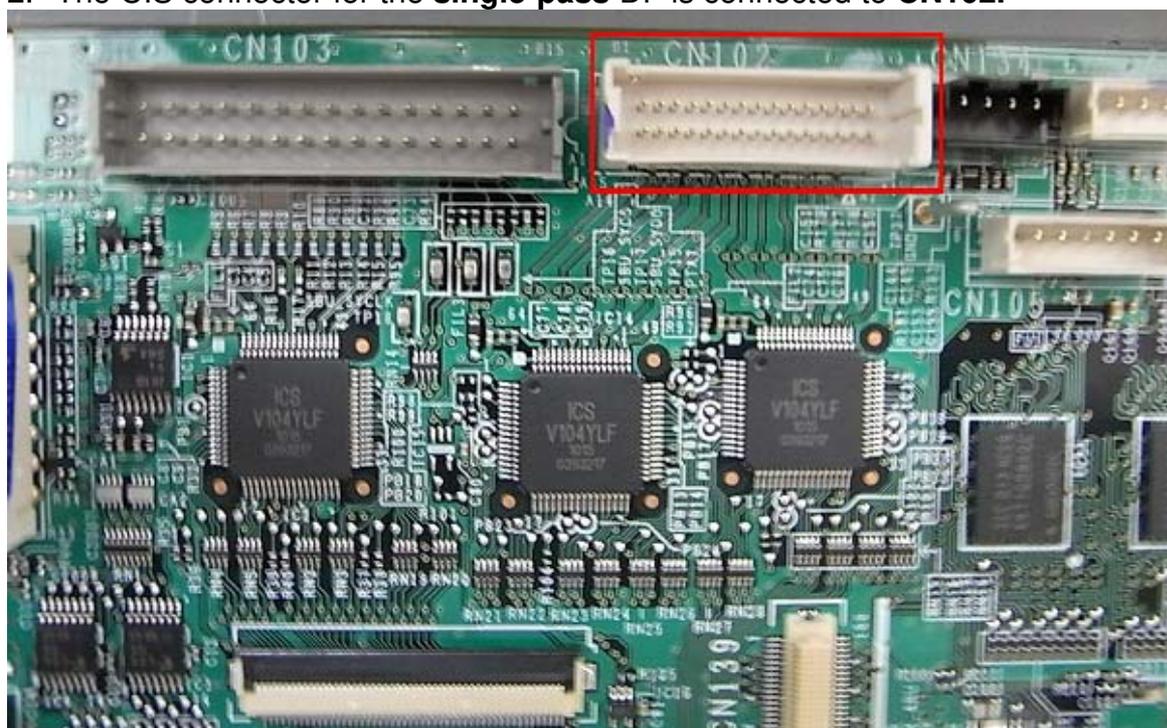
2. The CIS connector for the **single-pass** DF is connected to **CN102**.
