Model: AP-C3	Date: 15-Feb-12	No.: RD144001
--------------	-----------------	---------------

Subject: Firmware Release Note: ADF_MANASLU_B		Prepared by: H. Tamaki	
From: 1st Tech Service Sect., MFP/Printer Tech Service Dept.			
Classification:	<input type="checkbox"/> Troubleshooting	<input type="checkbox"/> Part information	<input type="checkbox"/> Action required
	<input type="checkbox"/> Mechanical	<input type="checkbox"/> Electrical	<input type="checkbox"/> Service manual revision
	<input type="checkbox"/> Paper path	<input type="checkbox"/> Transmit/receive	<input type="checkbox"/> Retrofit information
	<input type="checkbox"/> Product Safety	<input checked="" type="checkbox"/> Other (Firmware)	<input checked="" type="checkbox"/> Tier 2

Model: AP-C3d		Date: 20-Apr-12	No.: RD144037
Subject: Granule of black toner on 1 st printed paper		Prepared by: S. Hayami	
From: 1st Tech Service Sect., MFP/P Tech Service Dept.			
Classification:	<input checked="" type="checkbox"/> Troubleshooting	<input type="checkbox"/> Part information	<input checked="" type="checkbox"/> Action required
	<input type="checkbox"/> Mechanical	<input type="checkbox"/> Electrical	<input type="checkbox"/> Servi

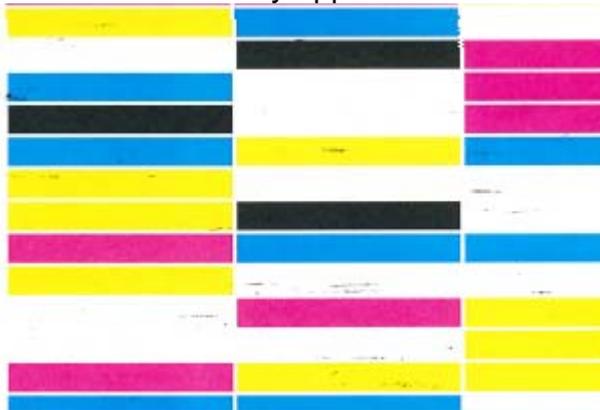
Granules of black toner may appear on the first sheet printed out (see the example below).

The toner is stored under high-temperature conditions, which causes some of the toner to aggregate. These toner particles are not mixed properly with the carrier, and as a result, this toner is not charged properly.

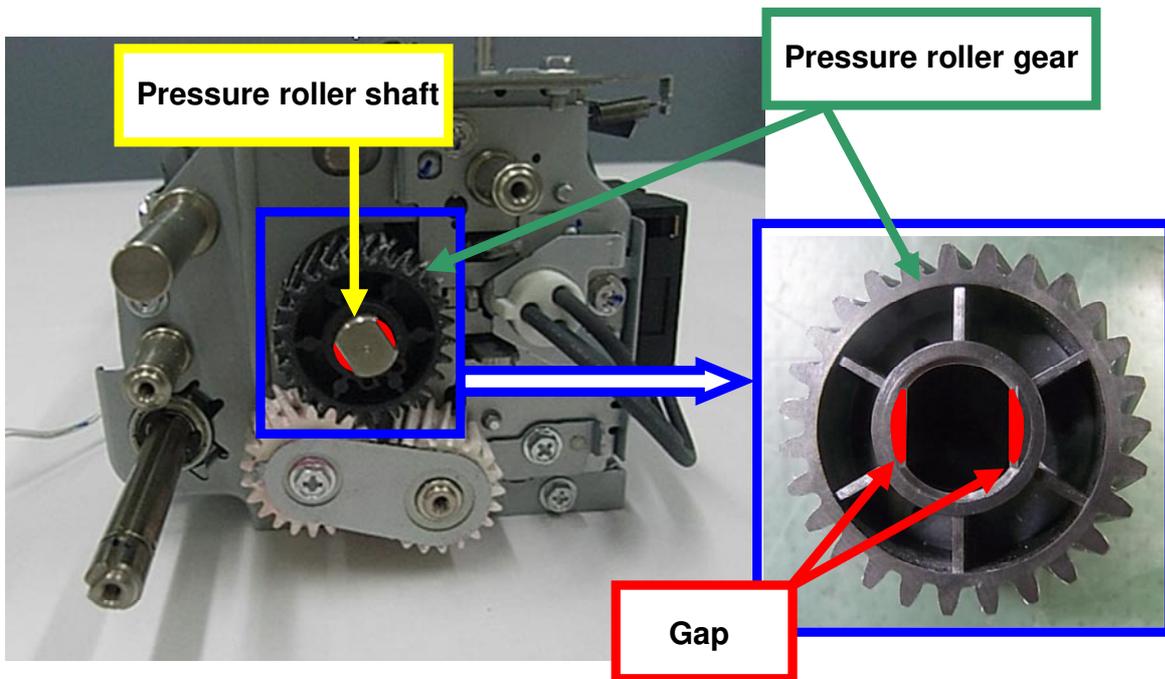
Gaps between the pressure roller gear and pressure roller shaft (marked in red below) may allow the shaft to slip inside the gear opening.

2. Permanent solution: The inside diameter of the pressure roller gear was changed to decrease the gaps.

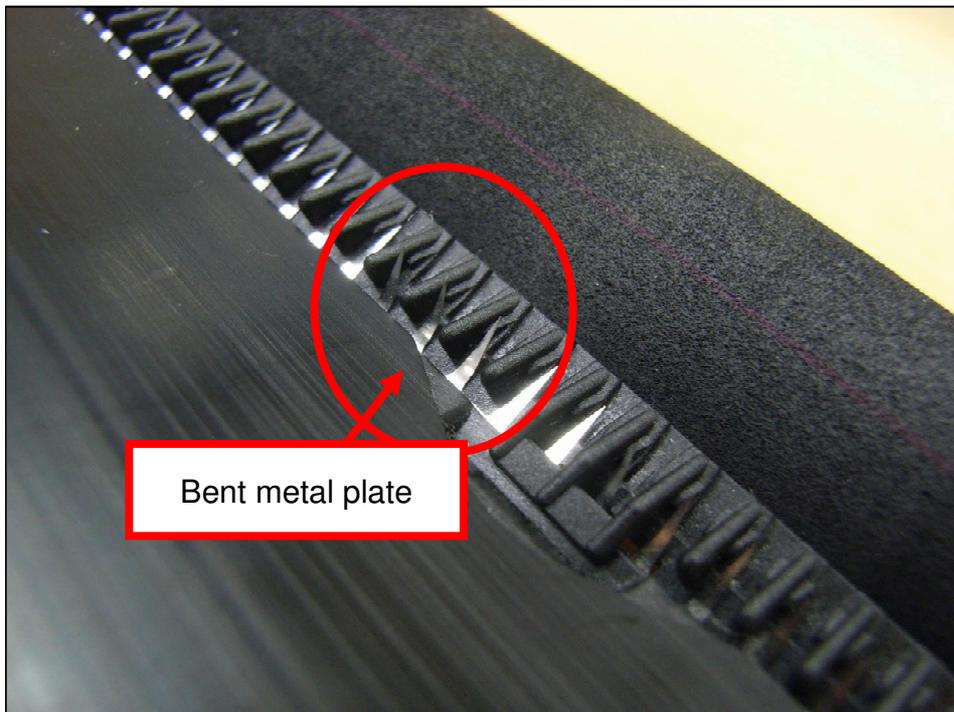
Sometimes, the head of the metallic anti-static plate in the paper transfer roller unit does not touch the plastic guide tightly enough. As a result, paper or the user's clothes may catch on the head area of this plate and the head of the plate is slightly bent. When the metallic plate is bent and the head of it sticks out into the paper path, passing paper encourages the bending and the plate becomes as shown below.

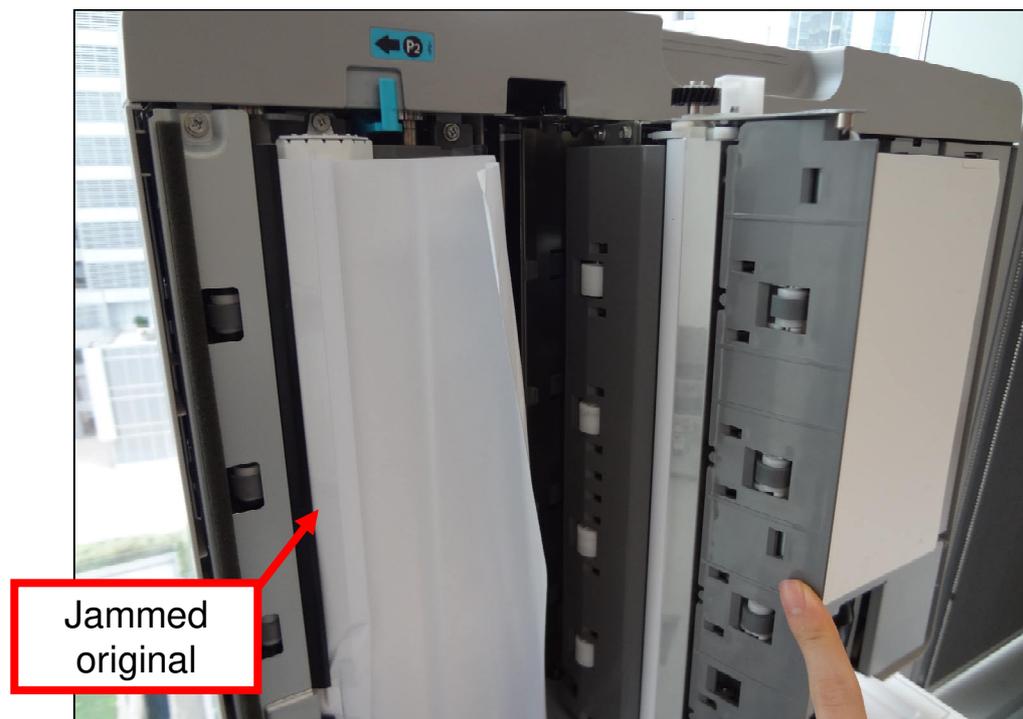
An original JAM66 (Registration Sensor: Off) occurs when using the Single Pass DF.

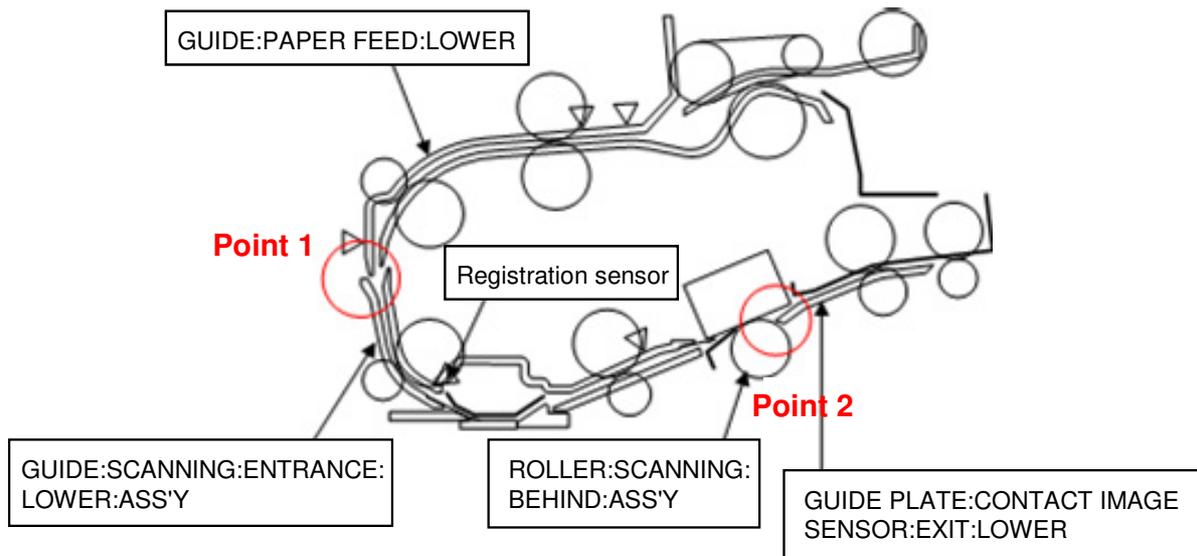
The original may impact the “GUIDE:SCANNING:ENTRANCE:LOWER:ASS'Y” after exiting the “GUIDE:PAPER FEED:LOWER”.

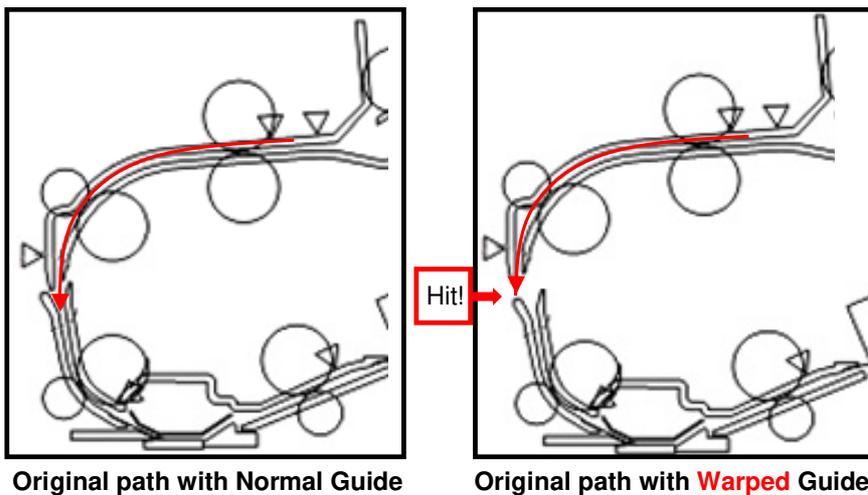
Or, the original may get caught in the relatively large gap between the “ROLLER:SCANNING:BEHIND:ASS'Y” and “GUIDE PLATE:CONTACT IMAGE if it is damaged or curled.
