Model: MET-C1cde	Date: 18-Jun-13	No.: RD149007
------------------	-----------------	---------------

Subject: Firmware Release Note: Java VM v11 UpdateTool (METC1EXe)		Prepared by: N. Yoshida	
From: 1st Tech Service Sect., MFP/Printer Tech Service Dept.			
Classification:	<input type="checkbox"/> Troubleshooting	<input type="checkbox"/> Part information	<input type="checkbox"/> Action required
	<input type="checkbox"/> Mechanical	<input type="checkbox"/> Electrical	<input type="checkbox"/> Service manual revision
	<input type="checkbox"/> Paper path	<input type="checkbox"/> Transmit/receive	<input type="checkbox"/> Retrofit information
	<input type="checkbox"/> Product Safety	<input checked="" type="checkbox"/> Other (Firmware)	<input checked="" type="checkbox"/> Tier 2

This RTB has been issued to announce the firmware release information for the **Java VM v11 Update Tool (METC1EXe)**.

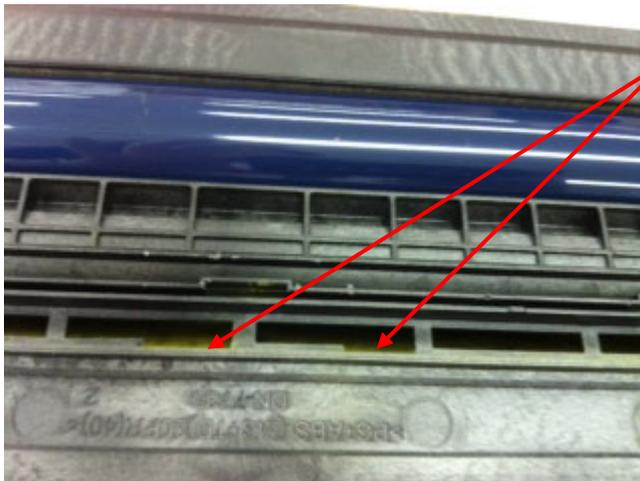
Photo showing broken ribs:

Make sure to completely remove the orange tape. If you remove the preset seal without removing the orange tape, this may break the ribs inside the unit. As a result, broken ribs may fall into the development unit and cause white lines to appear on the printouts.

Broken part

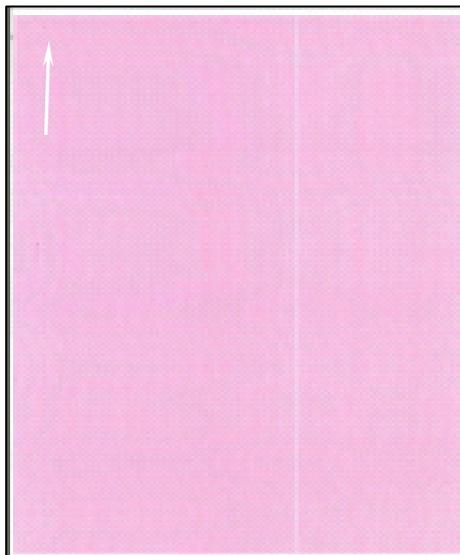
A white line is visible on the printout, as shown in the sample below:

The LD glass is dirty with toner, a foreign substance has been mixed in with the toner inside the development unit, or the toner inside the development unit has caked.

5. Print out five or more sheets of the 2-by-2 sample, and check the image quality. If this does not solve the symptom, replace the development unit.

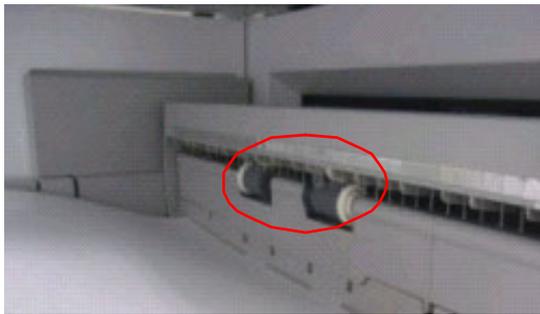
Noise occurs in the following area in the Bridge Unit 3070.

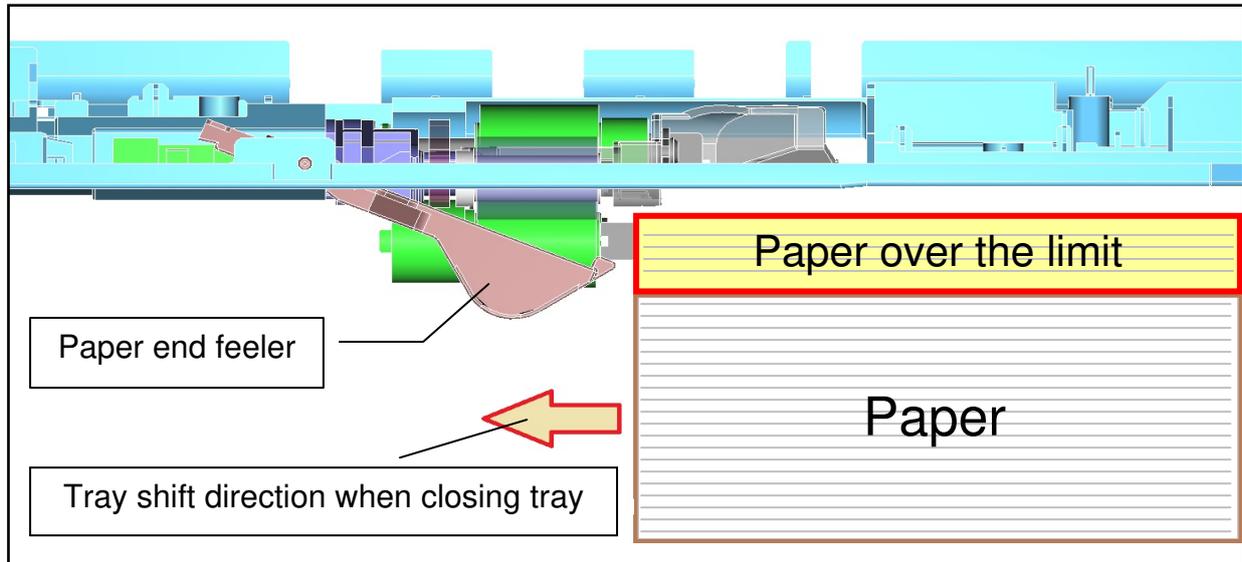
The paper tray is filled over the specification limit, causing the paper stack to hit the paper end feeler with force and knock the feeler off the paper feed unit.

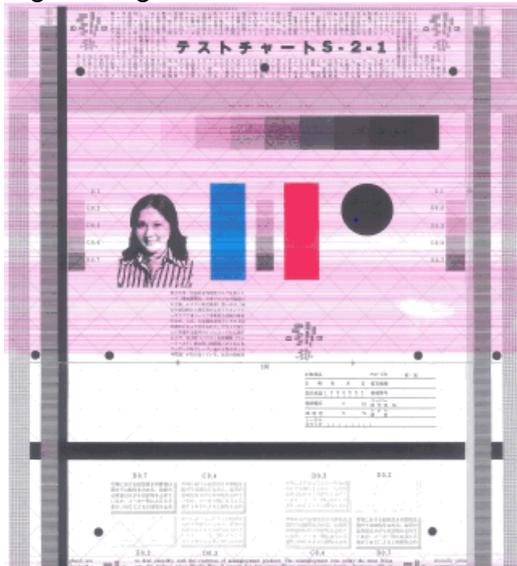
Light images

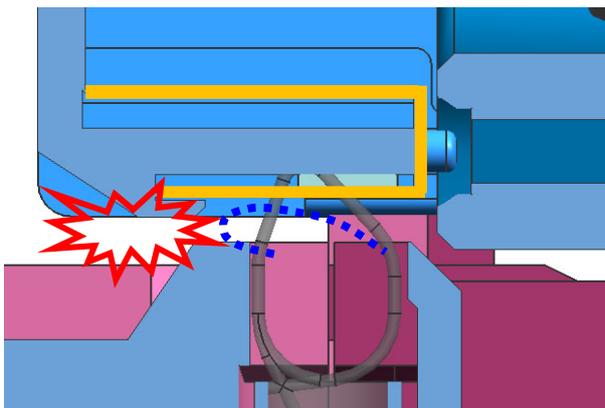
The bias terminal breaks when the PCDU is removed, causing the development bias to be too high or too low.

Machine side spring breaks, damaging connection with PCDU

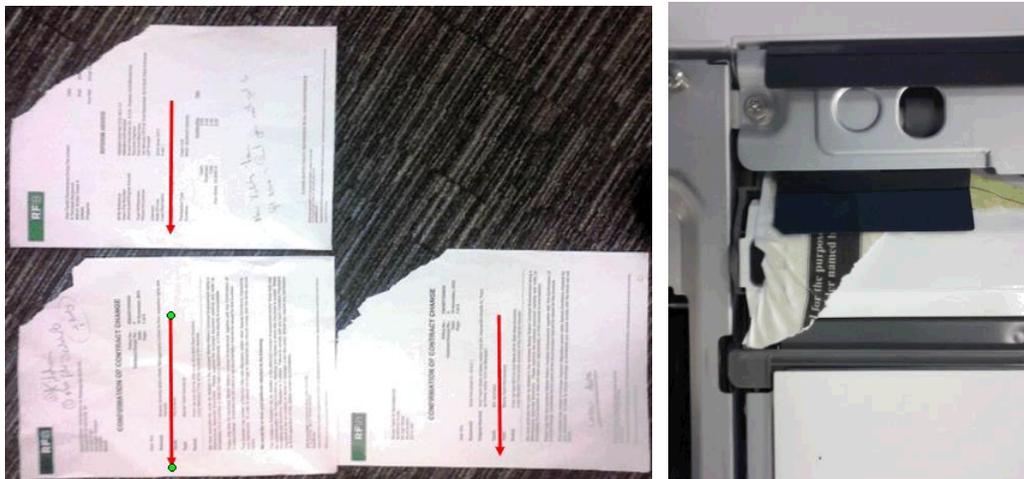
Jam code 66 occurs, the original is torn, or dog ears form in the original when using the SPDF DF3080.

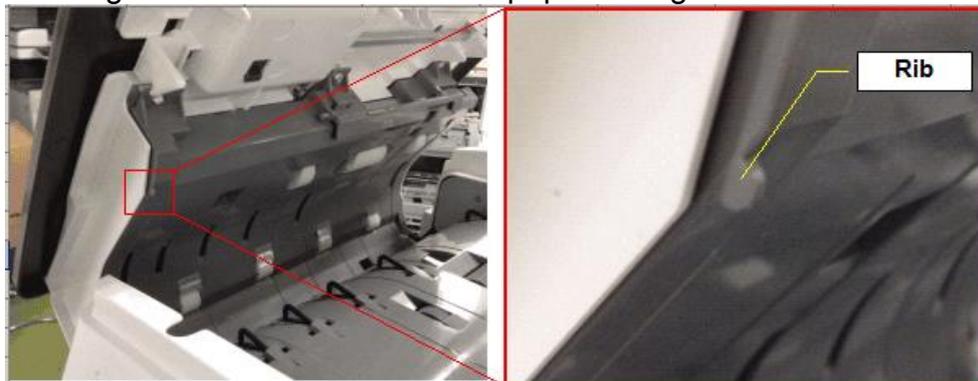
The original contacts the rib on the paper feed guide when it is fed.

Replace the SPDF guide with the modified part. (**See Procedure 2 below**)

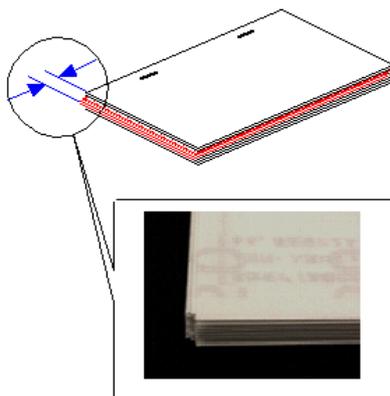
Example 2: Misalignment perpendicular to the paper exit direction

The jogger cannot align the sheets correctly under the following conditions.

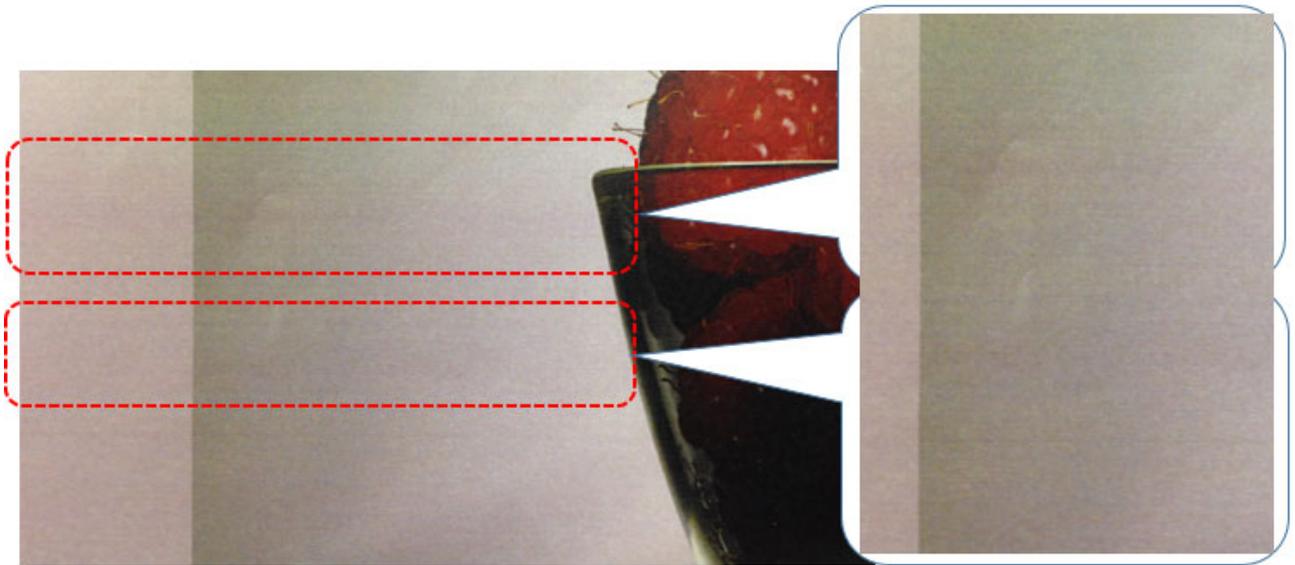
Horizontal banding (rainbow image) may occur at random intervals when printing out at 600dpi or 1200dpi with 4C gradation.

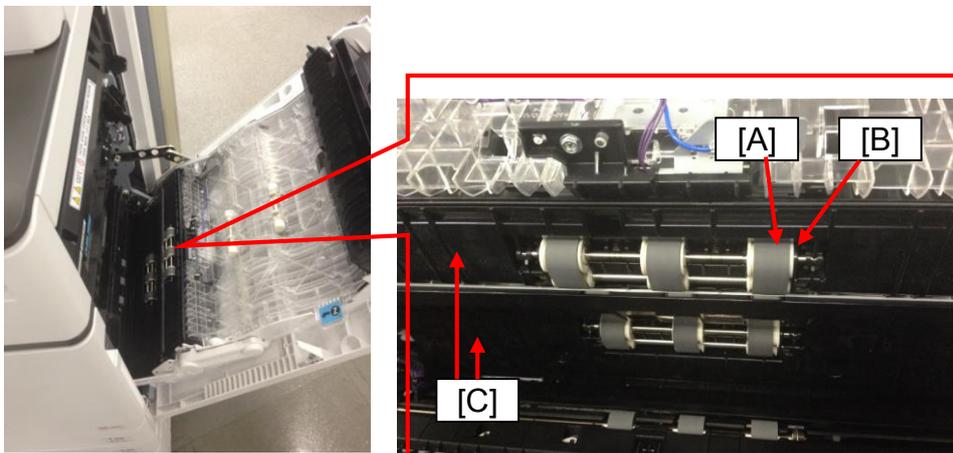
[A]: transport belt, [B]: pulley, [C]: guide plate

NOTE: The center of transport belts and rollers are not properly aligned when the belts go to one side, causing the belt to run over onto the pulley. Then that causes it to contact the holder.

*1: The holder [3] and a spacer are included in guide plate assembly, D1504704 and D1482671. Since it is easier to replace the guide plate as a whole unit, we recommend that you replace the unit during this procedure.

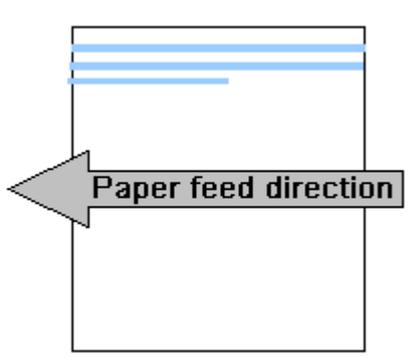
Horizontal black or full-color lines
 Dirty background

1. Replace the Charge Roller Unit.

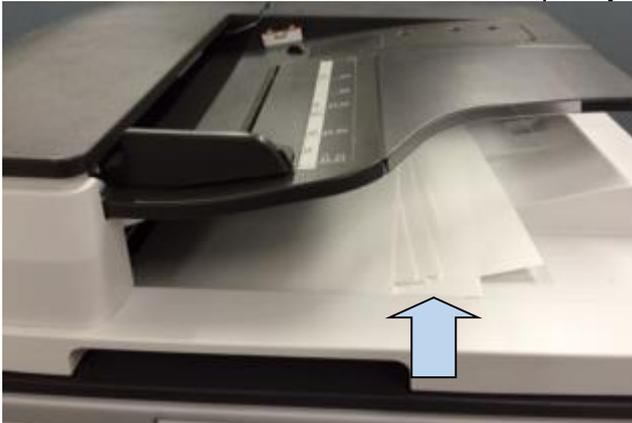
Originals fed from ARDF DF3090 are stacked poorly on the original exit tray.

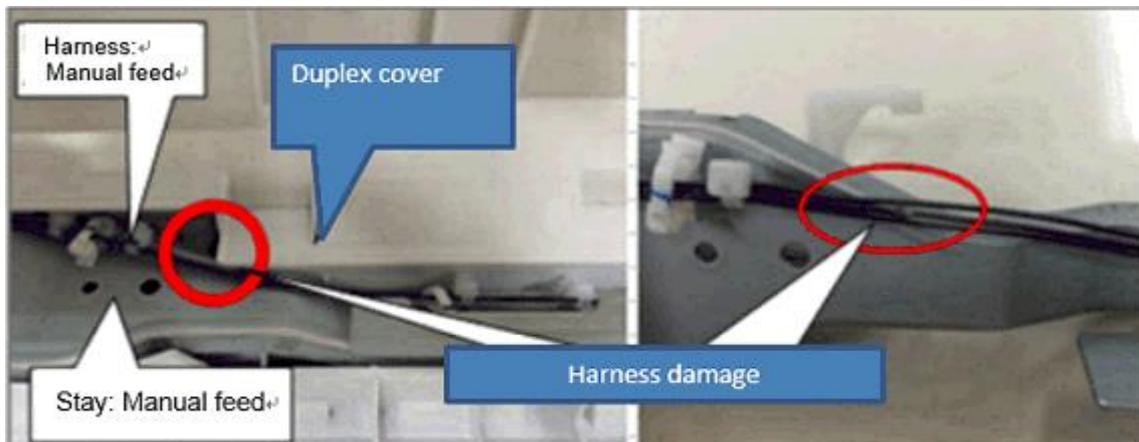
(Harness is pinched between manual feed unit and duplex cover and then damaged).

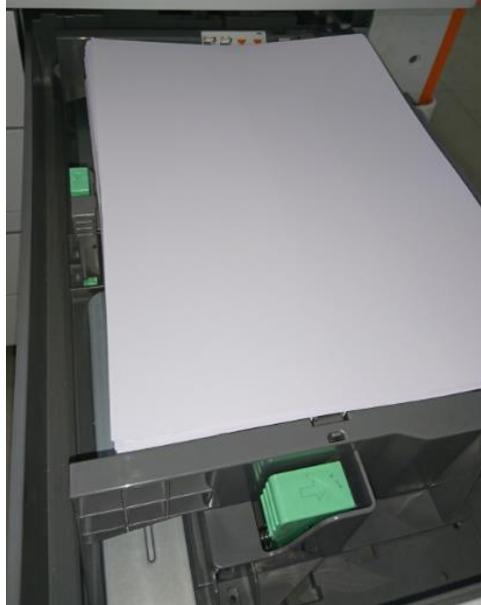
- Paper tray is over-loaded

- Misalignment of paper loading
- Paper End Detection Feeler breaks or falls off
- Paper End Detection Sensor error
- Paper Limit Sensor error
- Tray Lift Motor error

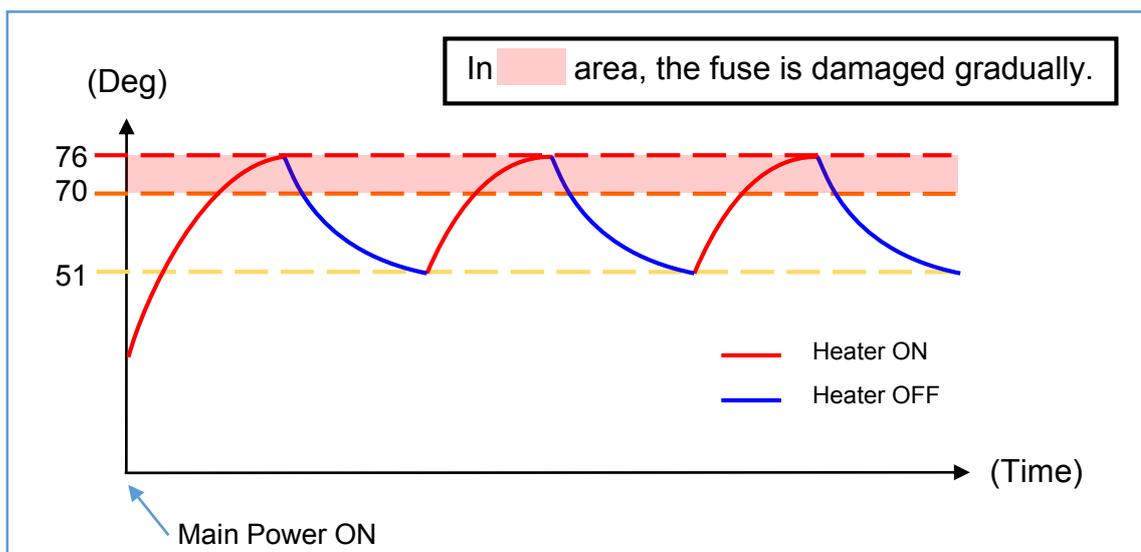
Therefore, the fuse will be damaged gradually within 70-76 degrees and then shut down following a long period of use.
