Model: MET-C1k	Date: 10-Nov-14	No.: RD237002
----------------	-----------------	---------------

Subject: Firmware Release Note: Network Support		Prepared by: E. Hinata	
From: 1st Tech Service Sect., MFP/Printer Tech Service Dept.			
Classification:	<input type="checkbox"/> Troubleshooting	<input type="checkbox"/> Part information	<input type="checkbox"/> Action required
	<input type="checkbox"/> Mechanical	<input type="checkbox"/> Electrical	<input type="checkbox"/> Service manual revision
	<input type="checkbox"/> Paper path	<input type="checkbox"/> Transmit/receive	<input type="checkbox"/> Retrofit information
	<input type="checkbox"/> Product Safety	<input checked="" type="checkbox"/> Other (Firmware)	<input checked="" type="checkbox"/> Tier 2

Model: MET-C1k	Date: 10-Nov-14	No.: RD237004
----------------	-----------------	---------------

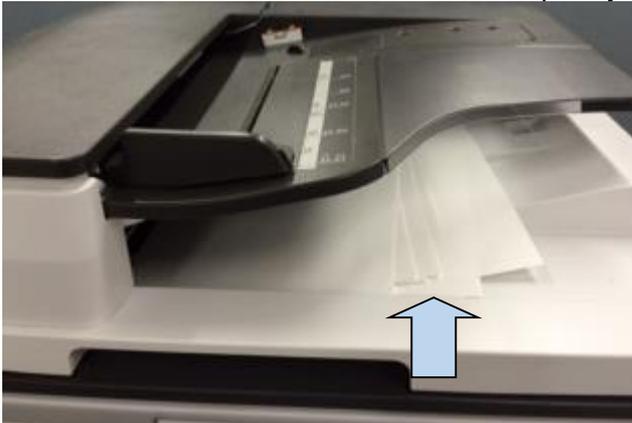
Originals fed from ARDF DF3090 are stacked poorly on the original exit tray.

CAUSE

- Originals are designed to exit slightly faster as soon as scanning completes.
- Original exit tray is not level between the operator and non-operator sides.

1. Added one more paper exit lever.
Note: The photo below shows the existing exit lever [A] and additional exit lever [A].
2. Added an auxiliary tray [B].
3. Modified the gate pawl [C] (to enable addition of a lever).

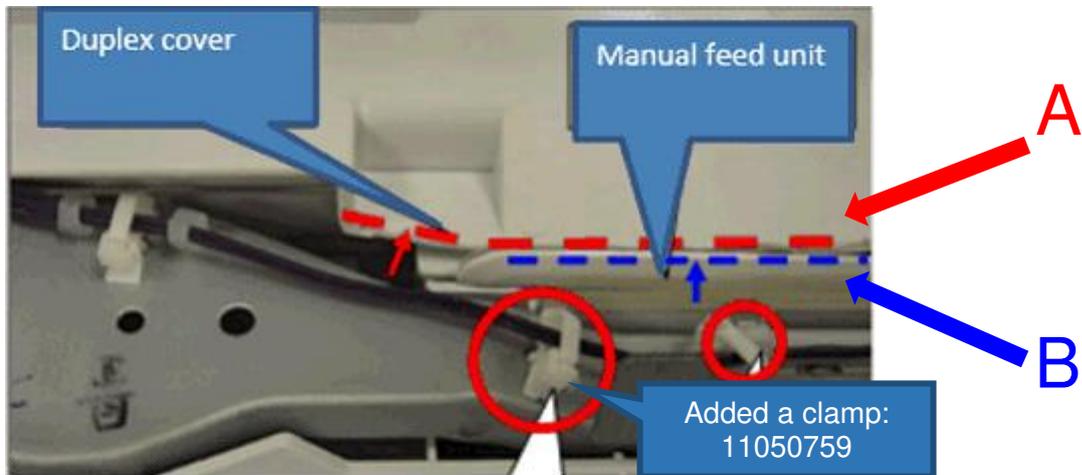
After change

(Edge of the duplex cover [A] was cut, wall of manual feed unit [B] was raised).

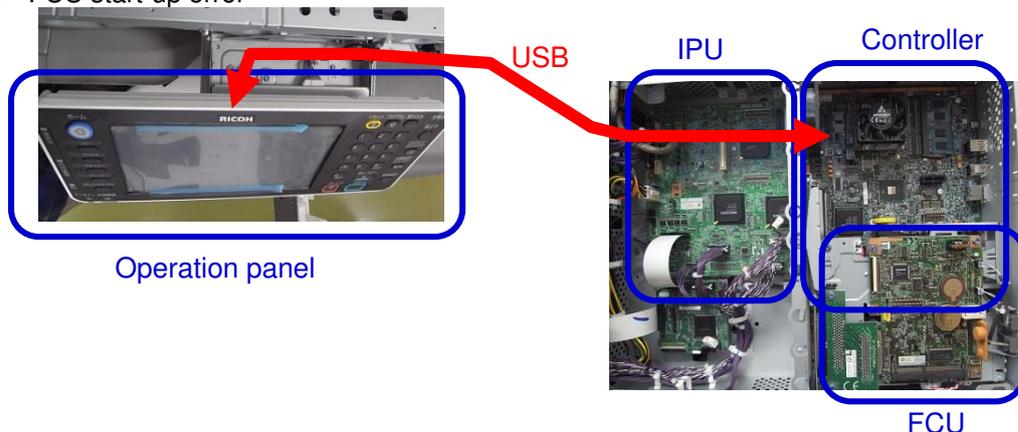
Figure 1: Operation panel, IPU and Controller / FCU

CAUSE

Possible causes include:

1. Failure of USB communication path (USB cable, IPU)
2. Data corruption of CTL onboard Flash memory
3. Poor supply voltage for CTL onboard ASIC
4. Firmware bug related to energy saving system
5. Defective CTL onboard converter
6. Defective CTL onboard resistors
7. FCU start-up error

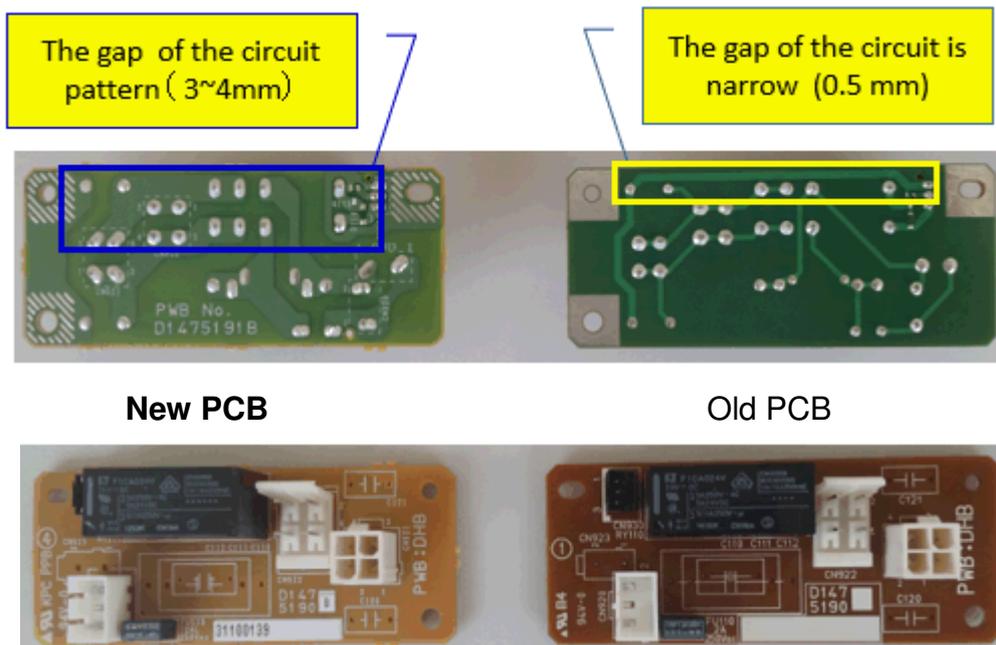
Reason: To further protect against shorts triggered by high voltage, which can happen if the lines on the PCB are too close to one another.

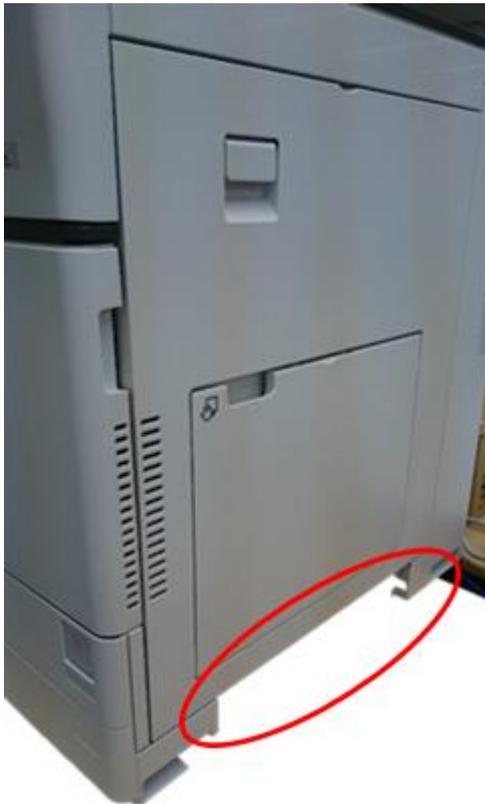
Small insects may get inside the machine from the open space at the bottom right.

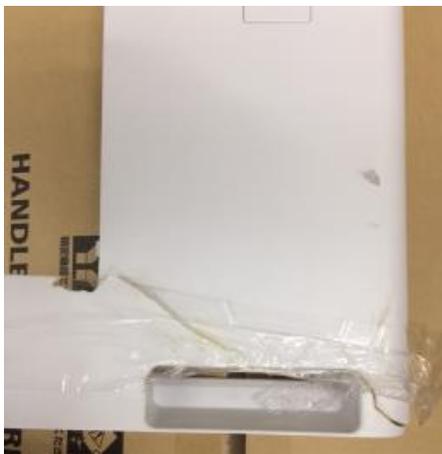
Figure.4 Broken right rear cover

- Make sure to do the following when installing the machine:
Hold the grip of the right rear cover as shown in **Fig. 2 (CORRECT)**.
Insert your fingers **all the way up and inside the grip**.
- If you do not, the right cover will break, as shown in Fig. 4.

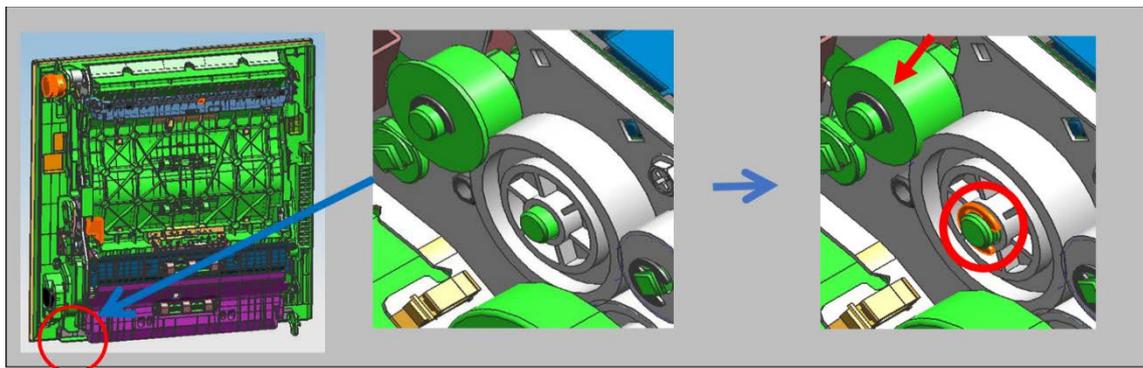
Change 4: There are no protruding parts to hold the gear. An e-ring added to stop the gear in position, and a groove added to the shaft for the e-ring.

Old P/N <Group B>	New P/N	Description	Int	Q'ty	Note
07200040E	07200040E	RETAINING RING - M4	-	3->4	D
D2414631	D0BQ4631	SIDE PLATE:REAR:DUPLX:PEEN	X/X	1	D
D2414644	D0BQ4644	GEAR:MECHANICAL ROLLER CLUTCH	X/X	1	D
