Model: MET-C2ab		Date: 17-Apr-17	No.: RD0AD002
Subject: HE Model Installation Procedure		Prepared by: E.Hinata	
From: 1st Tech Service Sect., MFP/P Tech Service Dept.			
Classification:	<input type="checkbox"/> Troubleshooting <input type="checkbox"/> Part information <input type="checkbox"/> Action required <input type="checkbox"/> Mechanical <input type="checkbox"/> Electrical <input type="checkbox"/> Service manual revision <input type="checkbox"/> Paper path <input type="checkbox"/> Transmit/receive <input type="checkbox"/> Retrofit information <input type="checkbox"/> Product Safety <input checked="" type="checkbox"/> Other (New model) <input type="checkbox"/> Tier 2

Model: MET-C2.1ab	Date: 10-Feb-17	No.: RD0AD001f
-------------------	-----------------	----------------

Subject: New model release information: MP C3004ex/3504ex/4504ex/5504ex/6004ex, MP C2004ex/2504ex		Prepared by: A.Shigeta	
From: 1st Tech Service Sect., MFP/P Tech Service Dept.			
Classification:	<input type="checkbox"/> Troubleshooting <input type="checkbox"/> Mechanical <input type="checkbox"/> Paper path <input type="checkbox"/> Product Safety	<input checked="" type="checkbox"/> Part information <input typ

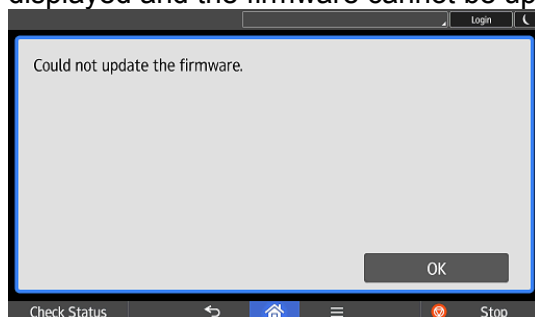
1. When users try to update the firmware from the Application Site, the following message is displayed and the firmware cannot be updated:

In that Network Support firmware, we found that the device encounter fax document disappears. So, we decided to unpublish the package firmware. However, the firmware update structure on the Application Site, Streamline NX v3, Device Manager NX Pro/Enterprise and CE menu uses the same method of ARFU, so we were forced to unpublish the package firmware worldwide, which caused the problem to surface.

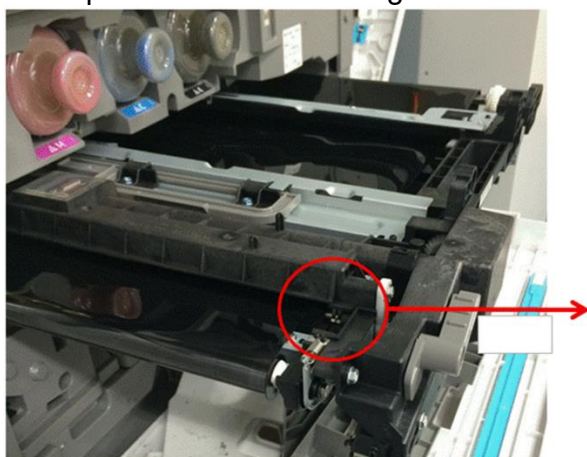
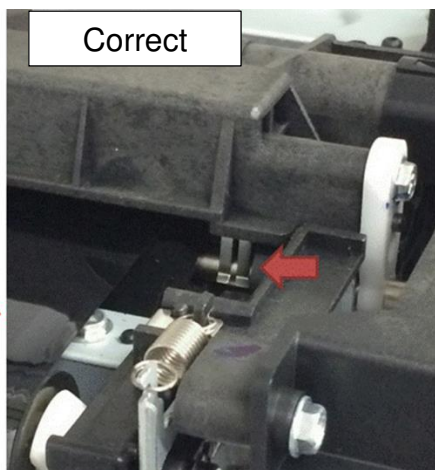
A grounding failure occurs with the belt cleaning unit in the ITB unit or paper transfer roller unit, either of which can generate electrical noise.

1. Check the grounding of the belt cleaning unit on ITB unit.
2. Replace the belt cleaning unit.

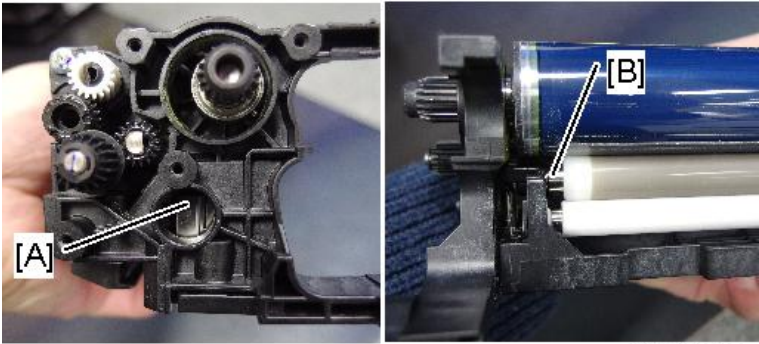
SC No.	Type	Error Name/Error Condition/Major Cause/Solution
<p>Check if the SC occurs by turning the power OFF then ON. If the SC occurs again, do the following steps. Check if the SC reoccurs by cycling the power after each step.</p> <ol style="list-style-type: none"> Check the PCU for the following points and recover or replace the PCU if there are any defects. <ul style="list-style-type: none"> Checking contaminants on the Charge Roller terminal [A] Checking damage or deformation of the Charge Roller terminal [A] Checking continuity to the Charge Roller terminal core bar [B]

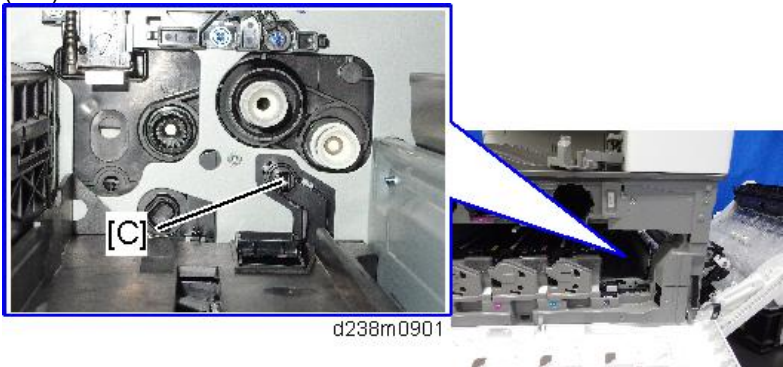
<p>d238m0900</p>		
<ol style="list-style-type: none"> Check if all connectors related to PCDU are connected securely. Replace the connectors if they are disconnected, or loose. Recover or replace the parts of the main machine if there are any defects after checking the following points. <ul style="list-style-type: none"> Checking contaminants on the charged power supplying plate [C] Checking damage or deformation of the charged power supplying plate [C] Checking continuity between the Charge Roller terminal core bar and the HVP (CB)

<p>d238m0901</p>		
<ol style="list-style-type: none"> Replace the HVP (CB). If SC occurs again, replace the BCU. If SC occurs again, replace the IOB

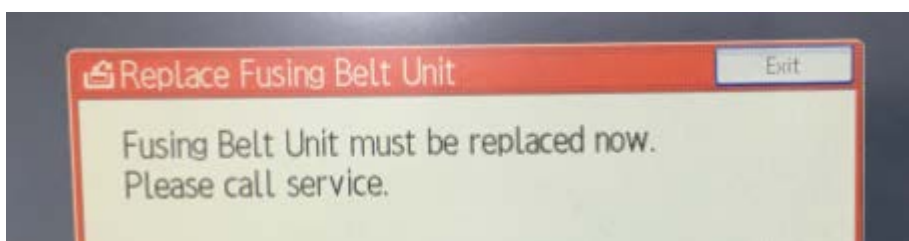
The message "Fusing Belt unit must be replaced now." is displayed before the target yield.

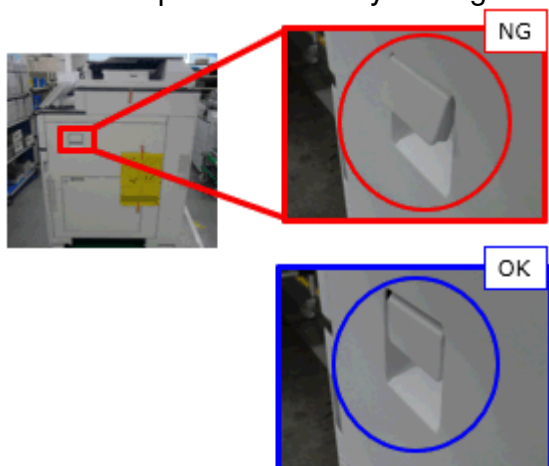
Lubricant contacts the shaft for the grip of the duplex unit, causing a chemical crack. As a result, the hook for the grip breaks and the spring detaches.

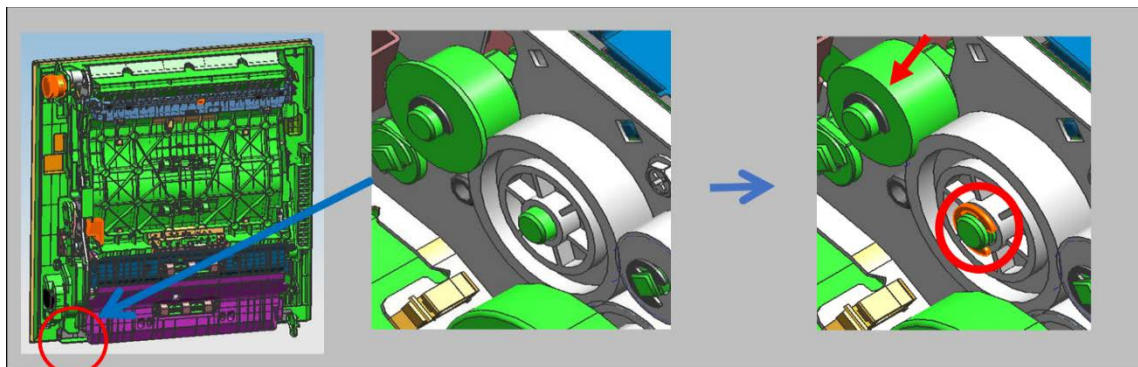
Change 4: There are no protruding parts to hold the gear. An e-ring added to stop the gear in position, and a groove added to the shaft for the e-ring.

Old P/N <Group B>	New P/N	Description	Int	Q'ty	Note
07200040E	07200040E	RETAINING RING - M4	-	3->4	D
D2414631	D0BQ4631	SIDE PLATE:REAR:DUPLEX:PEEN	X/X	1	D
D2414644	D0BQ4644	GEAR:MECHANICAL ROLLER CLUTCH	X/X	1	D
