Model: MET-C2.1cde	Date: 10-Feb-17	No.: RD0AF001f
--------------------	-----------------	----------------

Subject: New model release information: MP C3004ex/3504ex/4504ex/5504ex/6004ex, MP C2004ex/2504ex		Prepared by: A.Shigeta	
From: 1st Tech Service Sect., MFP/P Tech Service Dept.			
Classification:	<input type="checkbox"/> Troubleshooting <input type="checkbox"/> Mechanical <input type="checkbox"/> Paper path <input type="checkbox"/> Product Safety	<input checked="" type="checkbox"/> Part information <input type="checkbox"/> Electrical <input type="checkbox"/> Transmit/receive <input type="checkbox"/> Other ()	<input type="checkbox"/> Action required <input checked="" type="checkbox"/> Service manual revision <input type="checkbox"/> Retrofit information <input type="checkbox"/> Tier 2 <input type="checkbox"/> Tier 0.5

With the release of the new model for successor of MP C3004/3504/4504/5504/6004 and MP C2004/2504, this RTB was released to announce differences between the predecessor models and the new models.

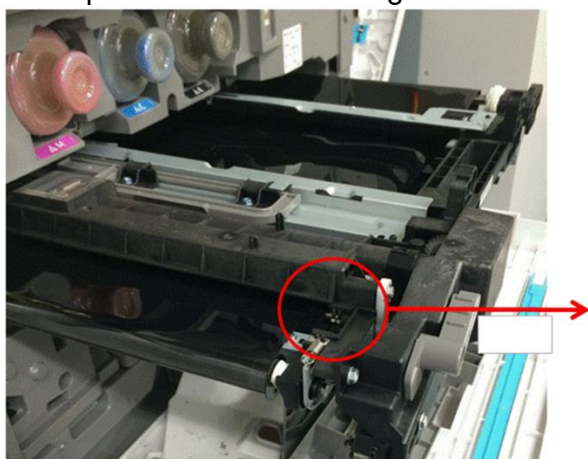
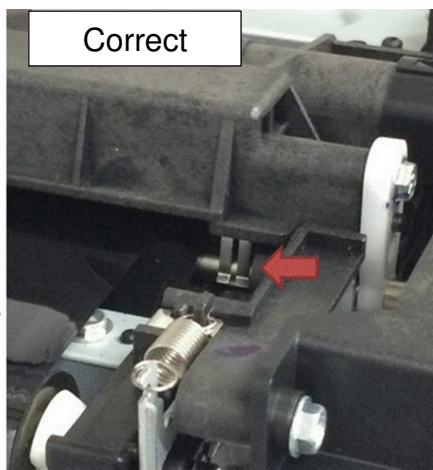
A grounding failure occurs with the belt cleaning unit in the ITB unit or paper transfer roller unit, either of which can generate electrical noise.

1. Check the grounding of the belt cleaning unit on ITB unit.
2. Replace the belt cleaning unit.

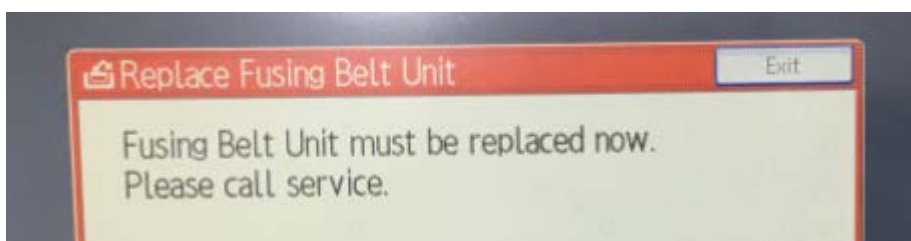
The message "Fusing Belt unit must be replaced now." is displayed before the target yield.

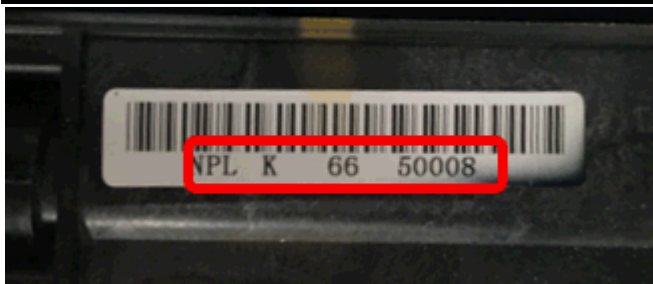
Model: Metis-C2abyz/C2.1 abyz		Date: 29-Jan-19	No.: RD239093
1 Subject: The toner Hopper are broken. (Early toner end, White line, Noise occur)		Prepared by: T.Kiyohara	
From: MFP section, OPOS Product Quality managemt Dept.			
Classification:	<input checked="" type="checkbox"/> Troubleshooting	<input type="checkbox"/> Part information	<input type="checkbox"/> Action required
	<input type="checkbox"/> Mechanical	<input type="checkbox"/> Electrical	<input type="checkbox"/> Service manual revision
	<input type="checkbox"/> Paper path	<input type="checkbox"/> Transmit/receive	<input type="checkbox"/> Retrofit information
	<input type="checkbox"/> Product Safety	<input type="checkbox"/> Other ()	<input type="checkbox"/> Tier 2

Replace the hopper and development unit at the same time.

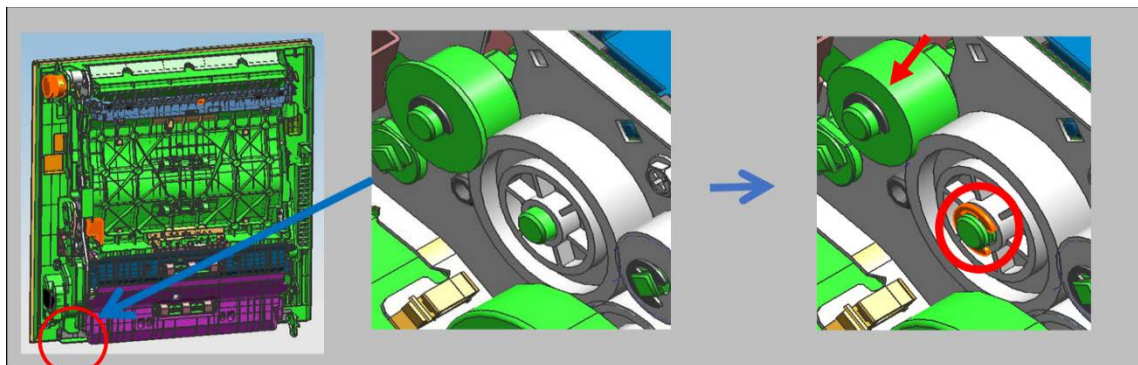
Change 4: There are no protruding parts to hold the gear. An e-ring added to stop the gear in position, and a groove added to the shaft for the e-ring.

Old P/N <Group B>	New P/N	Description	Int	Q'ty	Note
07200040E	07200040E	RETAINING RING - M4	-	3->4	D
D2414631	D0BQ4631	SIDE PLATE:REAR:DUPLEX:PEEN	X/X	1	D
D2414644	D0BQ4644	GEAR:MECHANICAL ROLLER CLUTCH	X/X	1	D
