Model: MET-C2.1yz	Date: 10-Feb-17	No.: RD0AH001f
-------------------	-----------------	----------------

Subject: New model release information: MP C3004ex/3504ex/4504ex/5504ex/6004ex, MP C2004ex/2504ex		Prepared by: A.Shigeta	
From: 1st Tech Service Sect., MFP/P Tech Service Dept.			
Classification:	<input type="checkbox"/> Troubleshooting	<input checked="" type="checkbox"/> Part information	<input type="checkbox"/> Action required
	<input type="checkbox"/> Mechanical	<input type="checkbox"/> Electrical	<input checked="" type="checkbox"/> Service manual revision
	<input type="checkbox"/> Paper path	<input type="checkbox"/> Transmit/receive	<input type="checkbox"/> Retrofit information
	<input type="checkbox"/> Product Safety	<input type="checkbox"/> Other ( )	<input type="checkbox"/> Tier 2 <input type="checkbox"/> Tier 0.5

With the release of the new model for successor of MP C3004/3504/4504/5504/6004 and MP C2004/2504, this RTB was released to announce differences between the predecessor models and the new models.

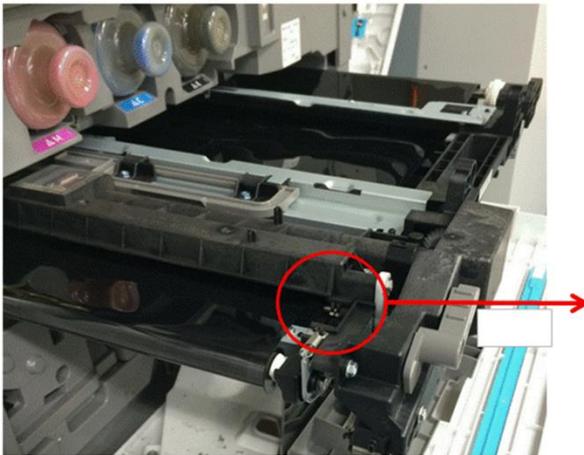
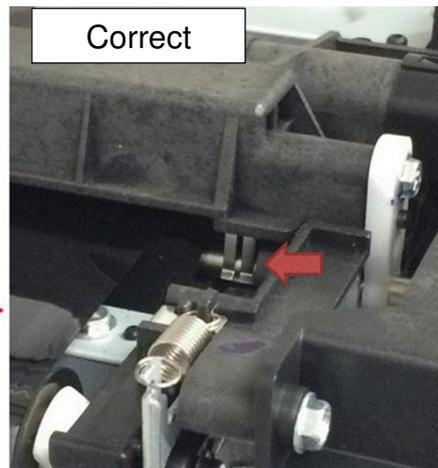
A grounding failure occurs with the belt cleaning unit in the ITB unit or paper transfer roller unit, either of which can generate electrical noise.

1. Check the grounding of the belt cleaning unit on ITB unit.
2. Replace the belt cleaning unit.

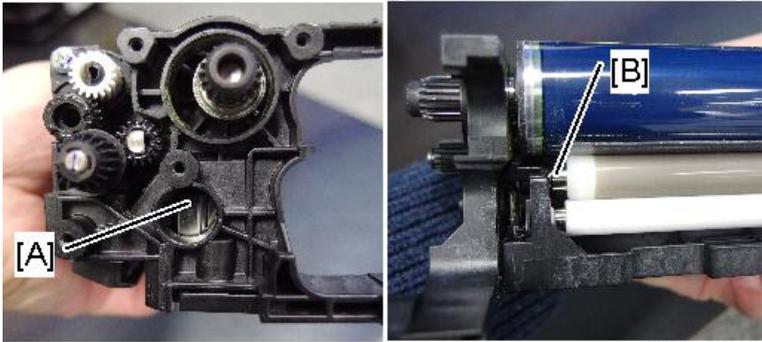
SC No.	Type	Error Name/Error Condition/Major Cause/Solution
<p>Check if the SC occurs by turning the power OFF then ON. If the SC occurs again, do the following steps. Check if the SC reoccurs by cycling the power after each step.</p>		
<p>1. Check the PCU for the following points and recover or replace the PCU if there are any defects.</p>		
<ul style="list-style-type: none"> <li>▪ Checking contaminants on the Charge Roller terminal [A]</li> <li>▪ Checking damage or deformation of the Charge Roller terminal [A]</li> <li>▪ Checking continuity to the Charge Roller terminal core bar [B]</li> </ul>

<p>d238m0900</p>		
<p>2. Check if all connectors related to PCDU are connected securely. Replace the connectors if they are disconnected, or loose.</p>		
<p>3. Recover or replace the parts of the main machine if there are any defects after checking the following points.</p>		
<ul style="list-style-type: none"> <li>▪ Checking contaminants on the charged power supplying plate [C]</li> <li>▪ Checking damage or deformation of the charged power supplying plate [C]</li> <li>▪ Checking continuity between the Charge Roller terminal core bar and the HVP (CB)</li> </ul>

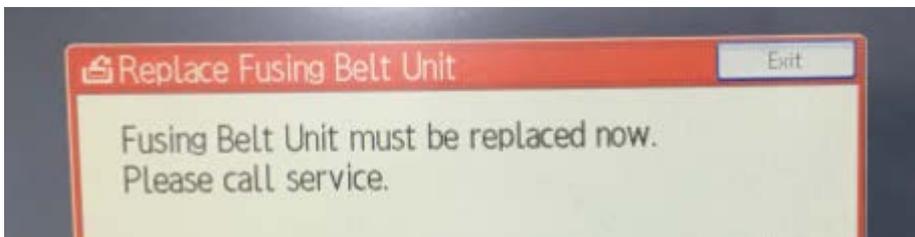
The message "Fusing Belt unit must be replaced now." is displayed before the target yield.

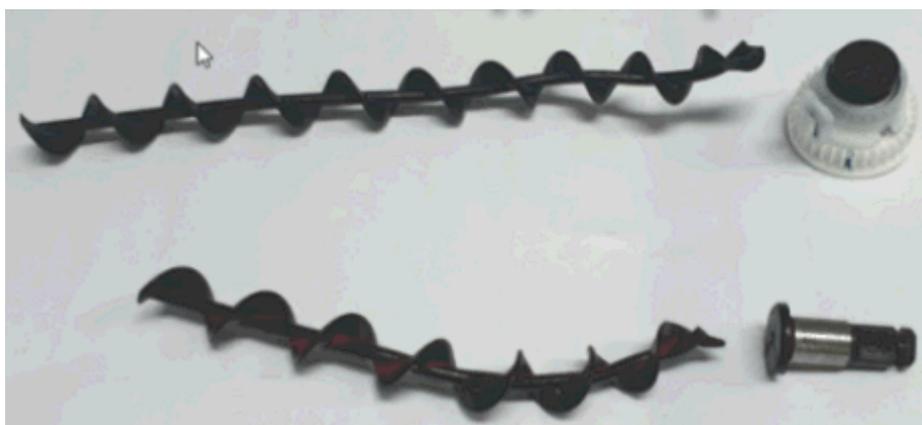
The toner hoppers break, triggering early Toner End, white lines, and/or noise.

Replace the hopper and development unit at the same time.

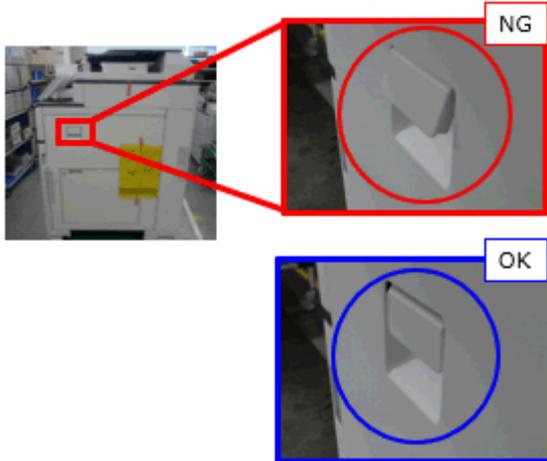
Lubricant contacts the shaft for the grip of the duplex unit, causing a chemical crack. As a result, the hook for the grip breaks and the spring detaches.

Replace the duplex unit grip.

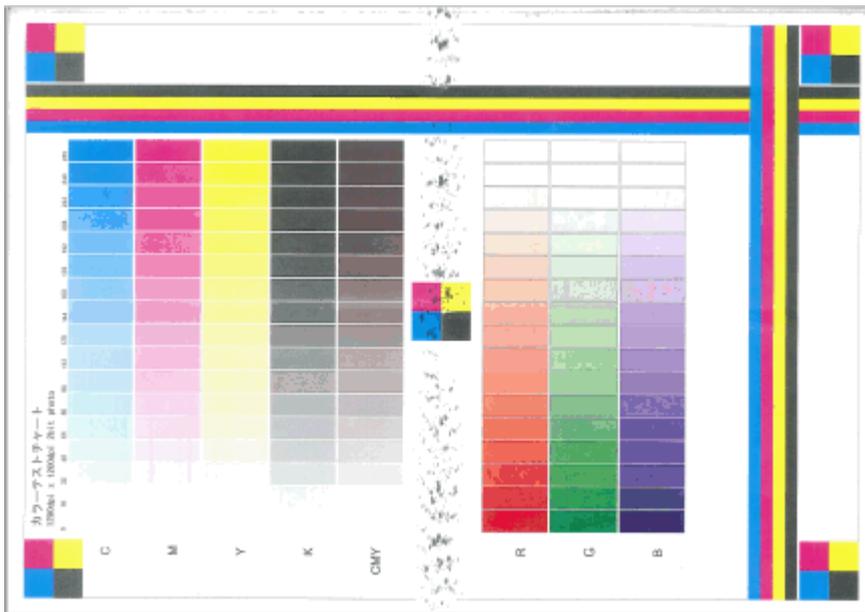
Developer drops onto the center area of the image when printing onto thick paper in half-speed mode.

The upper cover of the development unit deforms, and combined with the compressive force of the filter, this causes the gap between the cover and development roller to narrow. As a result, when making continuous prints in half-speed mode, the developer in the central area of the unit cannot be fully retrieved (the amount scooped in this mode is larger), and then leaks out.

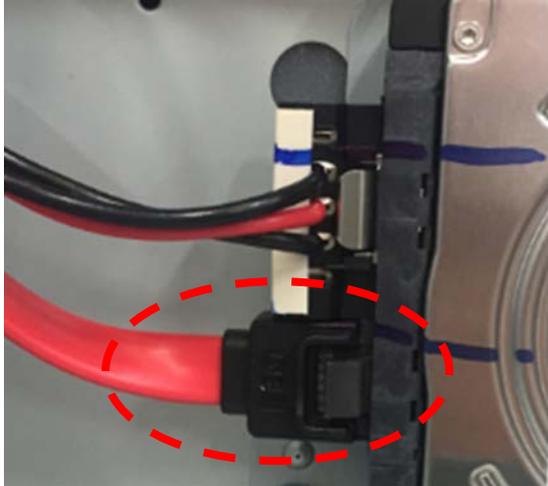
HDD cable provided from the vendor (D2415250:CABLE:HDD:SATA:210) is defective.

**Occurrence ratio:** 0.08% ( =4/5,808 machines)

1. Replace the HDD cable when SC8XX occurs.
2. If the symptom still occurs, replace the HDD or other parts (see Service Manual for procedure).
