Model: MET-C2ab	Date: 13-May-16	No.: RD239006
------------------------	-----------------	---------------

Subject: Firmware Release Note: PowerSaving Sys		Prepared by: M. Kumagai	
From: 1st Tech Service Sect., MFP/Printer Tech Service Dept.			
Classification:	<input type="checkbox"/> Troubleshooting <input type="checkbox"/> Mechanical <input type="checkbox"/> Paper path <input type="checkbox"/> Product Safety	<input type="checkbox"/> Part information <input type="checkbox"/> Electrical <input type="checkbox"/> Transmit/receive <input checked="" type="checkbox"/> Other (Firmware)	<input type="checkbox"/> Action required <input type="checkbox"/> Service manual revision <input type="checkbox"/> Retrofit information <input checked="" type="checkbox"/> Tier 2

This RTB has been issued to announce the firmware release information for the **PowerSaving Sys.**

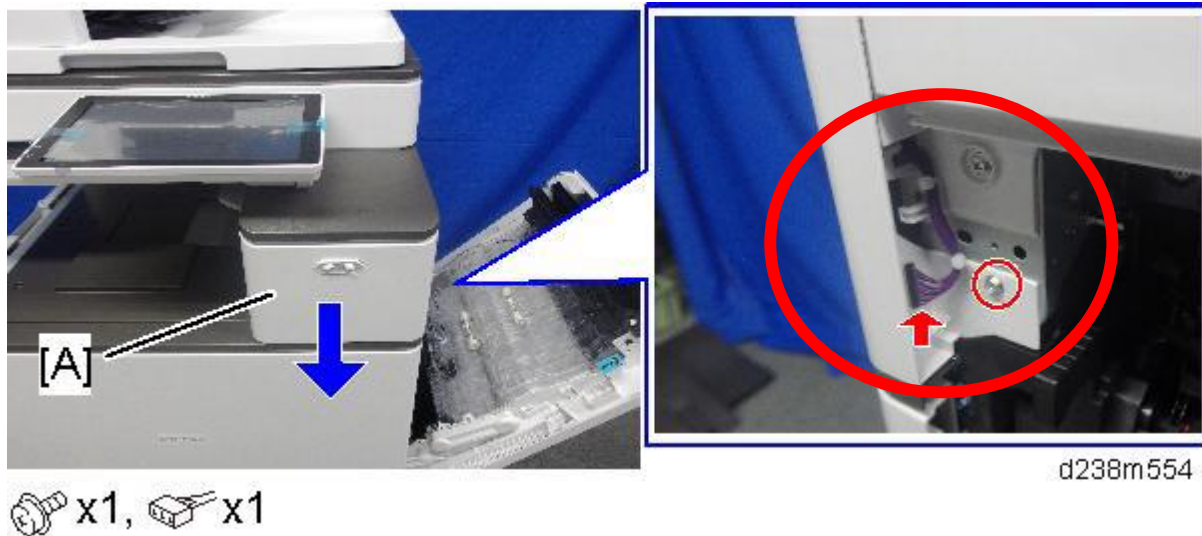
The connector for the proximity sensor comes loose.

Correctly reconnect the connector for the proximity sensor.

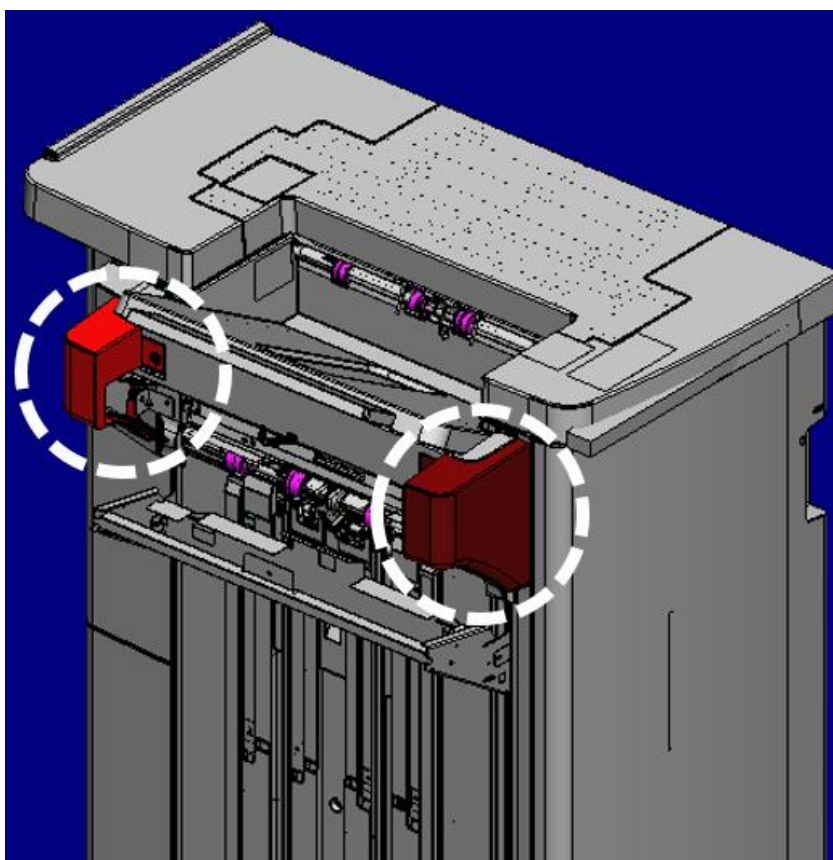
Do NOT take hold of the guide cover highlighted in RED when installing the finisher (SR3230/SR3240).

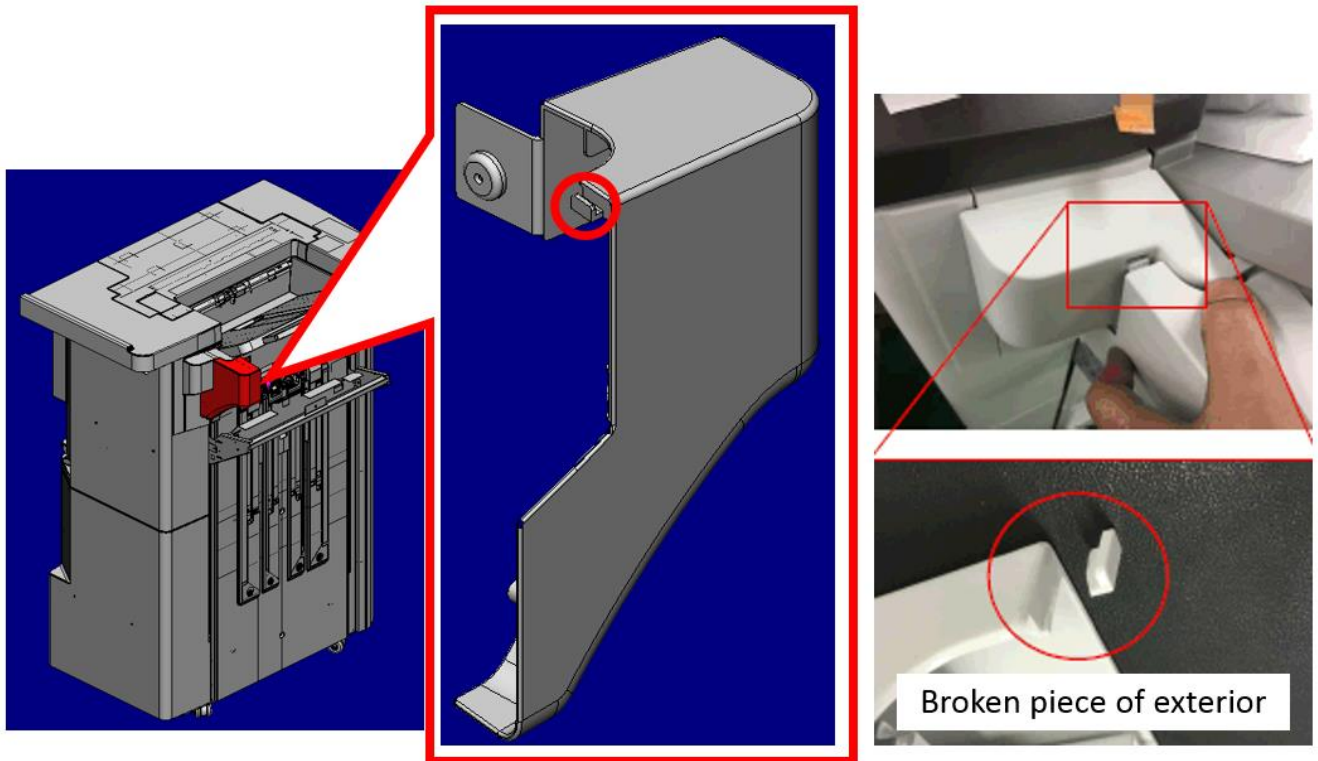
Fig.1

The broken piece drops into the clearance between the paper guide (GUIDE: PAPER: REAR: ASS'Y) and the exterior cover (COVER: PAPER: GUIDE) circled in YELLOW. (Fig.2)

This prevents the paper guide from returning to the home position.

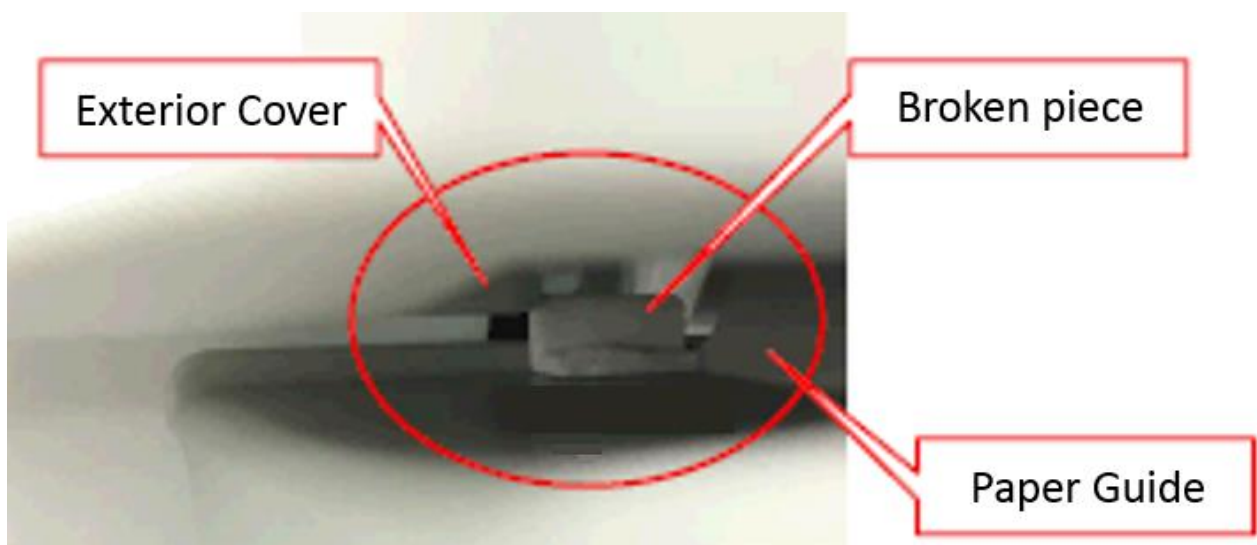
Check the clearance between the paper guide (GUIDE: PAPER: REAR: ASS'Y) and the exterior cover (COVER: PAPER: GUIDE) to see if there is a broken piece.

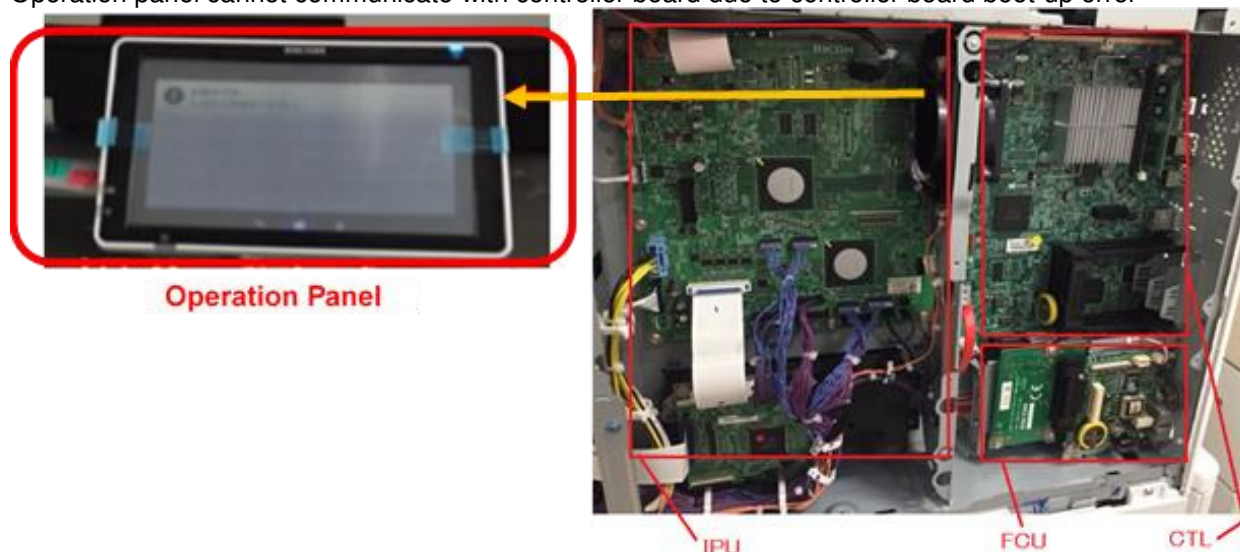
Figure 1: Operation panel, IPU and Controller / FCU

Possible causes of SC672-XX include:

- USB communication path failure (USB cable, IPU)
- Controller board boot up error and/or operation panel boot up error due to abnormal break in operations of controller board.

Possible causes of operation panel cannot light include:

- USB communication path failure (USB cable, IPU)
- Operation panel cannot communicate with controller board due to controller board boot-up error

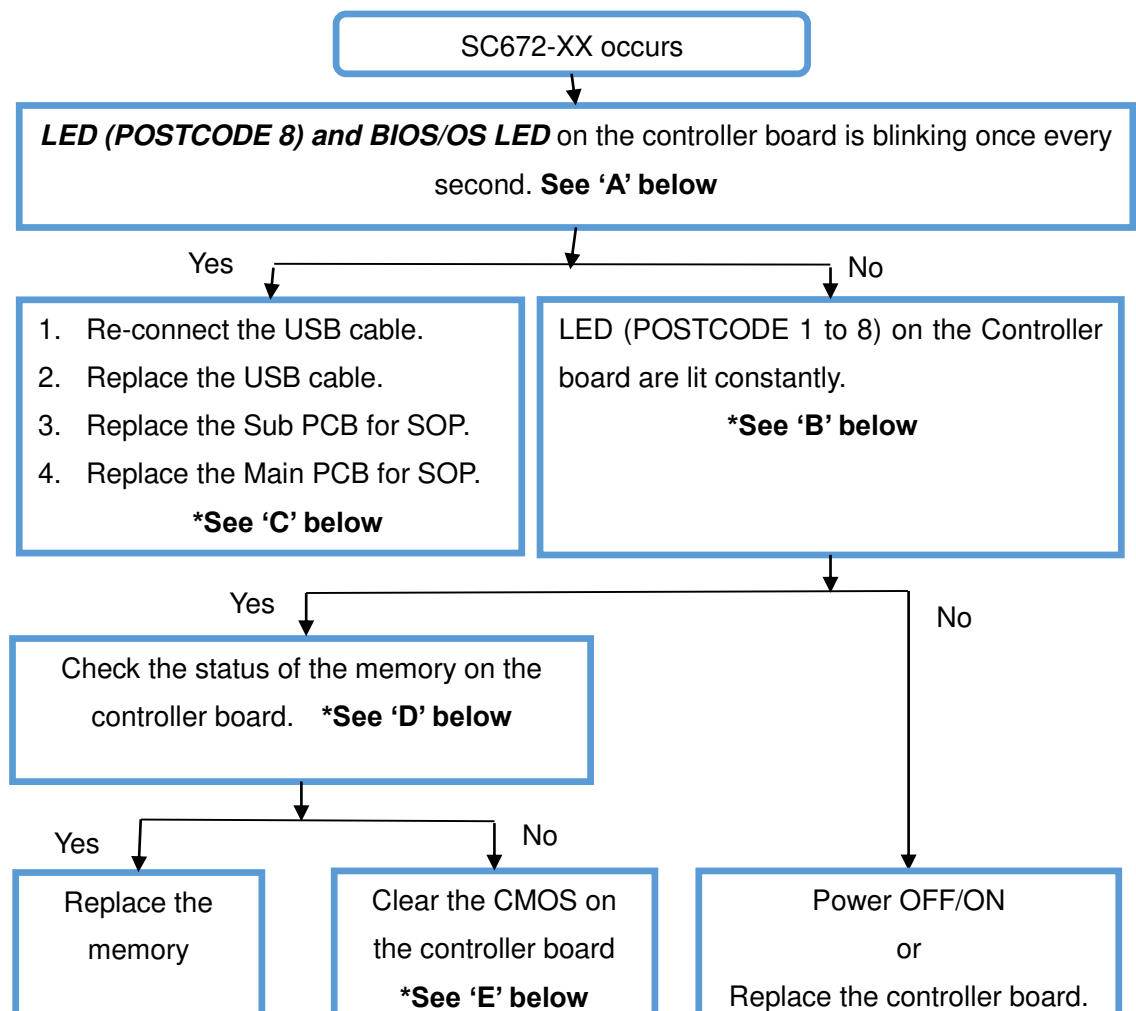
Flowchart to determine parts to replace when SC672-XX occurs

- If SC819 (cache error) appears in the SC history, replace the controller board.
- If SC991 (SCS: scs time count level c') appears in the SC history, replace the controller board and USB cable.

1. Turn the machine power OFF/ON.
2. Do the action in the **flowchart below** to determine the cause and best course of action when SC672-XX occurs.

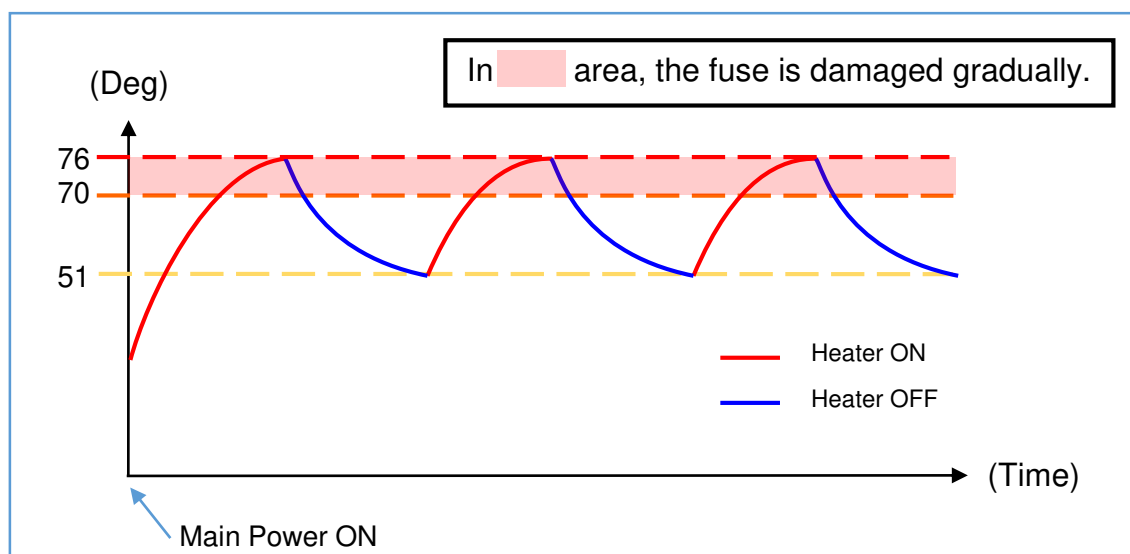
However, the fuse may shut down even if the temperature does not reach 98 degrees. This is because the fuse is damaged very gradually at temperatures of over 70 degrees.

Therefore, the fuse will be damaged gradually within 70-76 degrees and then shut down following a long period of use.

Replace the PCU heater with the modified item below.

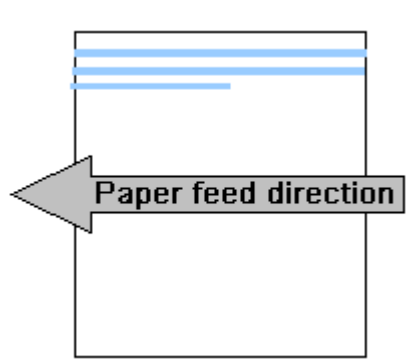
Horizontal black or full-color lines
Dirty background
