Model: MET-C2cde	Date: 13-May-16	No.: RD242006
-------------------------	-----------------	---------------

Subject: Firmware Release Note: PowerSaving Sys		Prepared by: M. Kumagai	
From: 1st Tech Service Sect., MFP/Printer Tech Service Dept.			
Classification:	<input type="checkbox"/> Troubleshooting	<input type="checkbox"/> Part information	<input type="checkbox"/> Action required
	<input type="checkbox"/> Mechanical	<input type="checkbox"/> Electrical	<input type="checkbox"/> Service manual revision
	<input type="checkbox"/> Paper path	<input type="checkbox"/> Transmit/receive	<input type="checkbox"/> Retrofit information
	<input type="checkbox"/> Product Safety	<input checked="" type="checkbox"/> Other (Firmware)	<input checked="" type="checkbox"/> Tier 2

This RTB has been issued to announce the firmware release information for the **PowerSaving Sys.**

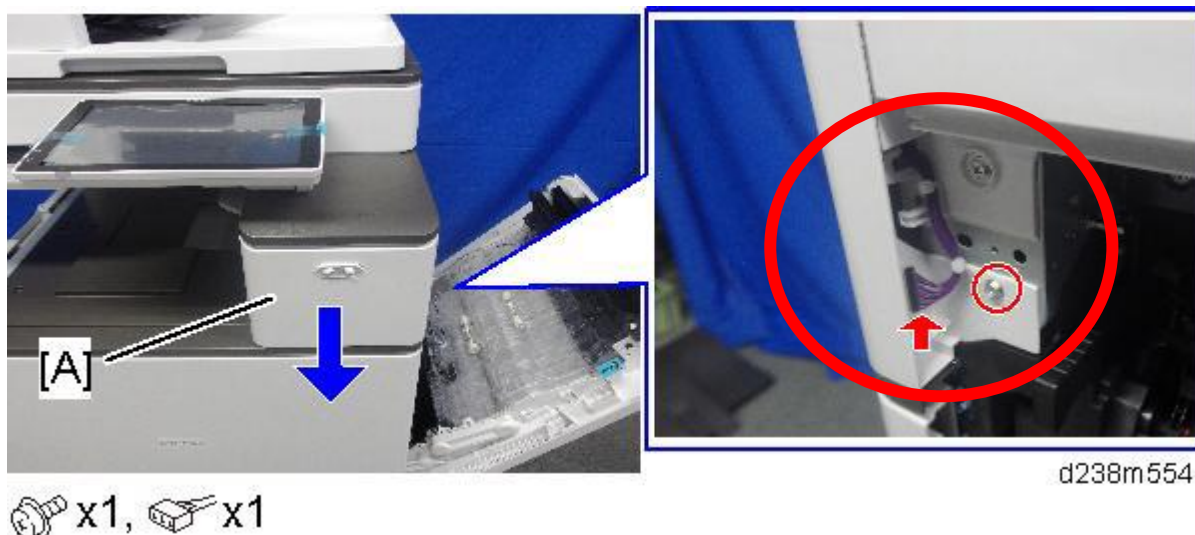
The connector for the proximity sensor comes loose.

Correctly reconnect the connector for the proximity sensor.

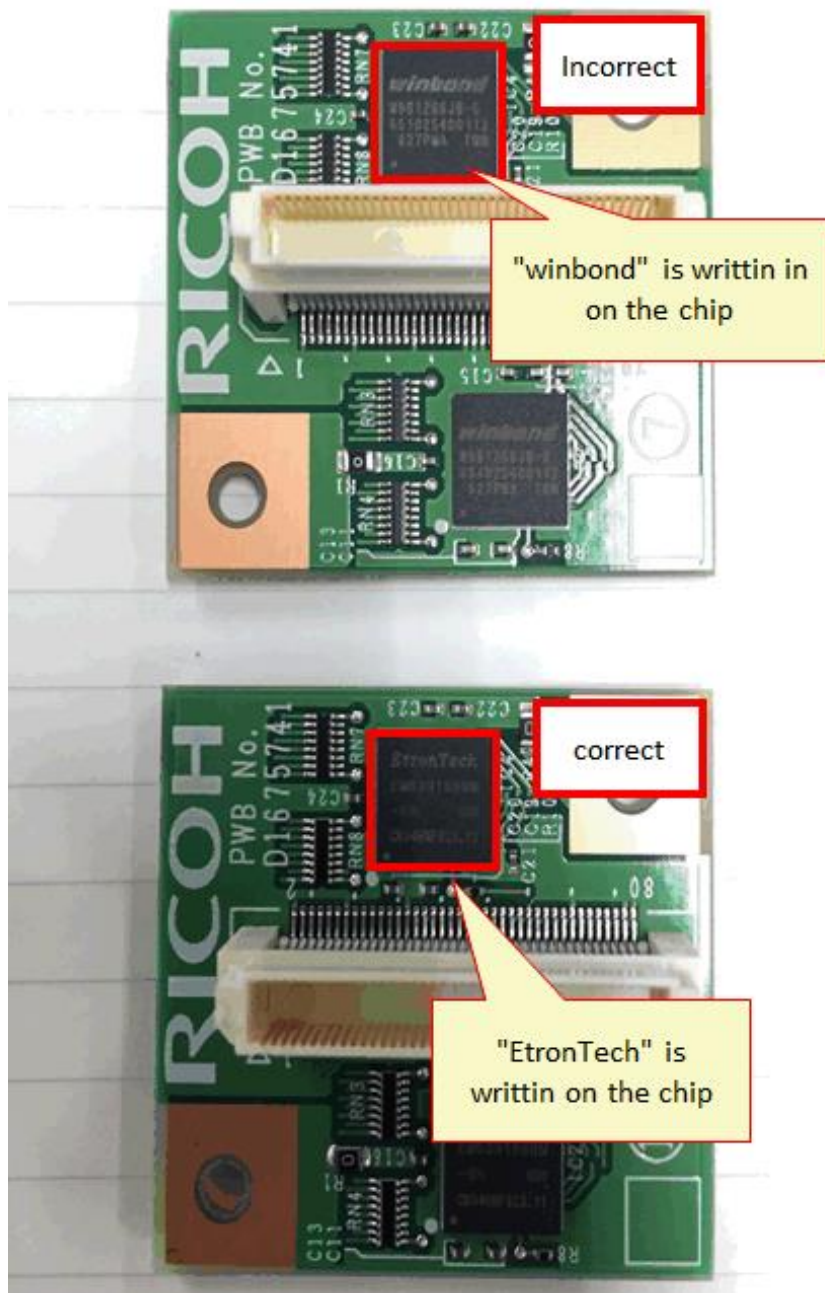
- Incorrect (affected) is the chip with "winbond" written on it.
- Correct (not affected) is the chip with "EtronTech" written on it.

Replace the Fax Memory Unit with the modified one.

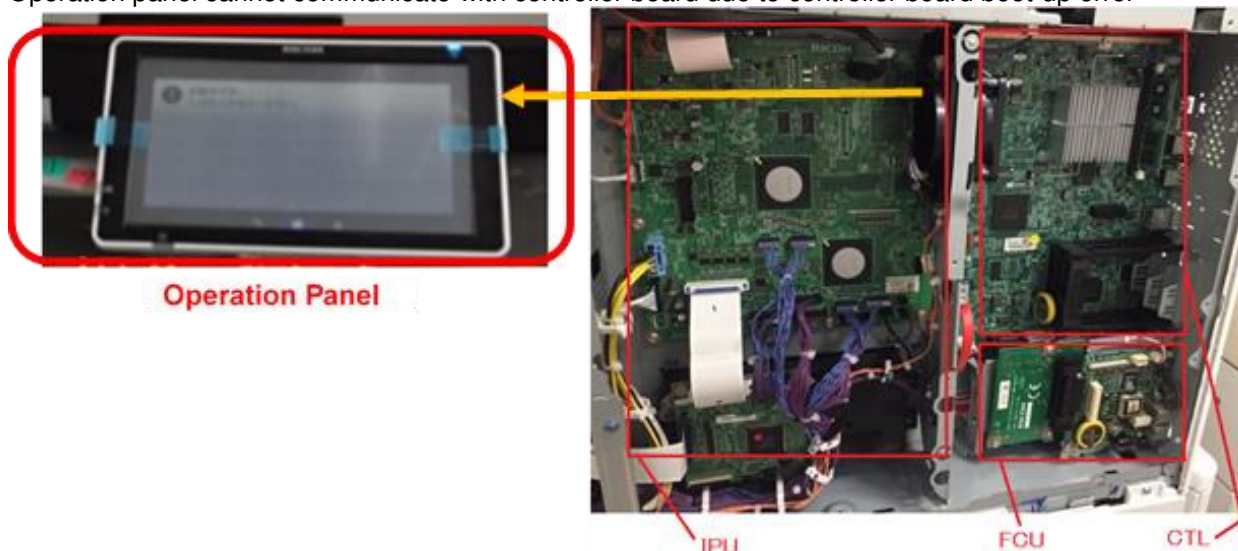
Figure 1: Operation panel, IPU and Controller / FCU

Possible causes of SC672-XX include:

- USB communication path failure (USB cable, IPU)
- Controller board boot up error and/or operation panel boot up error due to abnormal break in operations of controller board.

Possible causes of operation panel cannot light include:

- USB communication path failure (USB cable, IPU)
- Operation panel cannot communicate with controller board due to controller board boot-up error

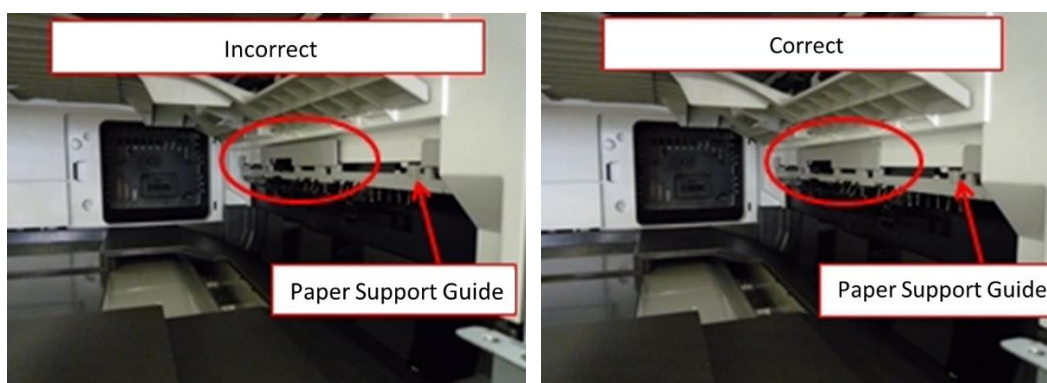
The paper support guide was incorrectly installed.

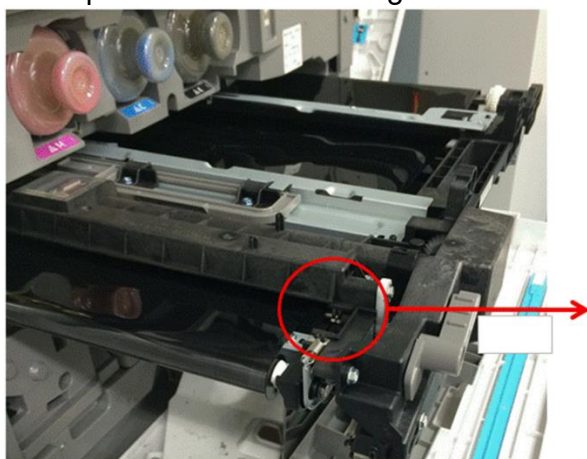
A grounding failure occurs with the belt cleaning unit in the ITB unit or paper transfer roller unit, either of which can generate electrical noise.

1. Check the grounding of the belt cleaning unit on ITB unit.
2. Replace the belt cleaning unit.
