Technical Bulletin

Model: MET-C2yz	Date: 13-May-16	No.: RD244001i
-----------------	-----------------	----------------

Subject: Firmware Release Note: System/Copy		Prepared by: M. Kumagai	
Classification:	<input type="checkbox"/> Troubleshooting <input type="checkbox"/> Mechanical <input type="checkbox"/> Paper path <input type="checkbox"/> Product Safety	<input type="checkbox"/> Part information <input type="checkbox"/> Electrical <input type="checkbox"/> Transmit/receive <input checked="" type="checkbox"/> Other (Firmware)	<input type="checkbox"/> Action required <input type="checkbox"/> Service manual revision <input type="checkbox"/> Retrofit information <input checked="" type="checkbox"/> Tier 2

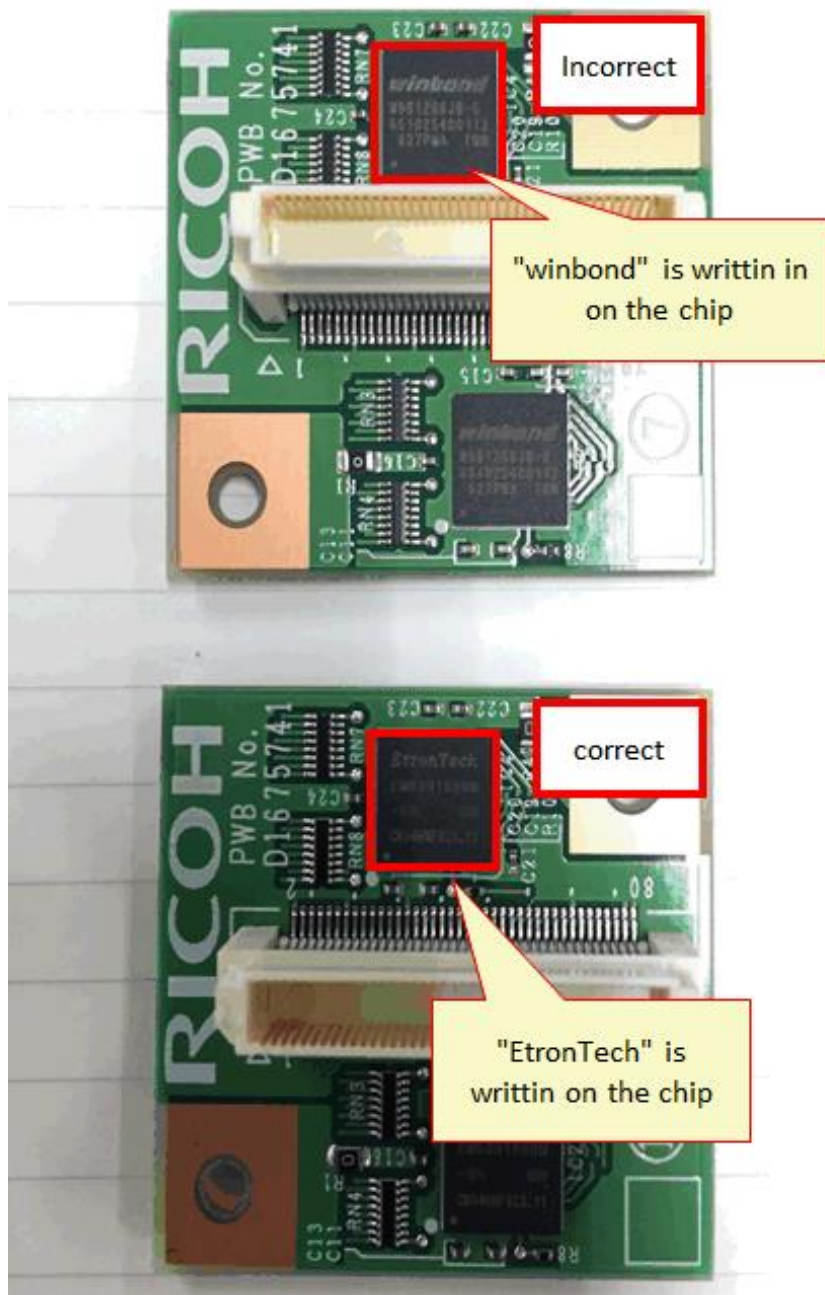
- Incorrect (affected) is the chip with "winbond" written on it.
- Correct (Not affected) is the chip with "EtronTech" written on it.

Replace the Fax Memory Unit with the modified one.

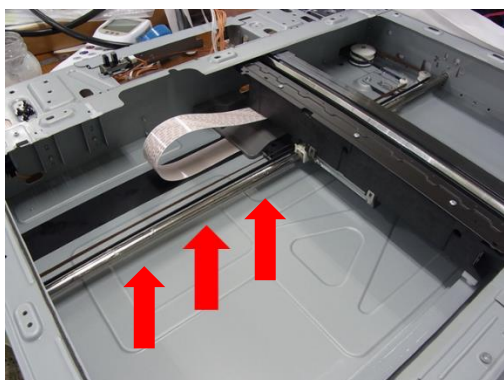
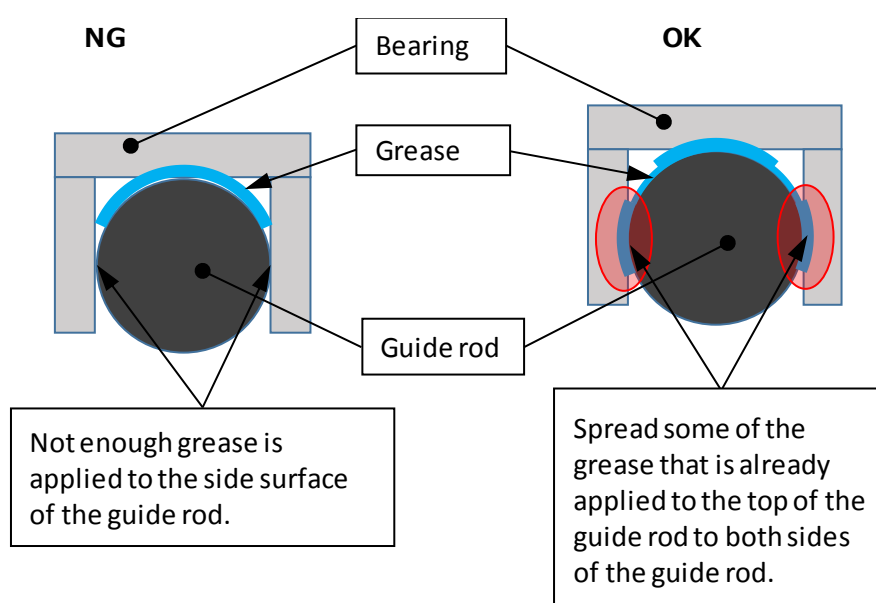
Not enough grease is applied to the side surface of the guide rod. As a result, there is friction between the scanner carriage and guide rod on both sides.

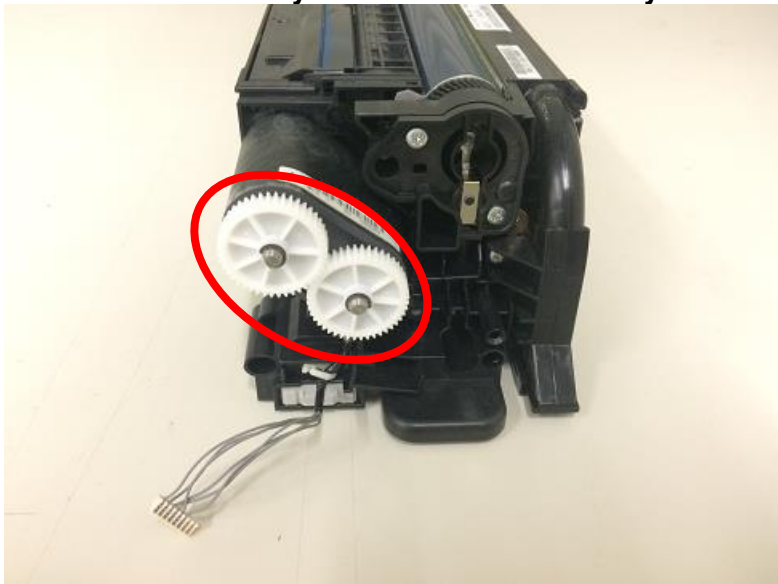
As one of the reasons that cause this symptom, the development unit was stored/transported in a position prior to its installation. This causes developer to accumulate on the gears at either end of the unit, disabling proper rotation of the development roller.

For Metis-C1abcdeyzk and Metis-C2abcdeyz

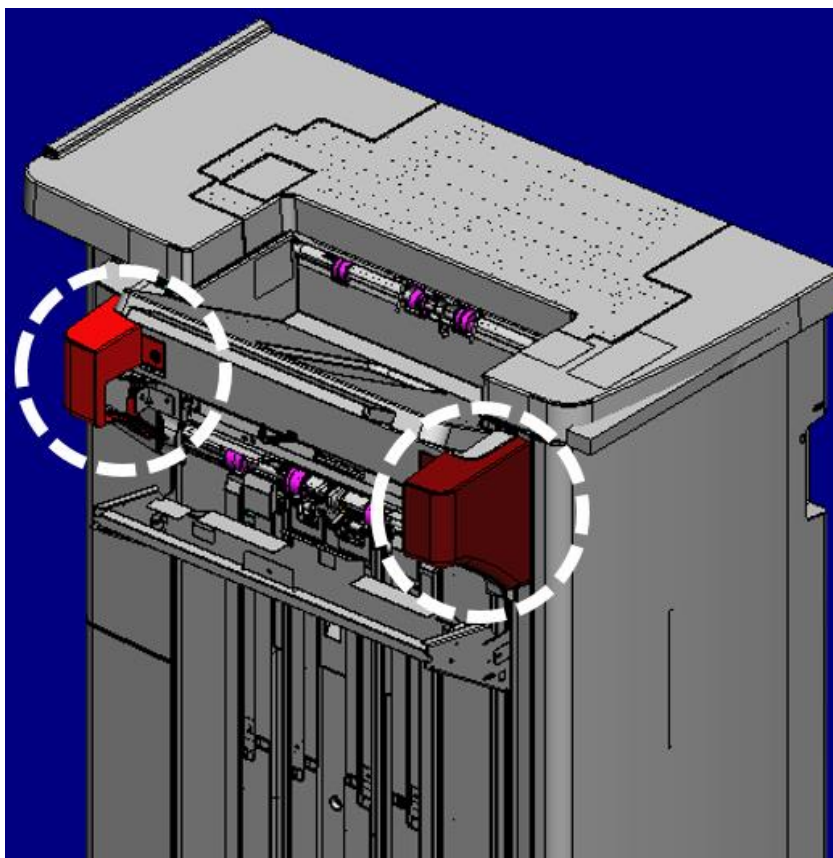
Do NOT take hold of the guide cover highlighted in RED when installing the finisher (SR3230/SR3240).

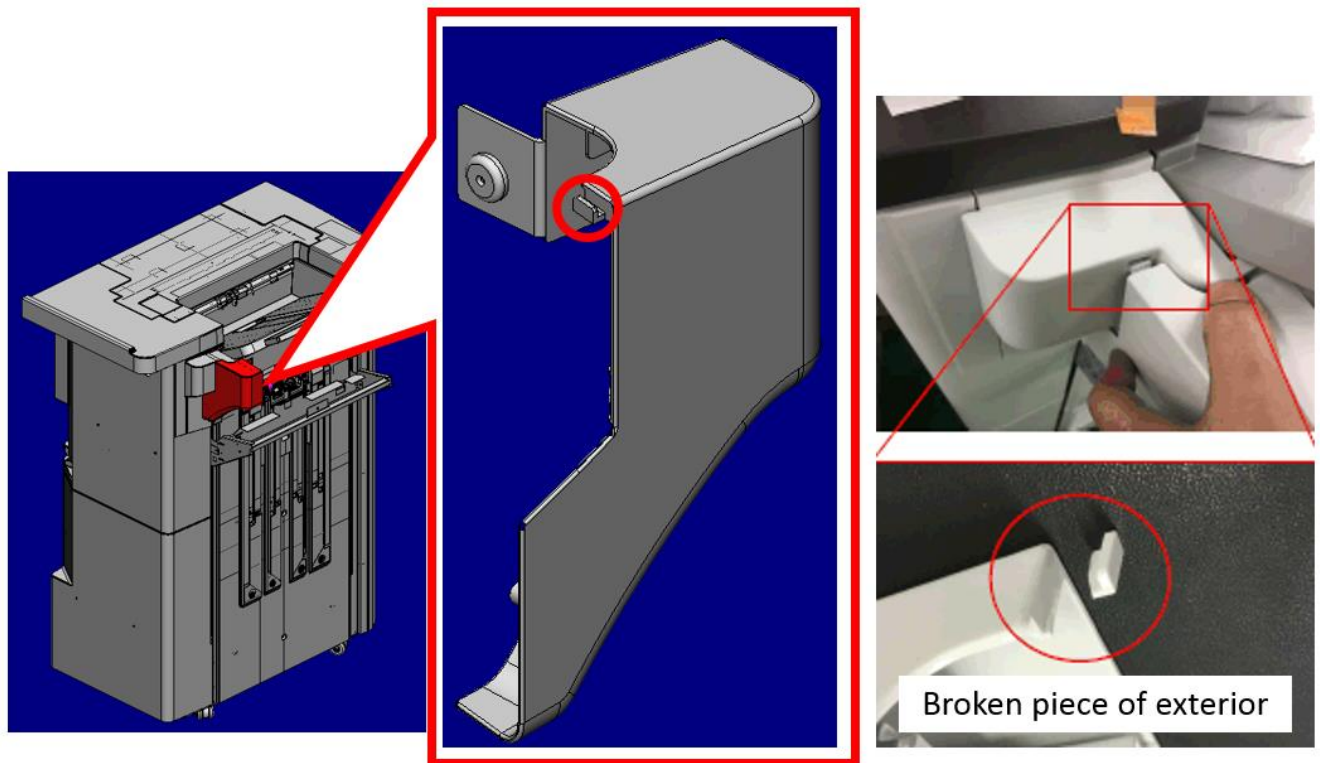
Fig.1

SC720-83 occurs due to breakage of the guide cover.

The broken piece drops into the clearance between the paper guide (GUIDE: PAPER: REAR: ASS'Y) and the exterior cover (COVER: PAPER: GUIDE) circled in YELLOW. (Fig.2)

This prevents the paper guide from returning to the home position.

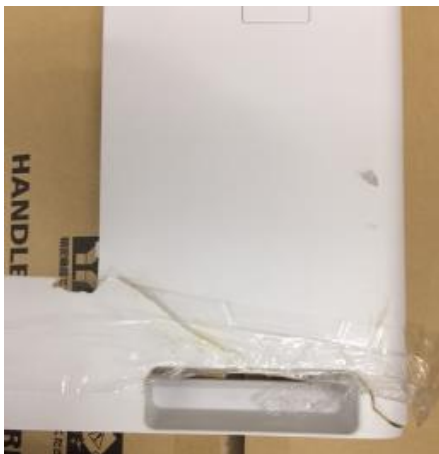
Figure.4 Broken right rear cover

Figure.3 Incorrect

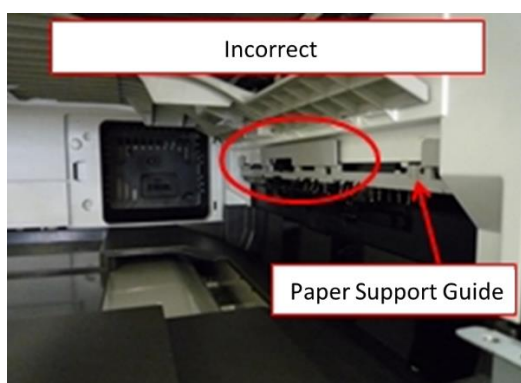
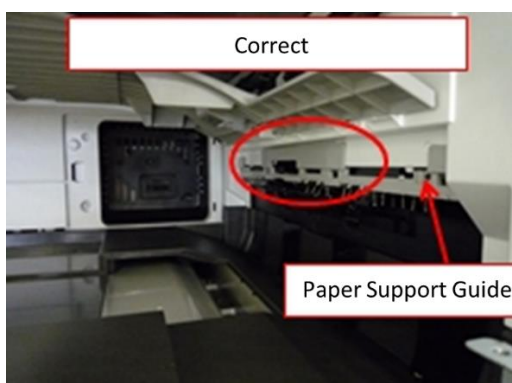
The paper support guide was incorrectly installed.

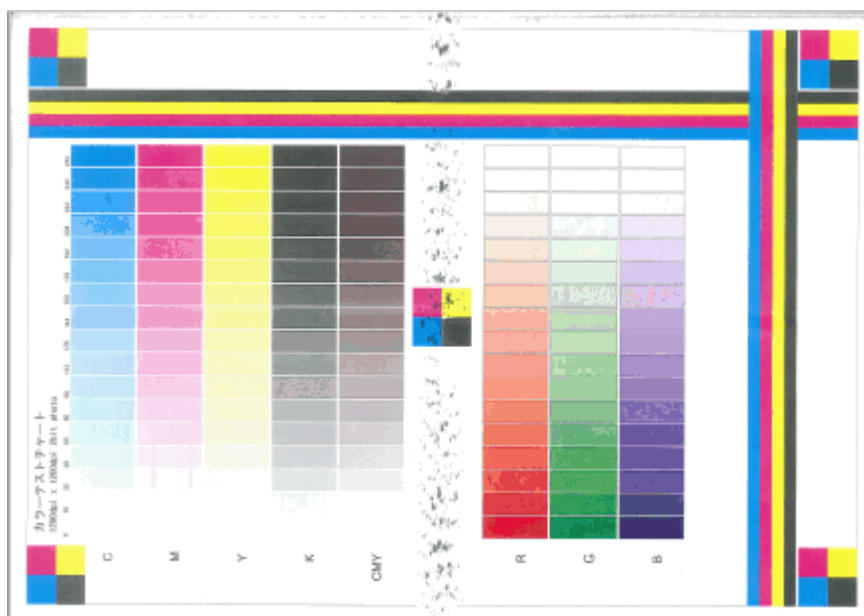
Developer drops onto the center area of the image when printing onto thick paper in half-speed mode.
