Model: AP-C2	Date: 10-Sep-08	No.: RD029001b
--------------	-----------------	----------------

Subject: Firmware Release Note: Language Install		Prepared by: T.Kiyohara	
From: 2nd Tech. Support Sec. Service Support Dept.			
Classification:	<input type="checkbox"/> Troubleshooting	<input type="checkbox"/> Part information	<input type="checkbox"/> Action required
	<input type="checkbox"/> Mechanical	<input type="checkbox"/> Electrical	<input type="checkbox"/> Service manual revision
	<input type="checkbox"/> Paper path	<input type="checkbox"/> Transmit/receive	<input type="checkbox"/> Retrofit information
	<input type="checkbox"/> Product Safety	<input checked="" type="checkbox"/> Other ()	<input checked="" type="checkbox"/> Tier 2

Subject: Firmware Release Note: Engine		Prepared by: Y.Urushihara	
From: 1st Tech Service Sect., MFP/Printer Tech Service Dept			
Classification:	<input type="checkbox"/> Troubleshooting	<input type="checkbox"/> Part information	<input type="checkbox"/> Action required
	<input type="checkbox"/> Mechanical	<input type="checkbox"/> Electrical	<input type="checkbox"/> Service manual revision
	<input type="checkbox"/> Paper path	<input type="checkbox"/> Trans

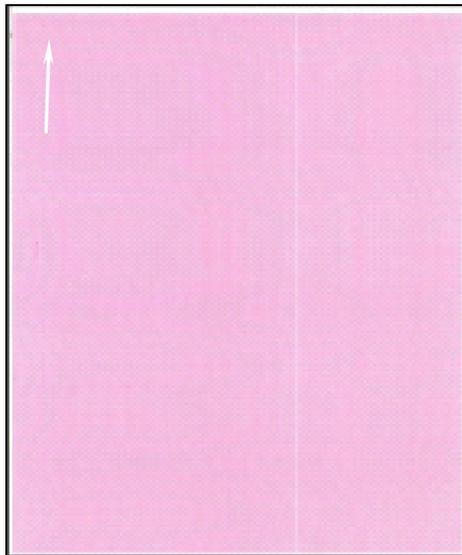
A white line is visible on the printout, as shown in the sample below:

5. Print out five or more sheets of the 2-by-2 sample, and check the image quality. If this does not solve the symptom, replace the developer.

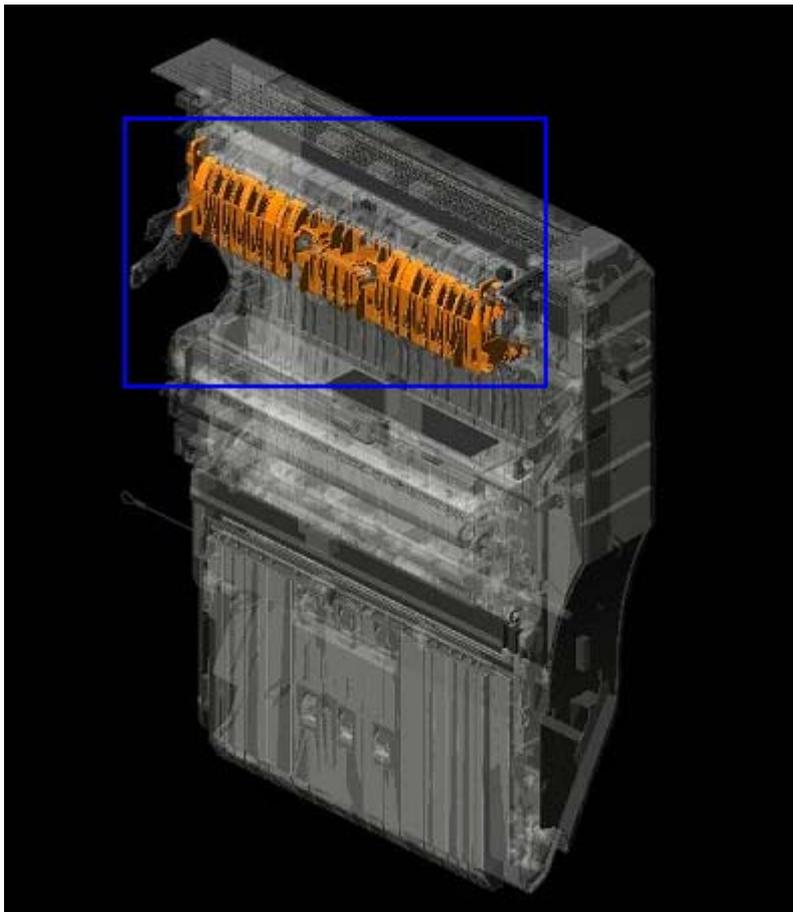
High temperature and a mechanical load cause the fusing entrance guide plate to bend.

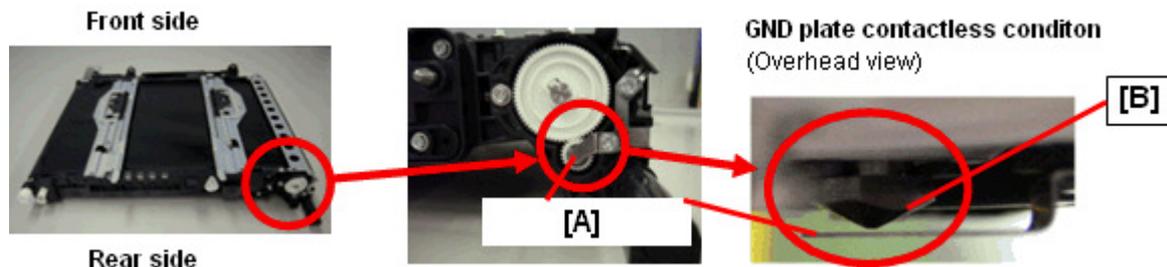
Sometimes, the GND plate at the rear side of the ITB cleaning unit [A] does not touch the lubrication application shaft [B]. As a result, a minor electrical leak occurs, which can trigger electrical noise. Sometimes, this effect appears as lines at 110mm intervals.

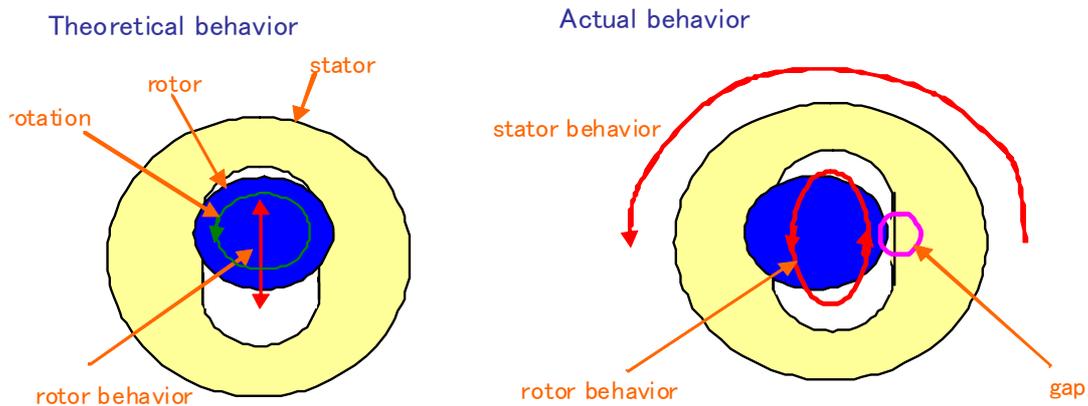
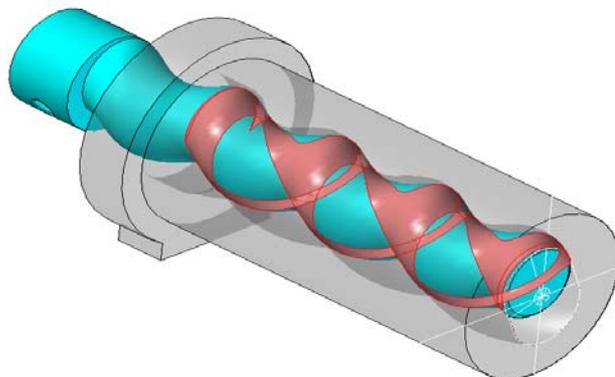
The rotor inside the pump unit moves in an elliptical pattern (instead of straight up and down), as shown in the illustration on the right below. This causes a gap to form between the rotor and stator. As a result, toner is not supplied correctly from the toner bottle to the development unit, and the machine incorrectly detects the Toner End condition.

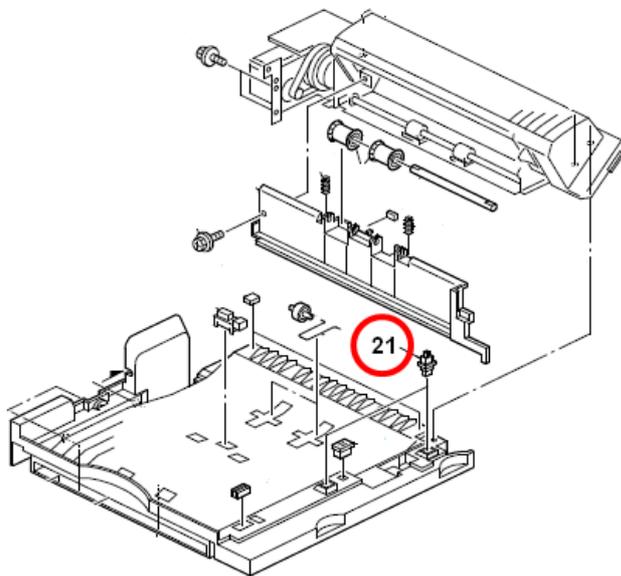
Jam 1 (Cover open) occurs frequently in the BU3030 Bridge unit.
 If you replace the push switch in the red circle below, this symptom occurs again.

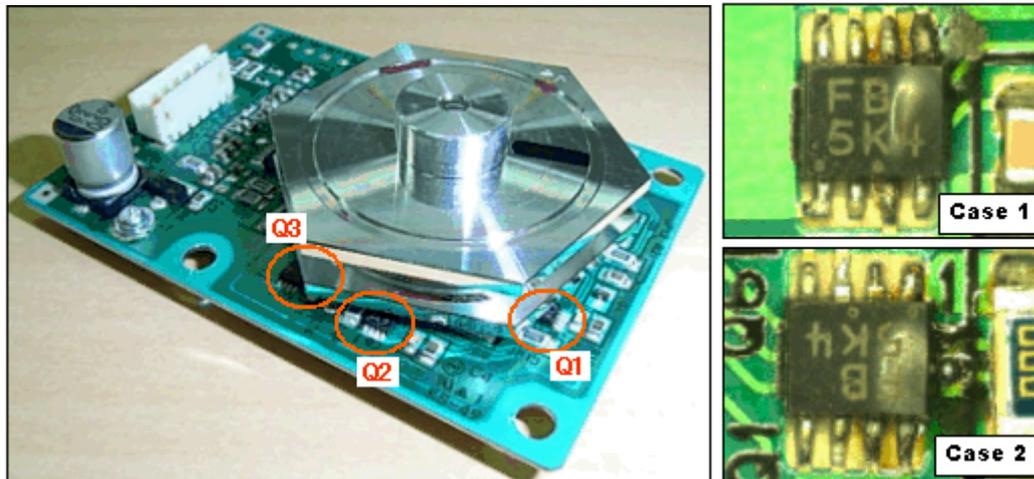
Note: The circuit breaks in the three areas circled in red below.

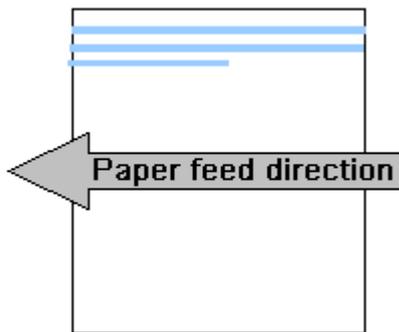
Horizontal black or colored lines, dirty background

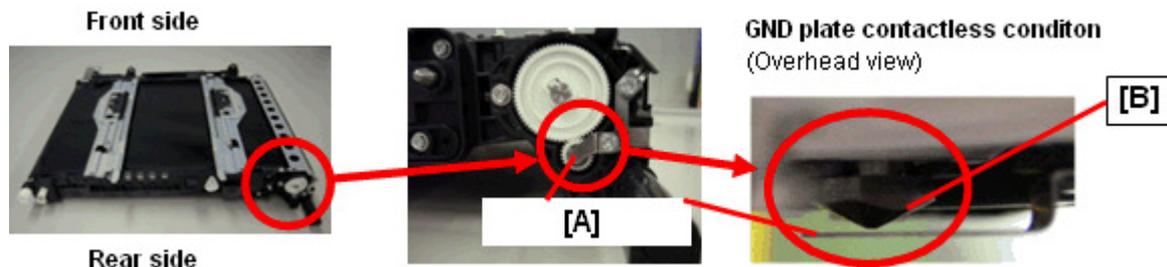
Sometimes, the GND plate at the rear side of the ITB cleaning unit [A] does not touch the lubrication application shaft [B]. As a result, a minor electrical leak occurs, which can trigger electrical noise. Sometimes, this effect appears as lines at 110 mm intervals.
