Model: V-C2	Date: 15-Nov-07	No.: RD014001o
-------------	-----------------	----------------

Subject: Firmware Release Note: Engine		Prepared by: C. Shimaji	
From: 1st Tech Service Sect., MFP/Printer Tech Service Dept			
Classification:	<input type="checkbox"/> Troubleshooting	<input type="checkbox"/> Part information	<input type="checkbox"/> Action required
	<input type="checkbox"/> Mechanical	<input type="checkbox"/> Electrical	<input type="checkbox"/> Service manual revision
	<input type="checkbox"/> Paper path	<input type="checkbox"/> Transmit/receive	<input type="checkbox"/> Retrofit information
	<input checked="" type="checkbox"/> Other ()

This RTB has been issued to announce the firmware release information for the **Engine**.

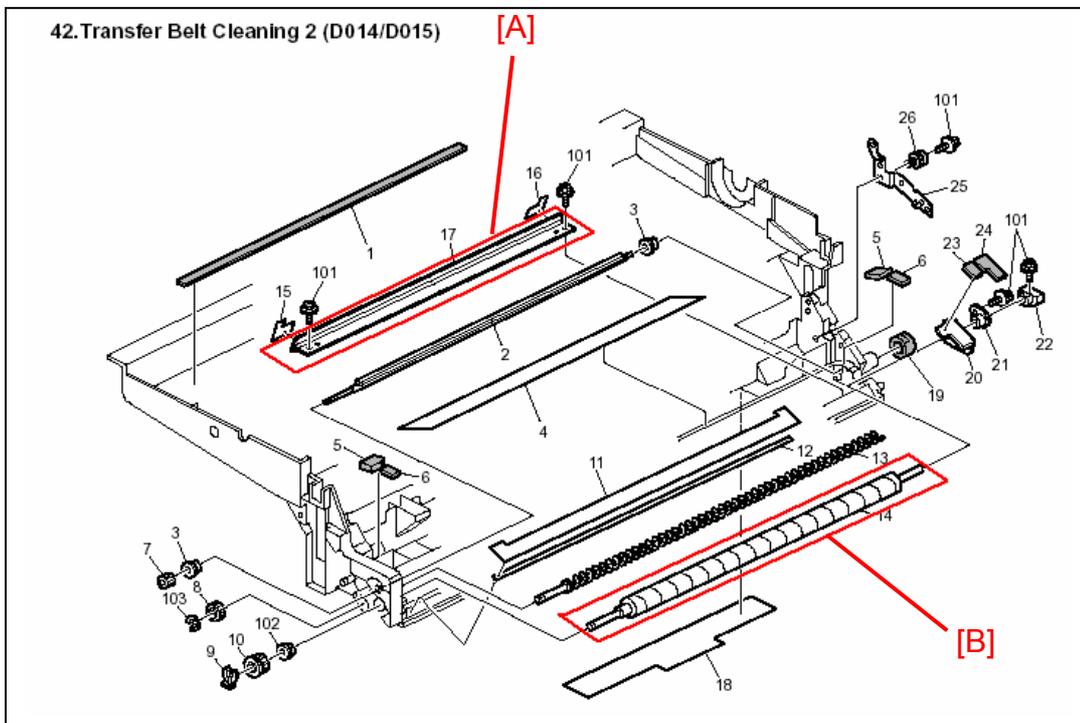
A manufacturing error in the brush scraper [A] causes damage to the ITB cleaning brush [B].

Note: For the replacement procedure, see the Service Manual.

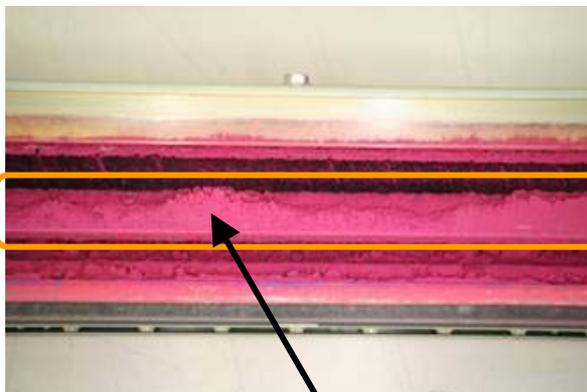
Mixture of lubricant powder and toner

Under low-temperature/low-humidity conditions, a mixture of lubricant powder and toner leaks out from the lubricant supply blade. As a result, white lines are produced on the surface of the charge roller.

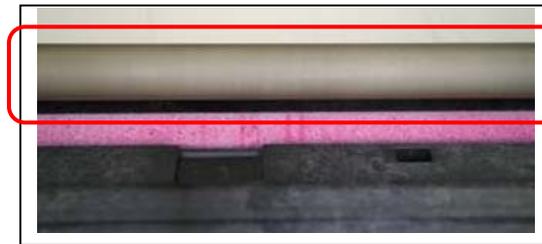
White lines can be cleaned off the surface using a dry cloth

- Make sure that dust does not get reattached to the roller surface.
- If you cannot clean the charge roller as shown in the photo below (white lines are completely removed), replace the charge roller.

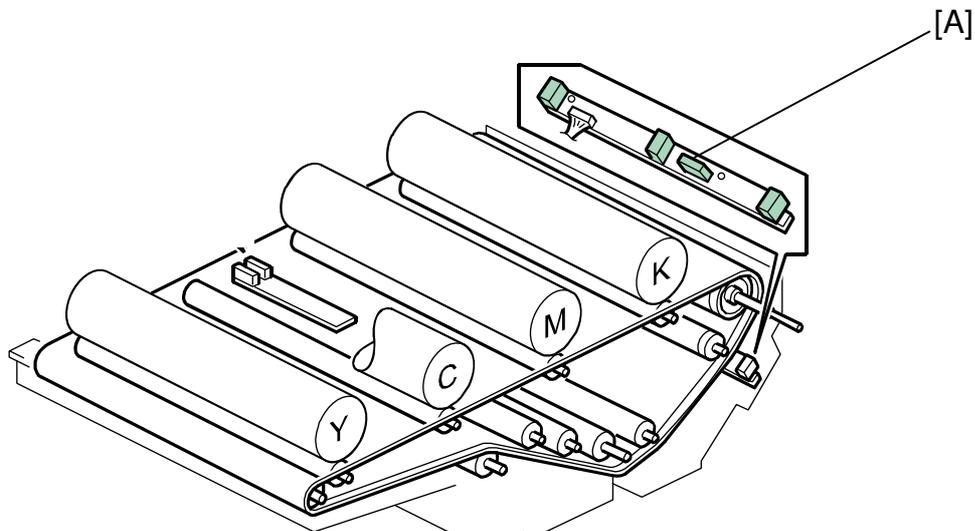
ID sensor [A] is dirty with toner.

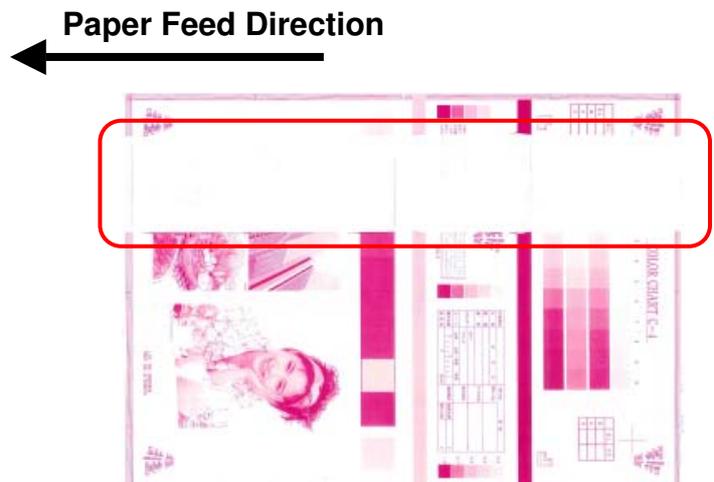
The image is missing in the area shown below (K, Y, C, and M).

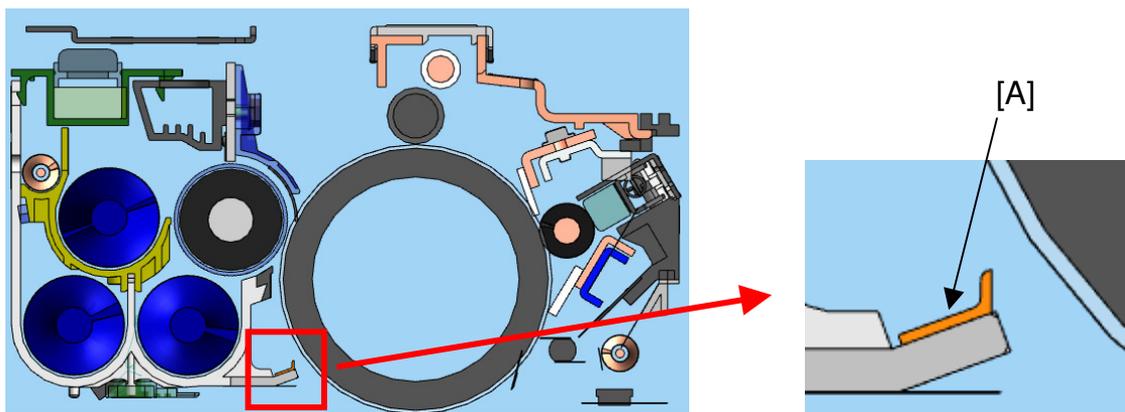
The toner catchpan [A] is not attached to the development unit (P/N: D0143005) in the correct position. This causes the catchpan to touch the OPC drum and remove toner from the surface in this area.

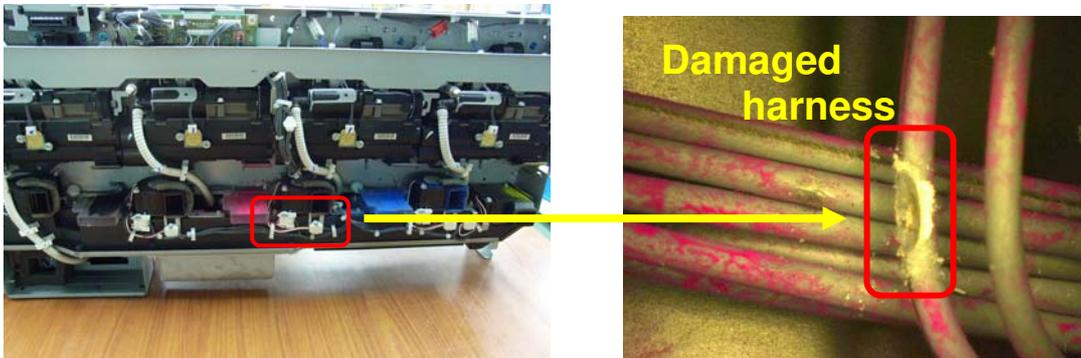
If the harness is damaged severely, a short circuit may occur and damage the PCB: CNB (D0145440).

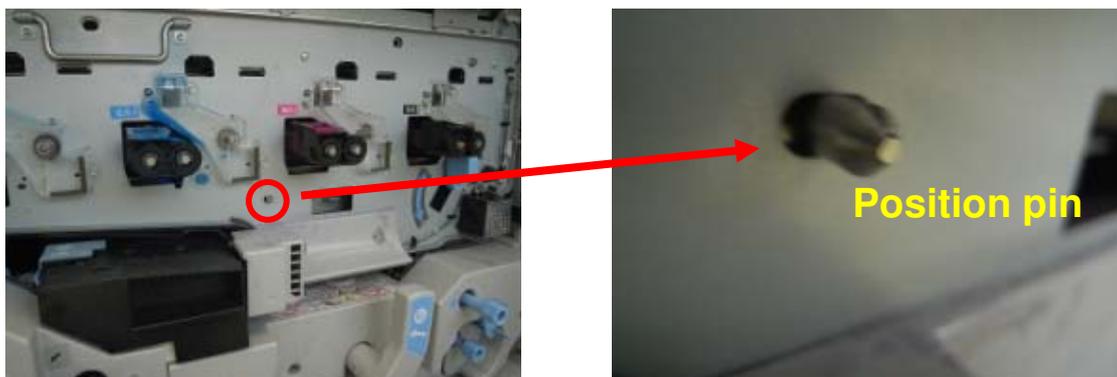
The harness is pinched and ultimately damaged by the positioning pin shown in the photo below.

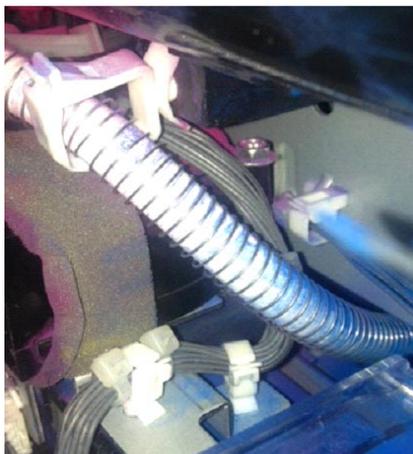
Correct

- Make sure to wire the harness **behind** the tube and **in front of** the screw. If you wired the harness around the screw as shown in the "Incorrect" photo, the screw head may damage and short the harness.

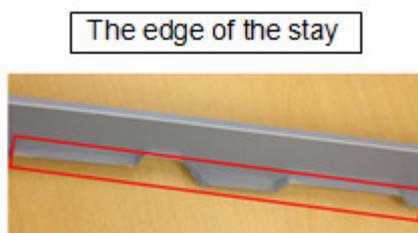
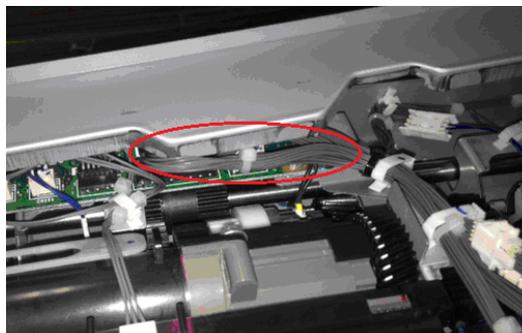
(The harness is pinched between the edge of the bracket and the surrounding part)

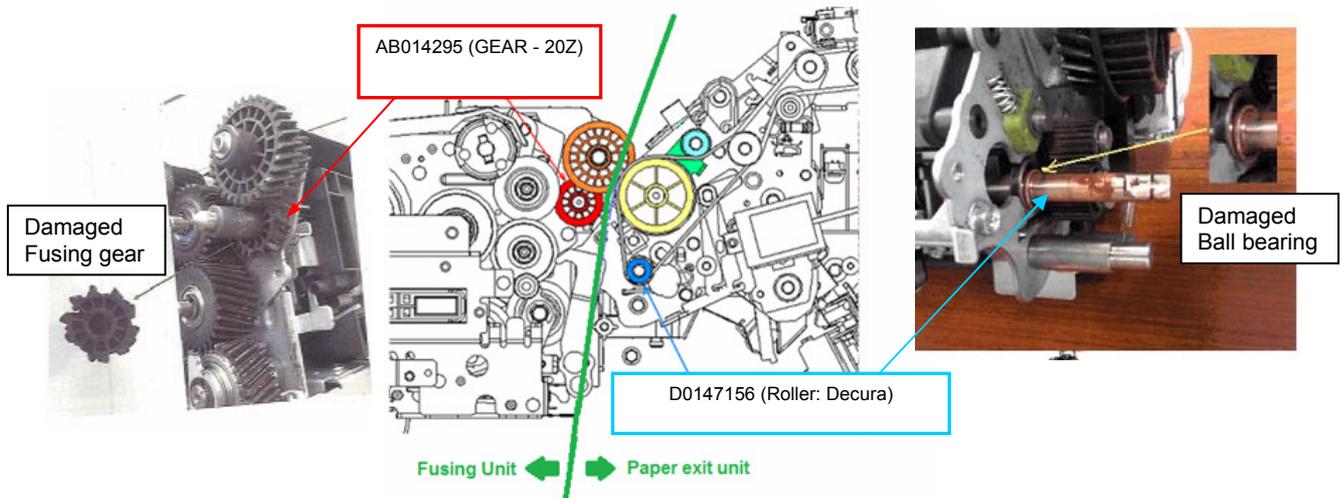
Lower durability in some decurler rollers may damage the ball bearings. As a result, if the machine is used in this condition, the fusing gear (GEAR - 20Z) may also break.

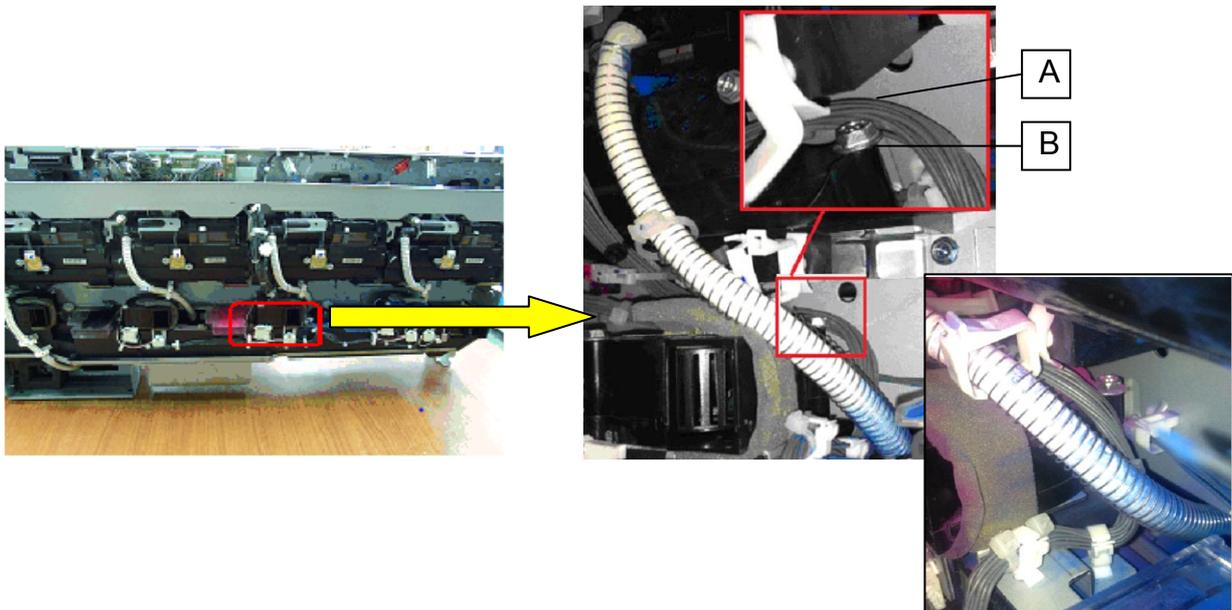
It was not defined where the harness covering was cut. It was assumed that the harness covering might be cut by the edge of the screw head while replacing the toner supply unit and/or toner hopper duct unit.
