Model: V-C3	Date: 11-Dec-09	No.: RD081001c
-------------	-----------------	----------------

Subject: Firmware Release Note: Printer		Prepared by: T. Toriumi	
From: 1st Overseas Tech Support Sec., 1st PQM Dept.			
Classification:	<input type="checkbox"/> Troubleshooting	<input type="checkbox"/> Part information	<input type="checkbox"/> Action required
	<input type="checkbox"/> Mechanical	<input type="checkbox"/> Electrical	<input type="checkbox"/> Service manual revision
	<input type="checkbox"/> Paper path	<input type="checkbox"/> Transmit/receive	<input type="checkbox"/> Retrofit information
	<input type="checkbox"/> Product Safety	<input checked="" type="checkbox"/> Other (Firmware)	<input checked="" type="checkbox"/> Tier 2

This RTB has been issued to announce the firmware release information for the **Printer**.

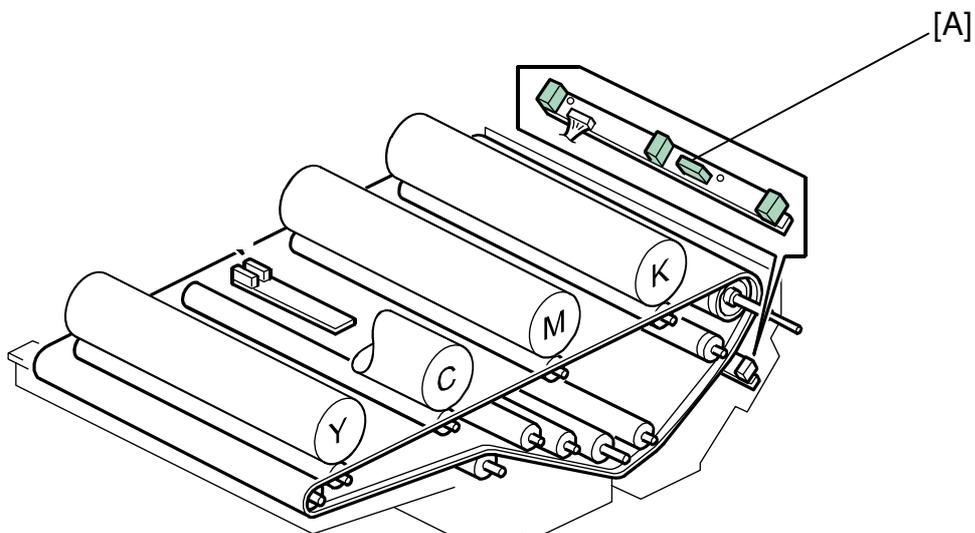
**CAUSE:**

ID sensor [A] is dirty with toner.

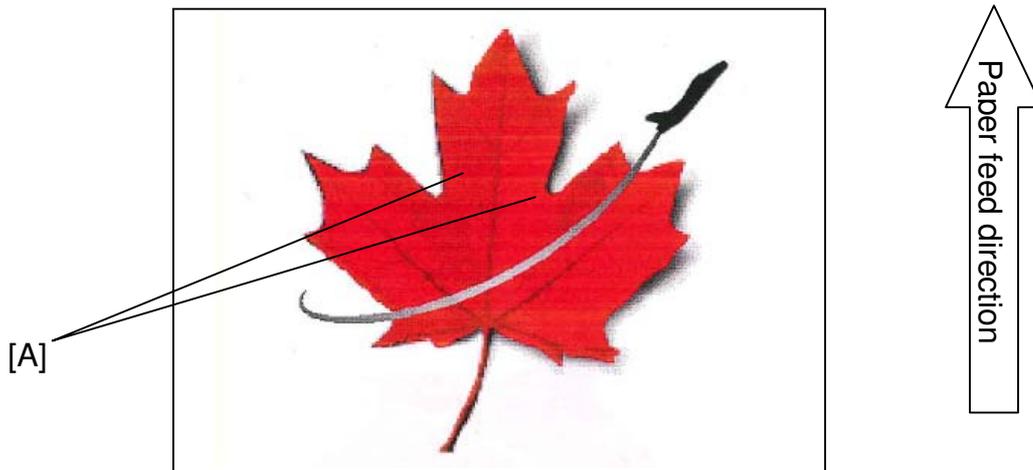
Banding [A] appears in solid images that are printed using magenta toner (the red leaf above, for example) on top of a white background.

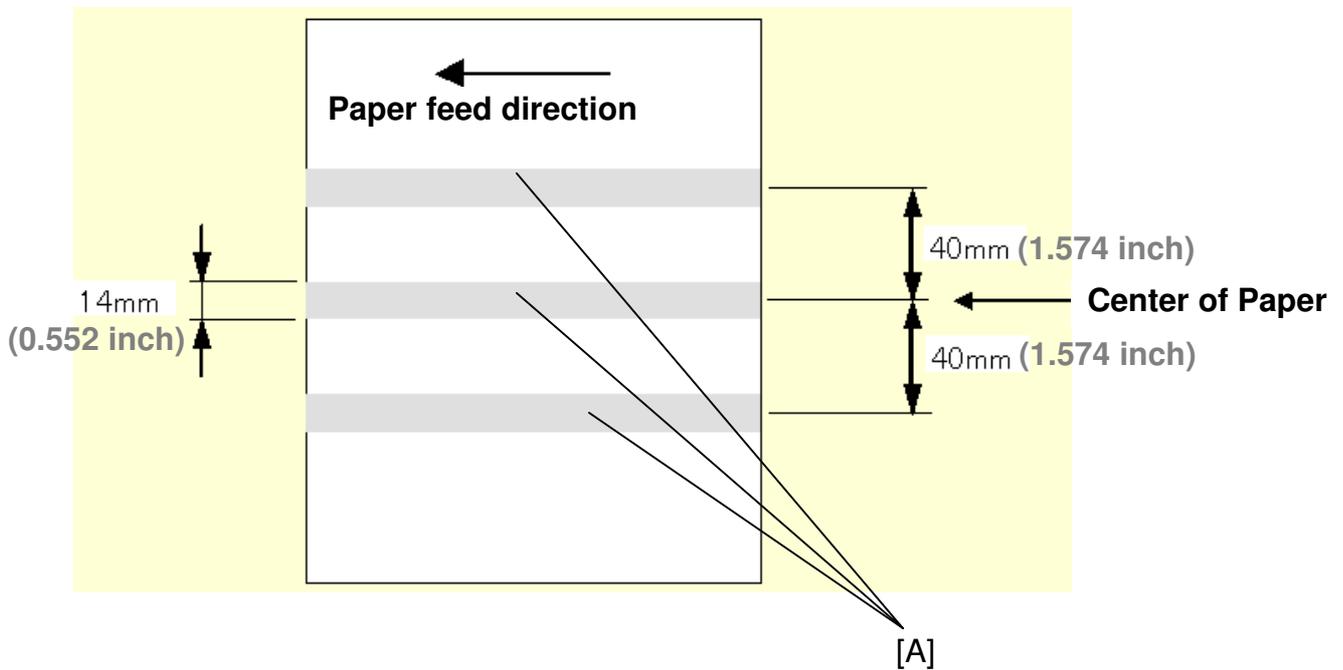
Dirty horizontal bands [A] appear at intervals of 40mm, especially under low-temperature conditions.

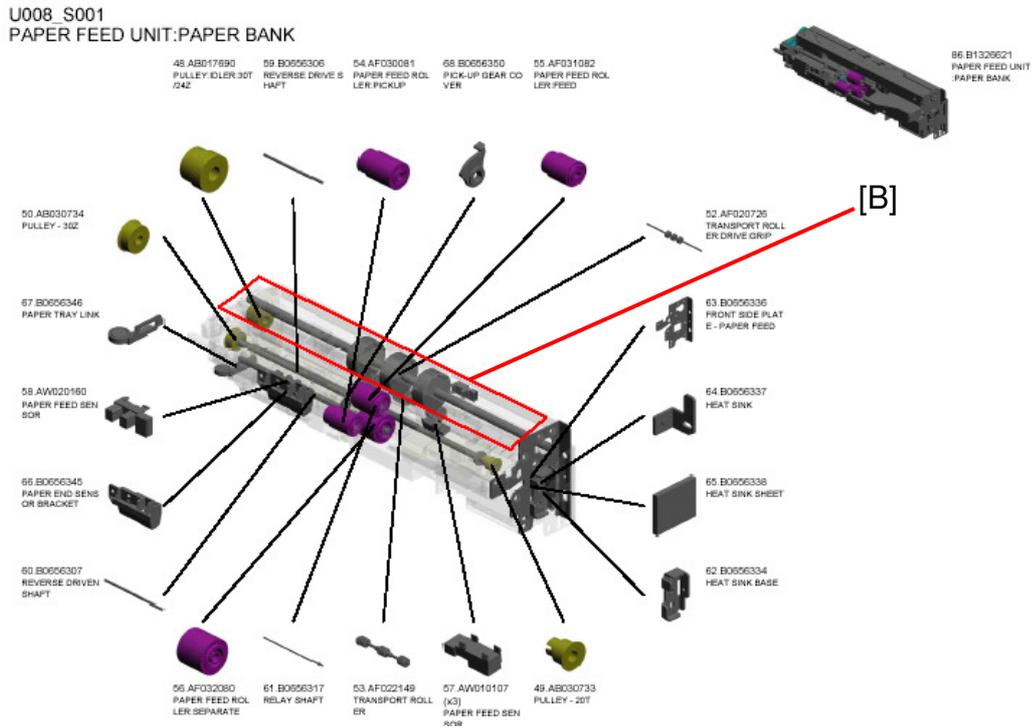
Under low-temperature conditions, paper dust tends to build up on the ITB and ITB cleaning blade (especially in the area corresponding to the position of the Paper Feed Roller [B] in the paper feed unit). These areas are damaged, and this appears on the paper as horizontal bands.

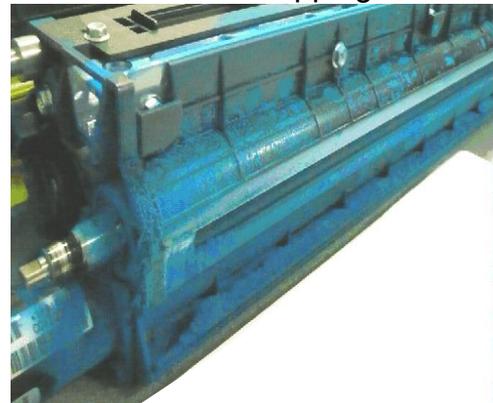
**Before toner dropping**

This amount of toner in the trough area indicates that toner dropping (scattering outside the unit) will occur in the near future. This amount of toner can build up even when the machine is used under the target color APV and environmental conditions.

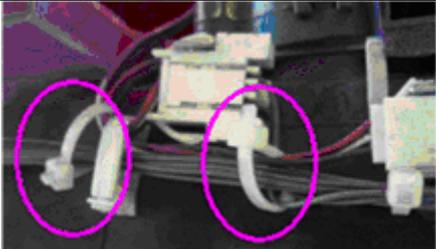
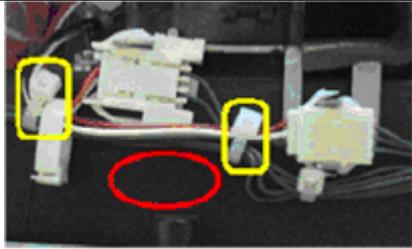
<p><b><i>INCORRECT:</i></b> The binds (circled in pink) are too loose</p>	<p><b><i>Correct:</i></b> The binds (circled in yellow) are tightened properly, so that the positioning pin of the drum face plate does not touch the harnesses (circled in red)</p>

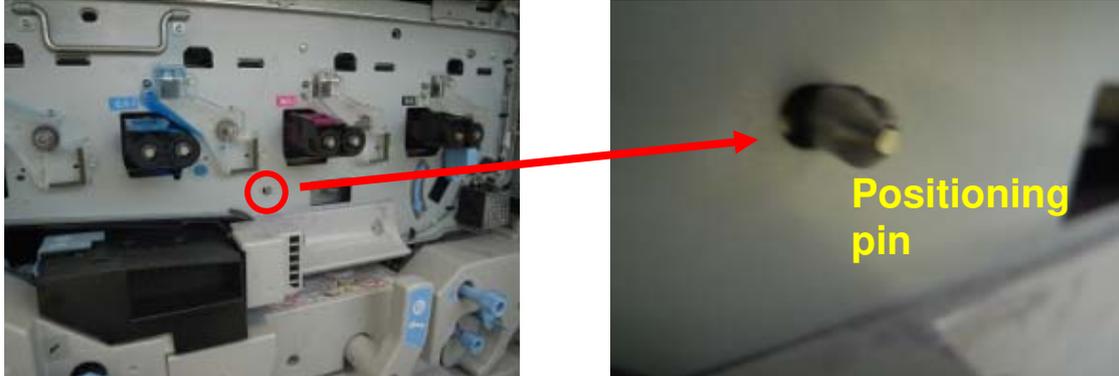
The harness is pinched and ultimately damaged by the positioning pin shown in the photo below.

2. Check the individual cables of the harness [A] for damage (See the photograph on pg. 1). For any cable that is damaged, wrap a piece of Teflon tape twice around the damaged area.

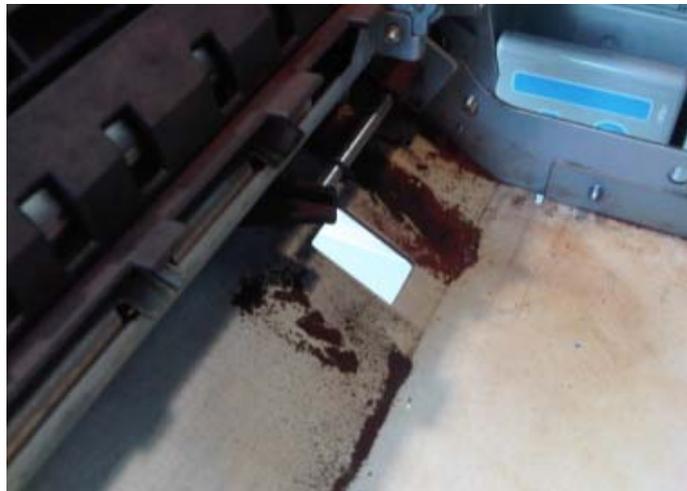
Rust powder from the fusing gears is scattered in the area under the fusing unit.

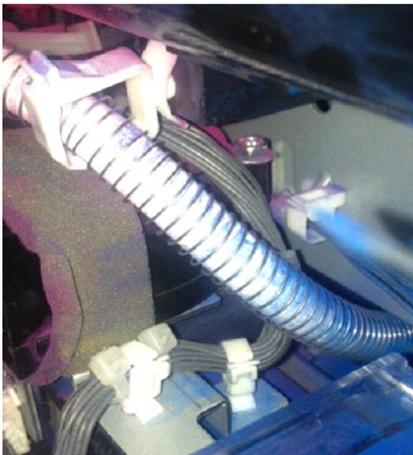
**Correct**

- Make sure to wire the harness **behind** the tube and **in front of** the screw. If you wired the harness around the screw as shown in the "Incorrect" photo, the screw head may damage and short the harness.

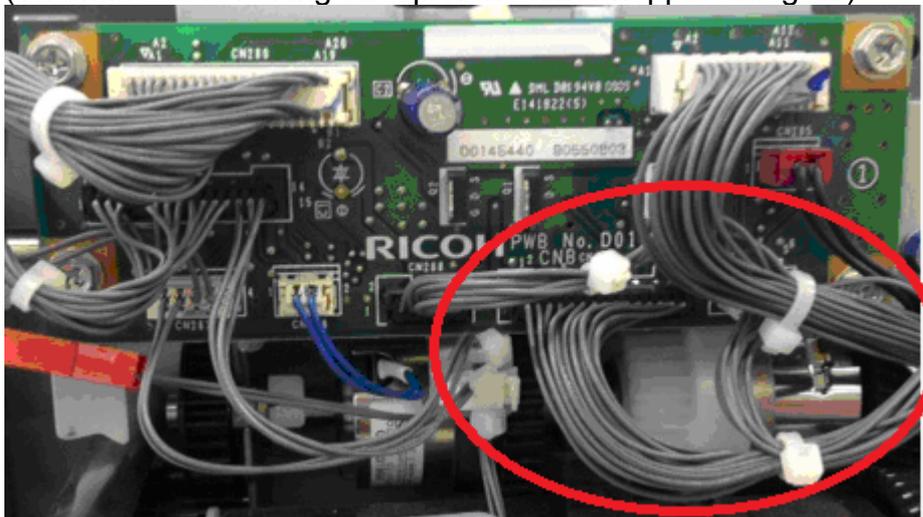
(The harness is resting on top of the toner hopper unit gear)

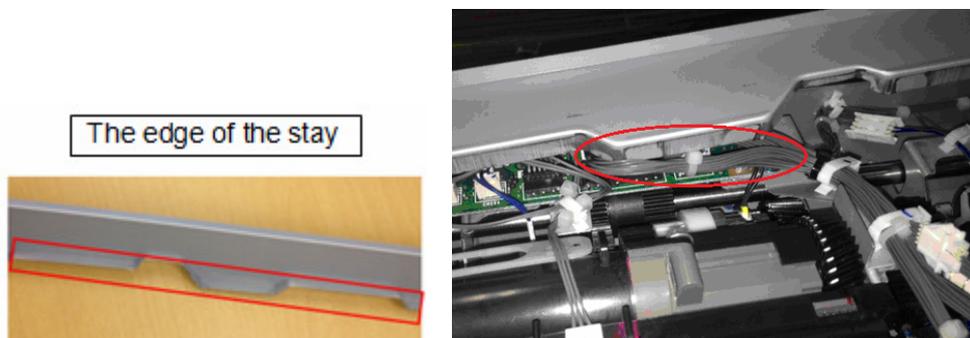
**Incorrect**

(The harness is pinched between the edge of the bracket and the surrounding part)

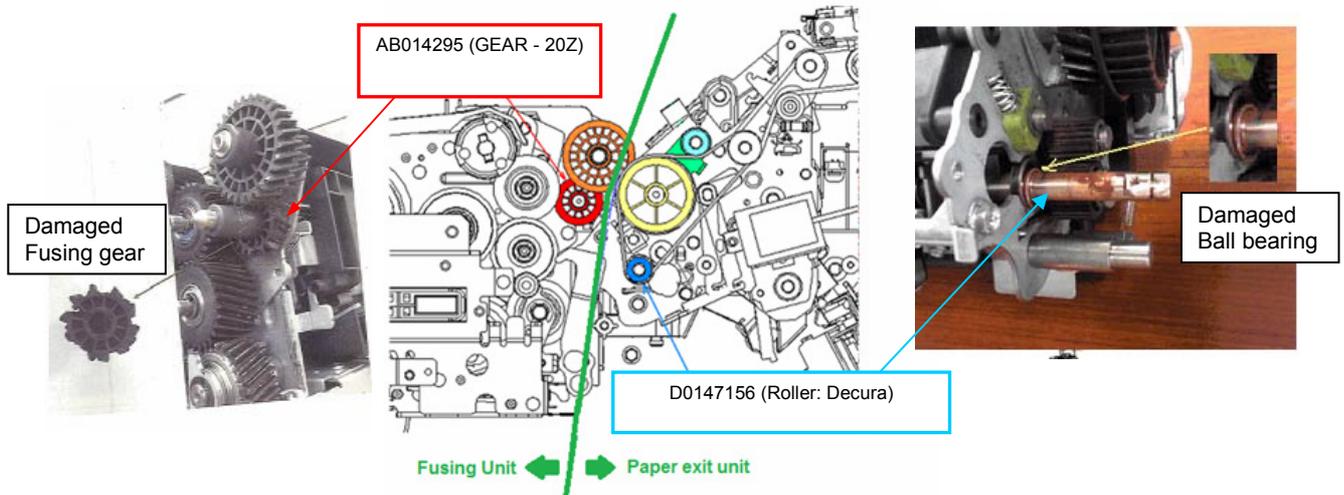
Lower durability in some decurler rollers may damage the ball bearings. As a result, if the machine is used in this condition, the fusing gear (GEAR - 20Z) may also break.

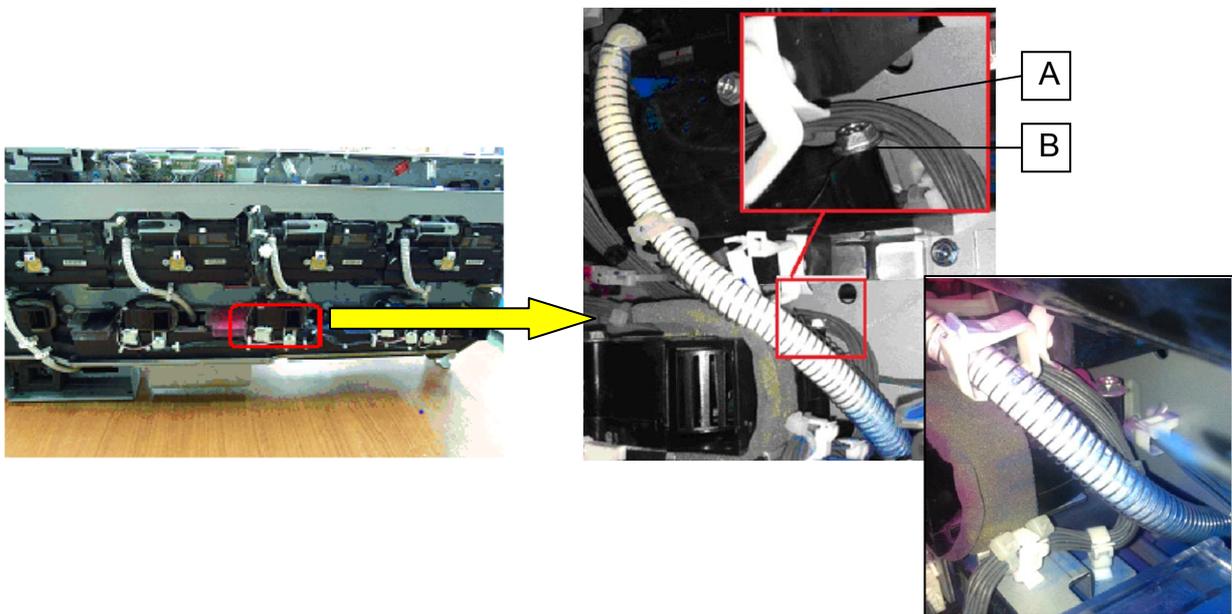
It was not defined where the harness covering was cut. It was assumed that the harness covering might be cut by the edge of the screw head while replacing the toner supply unit and/or toner hopper unit duct.
